“Yacht Club Road Study” for

## The Town of Edisto Beach

*Technical Memorandum – July 2025*

### Edisto Beach – Yacht Club Road Study

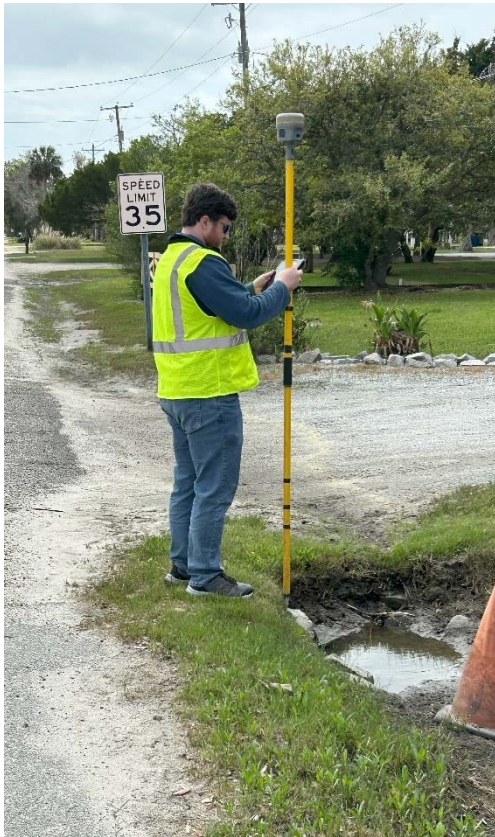
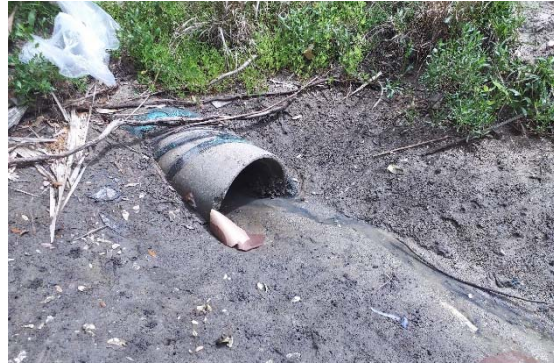
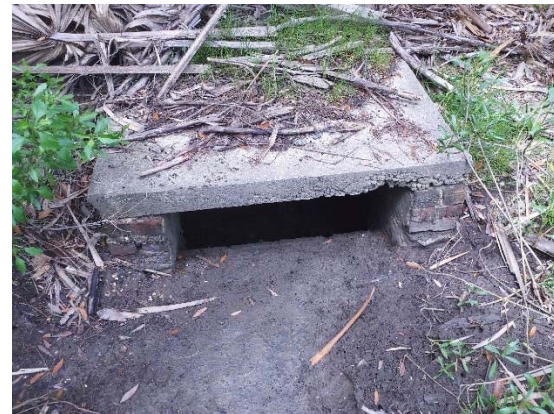
Exhibit A: Field Investigation using the R12i GPS unit and images of the system.

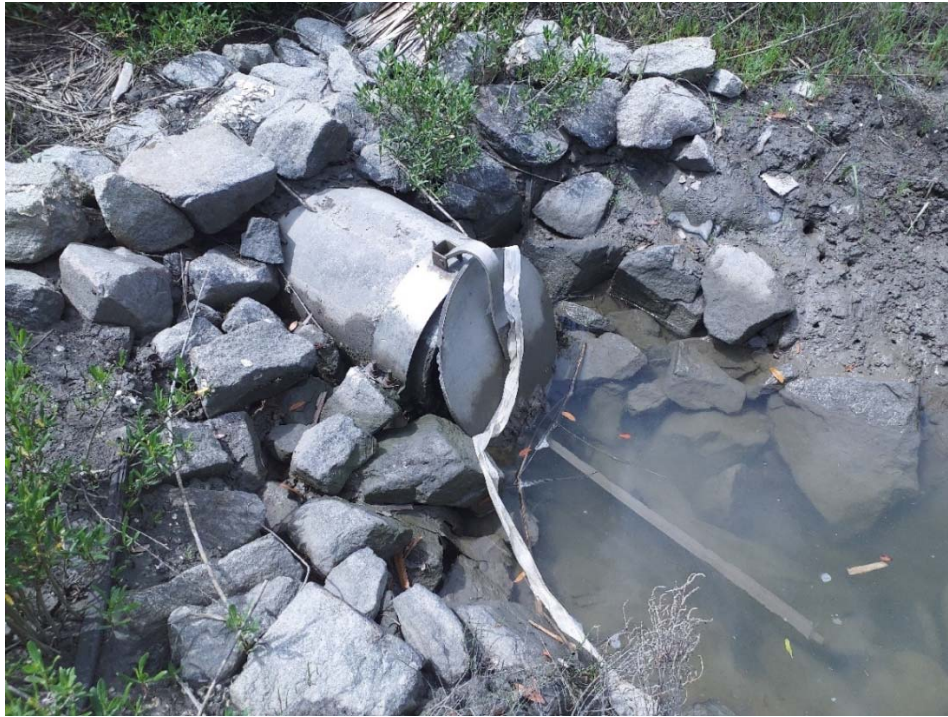
A few observations were made that could improve some of the flooding conditions until the recommended improvements can be implemented. The tide gate structure at the outfall must be restored and functional. This tide gate is currently nonfunctional due to riprap and debris impairments that do not allow for full closure of the gate and the corresponding intrusion of saltwater into the drainage system (see Exhibit B). It is also recommended that **until improvements are made to the system**, all ditches be maintained to allow for positive drainage to the existing stormwater system. The highlighted ditches to be maintained can be seen in Appendix B.

Exhibit B: The outfall Tide Gate currently is inoperable due to obstructions.

A comprehensive analysis of the Yacht Club Road Basin was carried out allowing for several improvements to be identified to reduce the flooding that is currently affecting residents and transportation in the area. These recommendations include an upsizing of the current drainage system as shown in Appendix B, an expansion of the footprint of the drainage system, the reinstatement of functionality of the tide gate at the outfall and installation of a WaSTOP Inline Check Valve on the outfall when it is replaced with a 36" RCP
