**Edisto Beach
Annual Beach & Inshore Survey**

2021
MONITORING REPORT

**2017 BEACH RESTORATION AND
GROIN LENGTHENING PROJECT
Edisto Beach, Colleton County (SC)**

SURVEY REPORT NO 4
Annual Beach and Inshore Surveys
Assessment of Beach and Groin Conditions

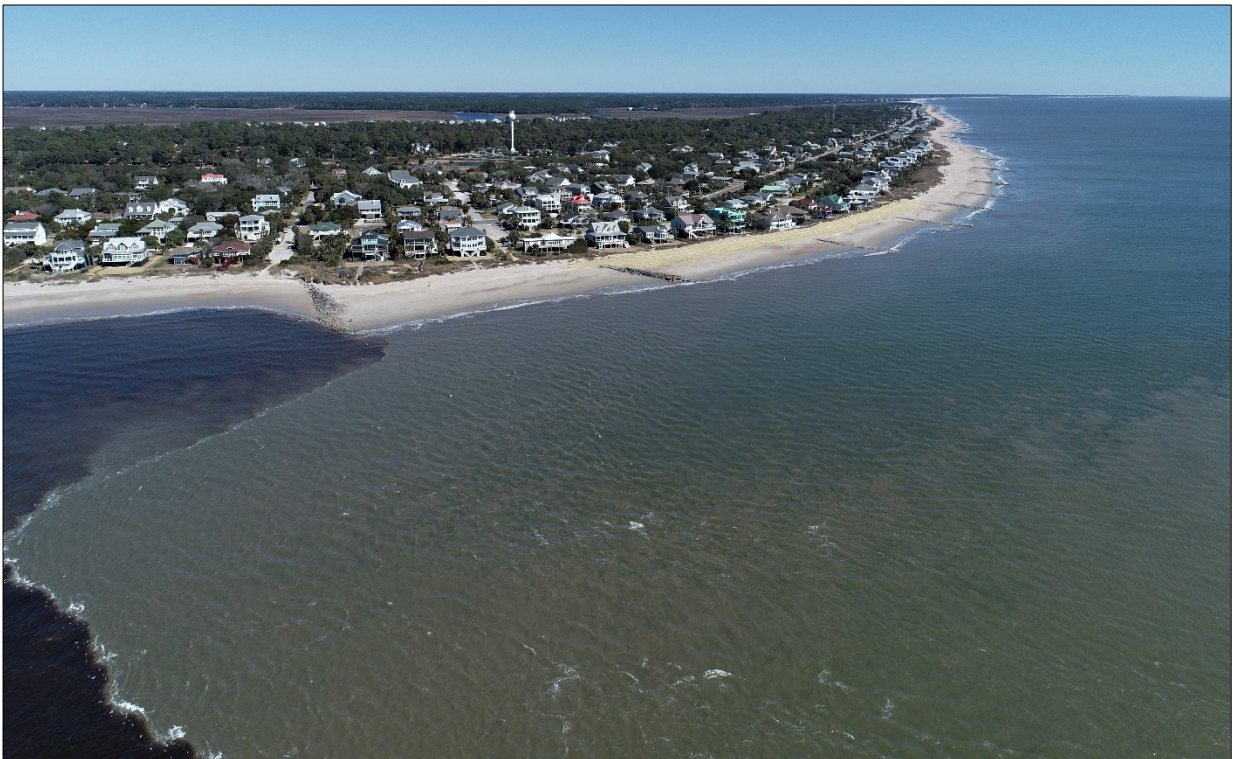
FIGURE 1.1. Edisto Beach (SC) in February 2021. [Photo by D Giles]

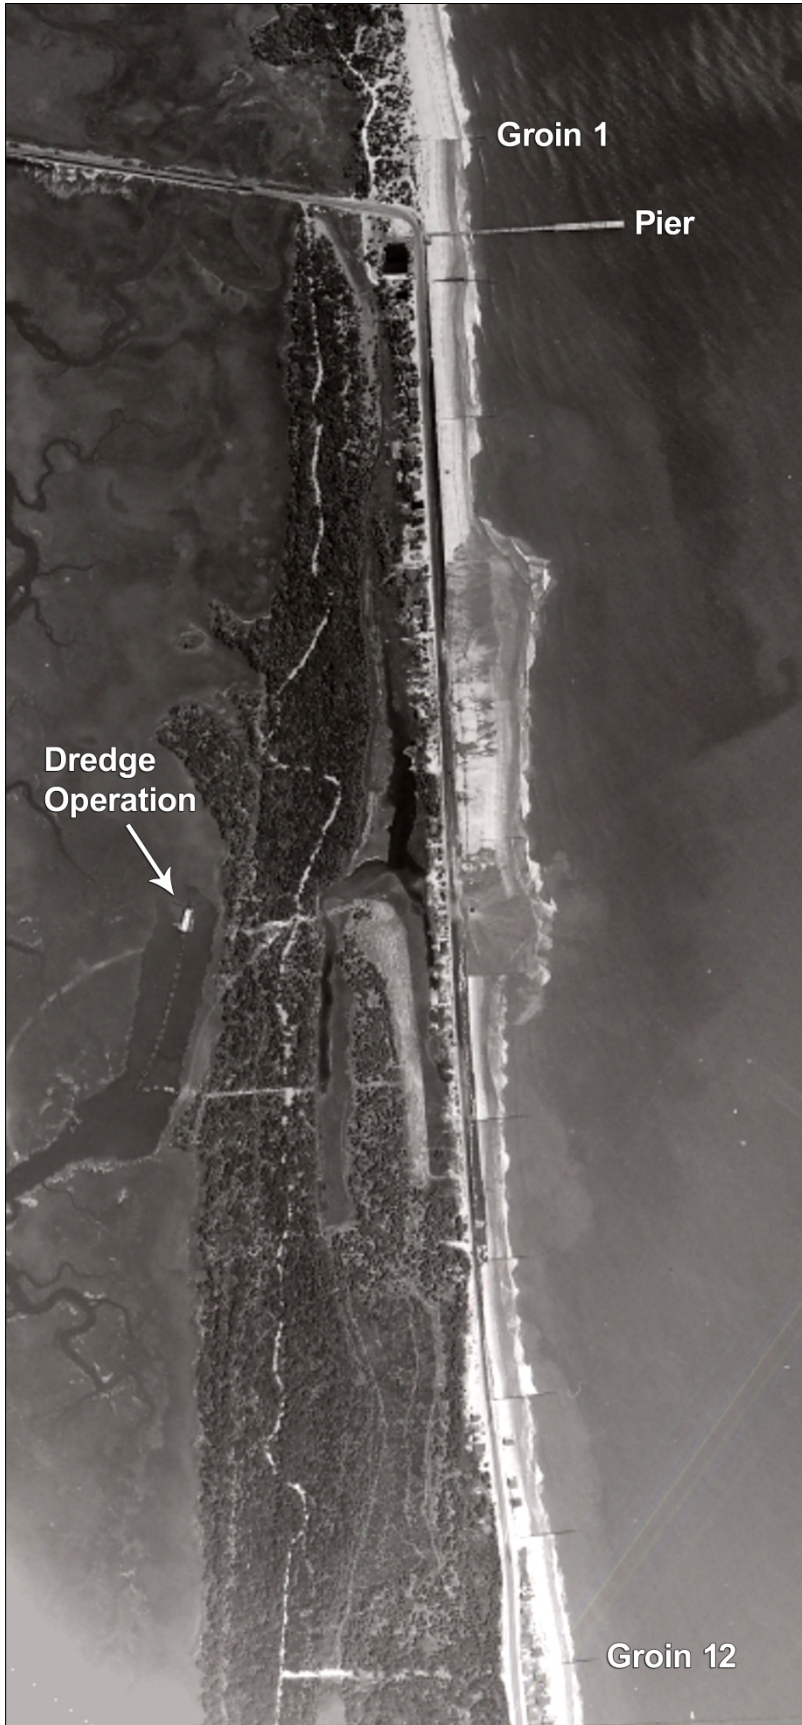
FIGURE 2.4.

May 1954 nourishment and groin construction at Edisto Beach which reclaimed oceanfront lots seaward of Palmetto Boulevard.

In the mid-1950s, erosion near the Pavilion had progressed such that groins alone were not sufficient to protect Palmetto Boulevard. The South Carolina Highway Department combined groin construction with the first nourishment of Edisto Beach in 1954 using sand, shells, and mud from the marsh behind the island (Fig 2.4). Excavations created the “boat basin” and reclaimed ~1.2 miles of shoreline between Groins 1 and 12. Much of the material was unsuitable for the beach and washed away quickly because it was too fine. The 1954 nourishment project placed ~830,000 cubic yards (cy) along 5,400 linear feet (lf) from the Pavilion south, allowing reclamation of beachfront property down to the “600” block (Kana 2012).

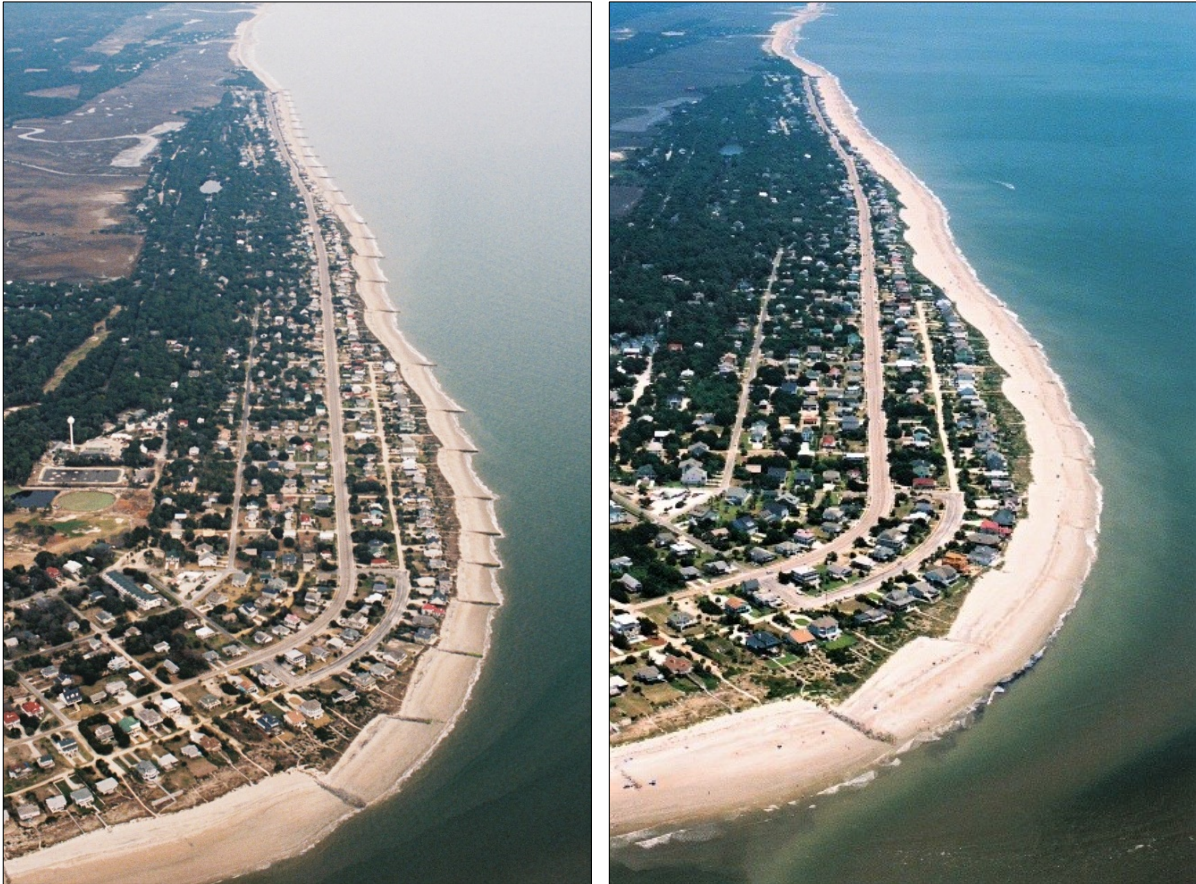
FIGURE 2.5. Aerial photographs showing the state of Edisto Beach before the 2006 renourishment (left, taken by T Kana 10 February 2006) and after project completion (right, T Kana, 9 June 2006). That project resulted in the placement of nearly 900,000 cy of beach-quality material along Edisto Island between the State Park and The Point. Notice the shoreline offset in the background of both images, highlighting the chronic erosion experienced along Edingsville Beach and between Jeremy Inlet and Edisto Beach State Park. This chronic erosion can cause sand deficits along the northern reaches of Edisto Beach itself.

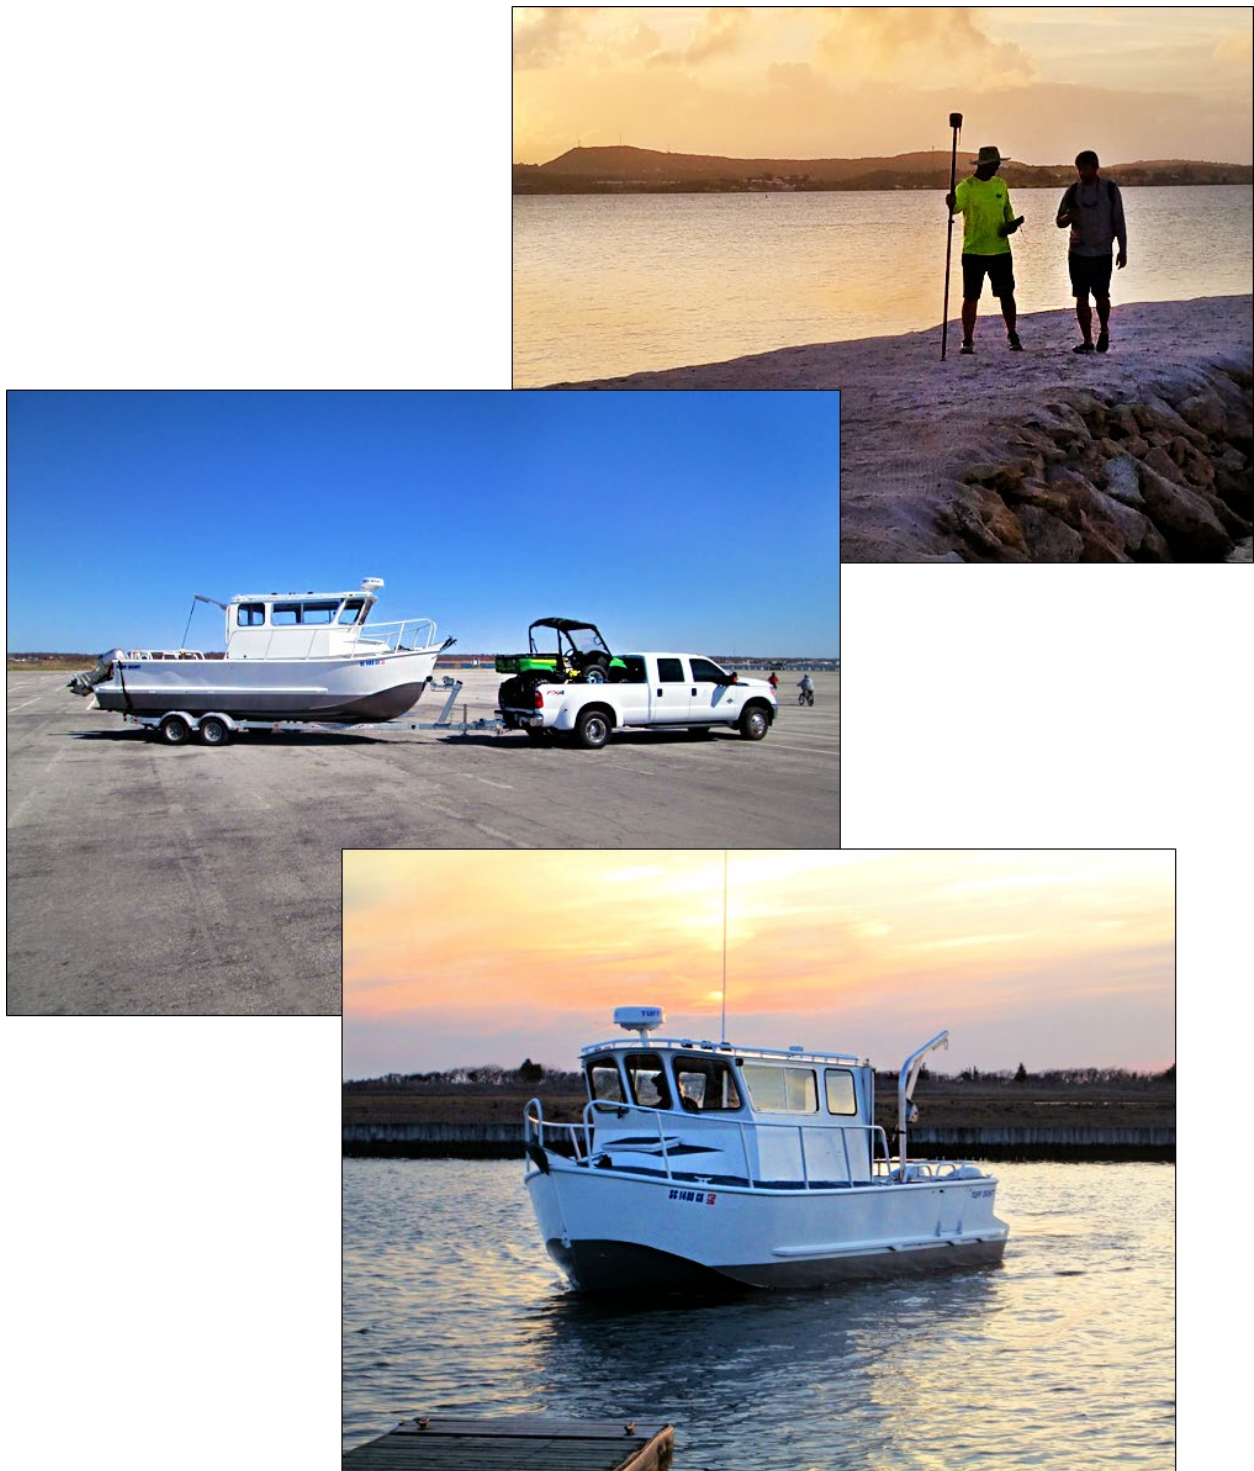
FIGURE 3.2. CSE beach monitoring methods include land-based data collection using Trimble™ RTK-GPS from the backshore to low-tide wading depth and over-water work using RTK-GPS linked to a precision echo sounder aboard CSE's survey boat (R/V *Southern Echo*).

Surveys were conducted by combining a land-based survey and a bathymetric survey. Land surveys were accomplished using an RTK-GPS between the foredune and low-tide wading depth. In contrast, over-water work was performed via RTK-GPS (Applanix™ POS MV) combined with a precision echo sounder (Odom™ Echotrac CV100) mounted on CSE’s shallow-draft research vessel (R/V *Southern Echo*) (Fig 3.2). Working around the tidal cycle, data collected on land were extended into shallow depths in the surf zone at low tide. Then data were collected from the boat at high tide such that overlap of the two surveys occurred close to shore. Appendix A includes profiles for selected dates (pre-nourishment and post-nourishment).

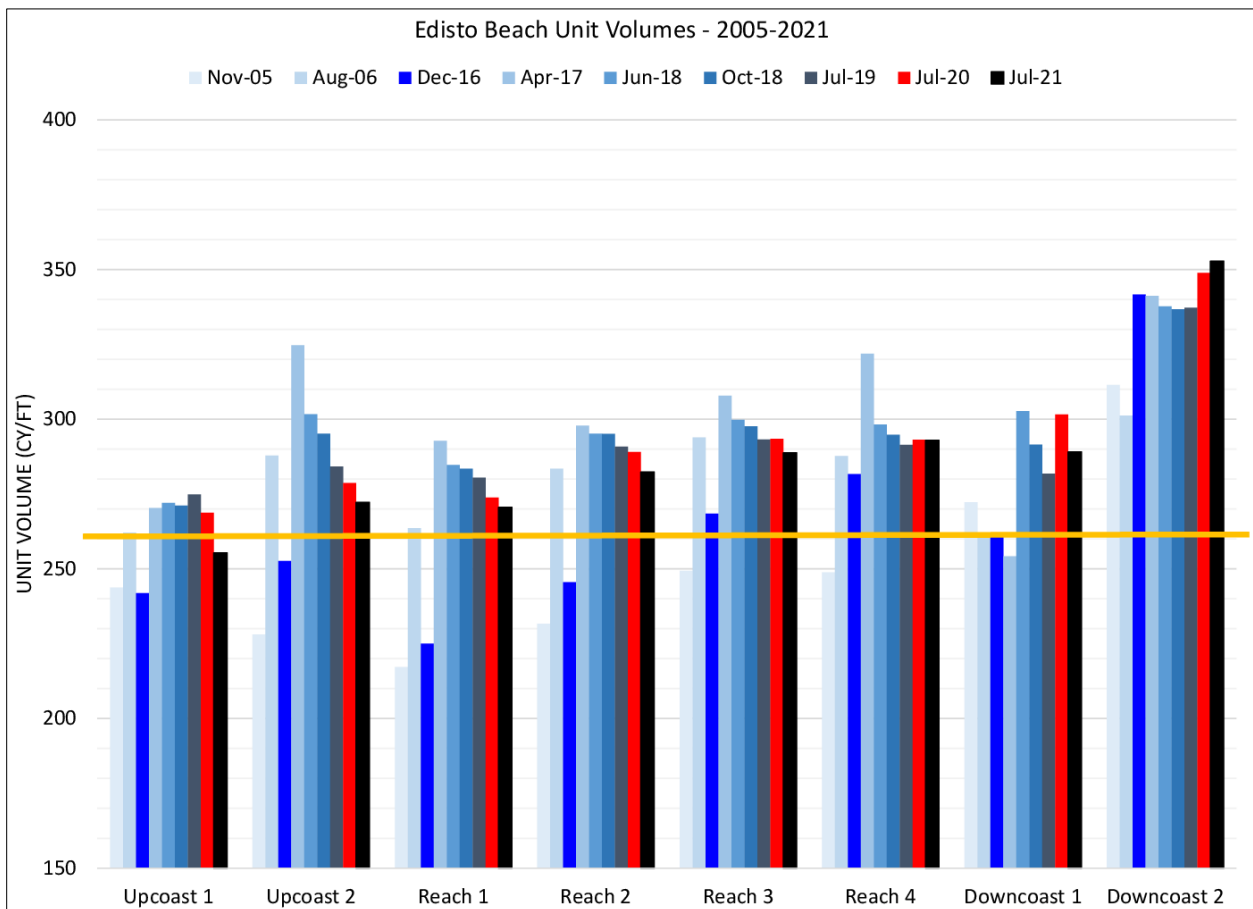
FIGURE 4.1. Unit volume for each reach at Edisto Beach for selected dates from 2005 to 2021. Volumes are calculated to -15 ft NAVD.

Volume changes by reach, groin cell, and station are discussed in this section. Groin cells showing a significant change in volume relative to the previous condition are highlighted. Volume changes for individual reaches are shown in Figure 4.1. Individual stations within groin cells (Fig 4.2), which help identify sediment transport patterns near the time of the survey, will also be discussed. Unit volumes for each station are shown in Figure 4.3.

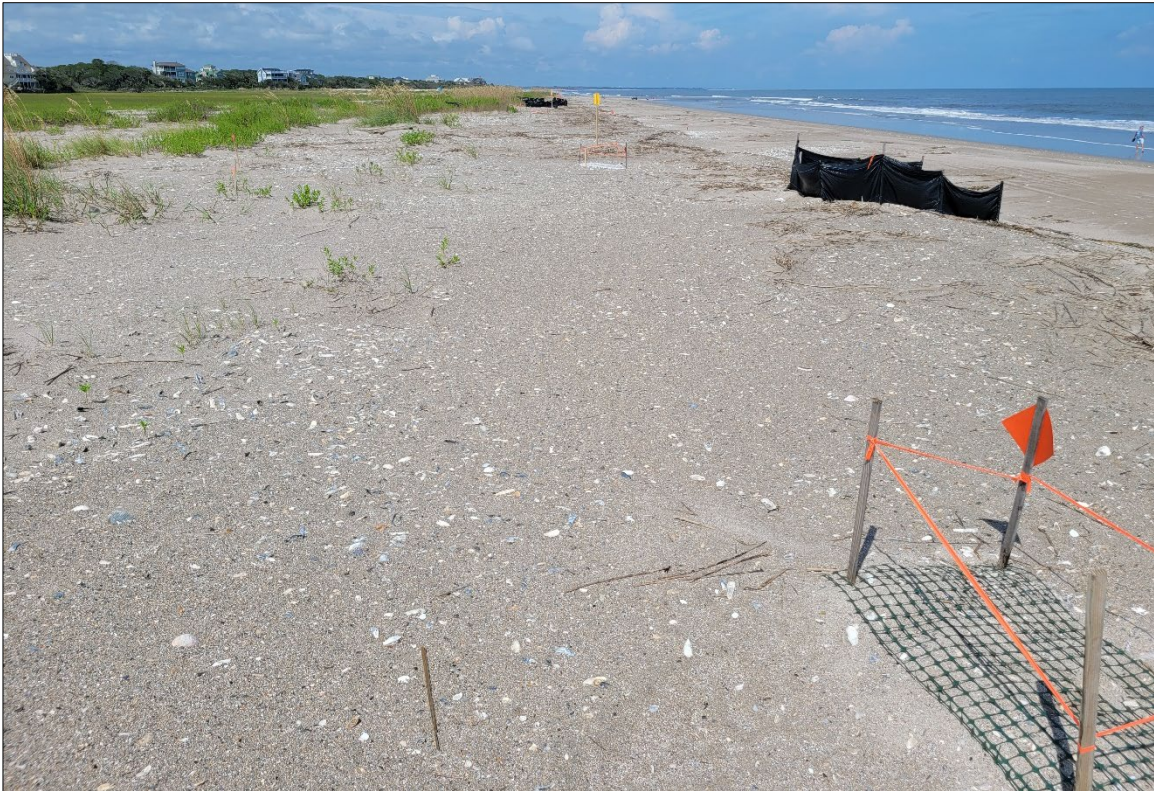
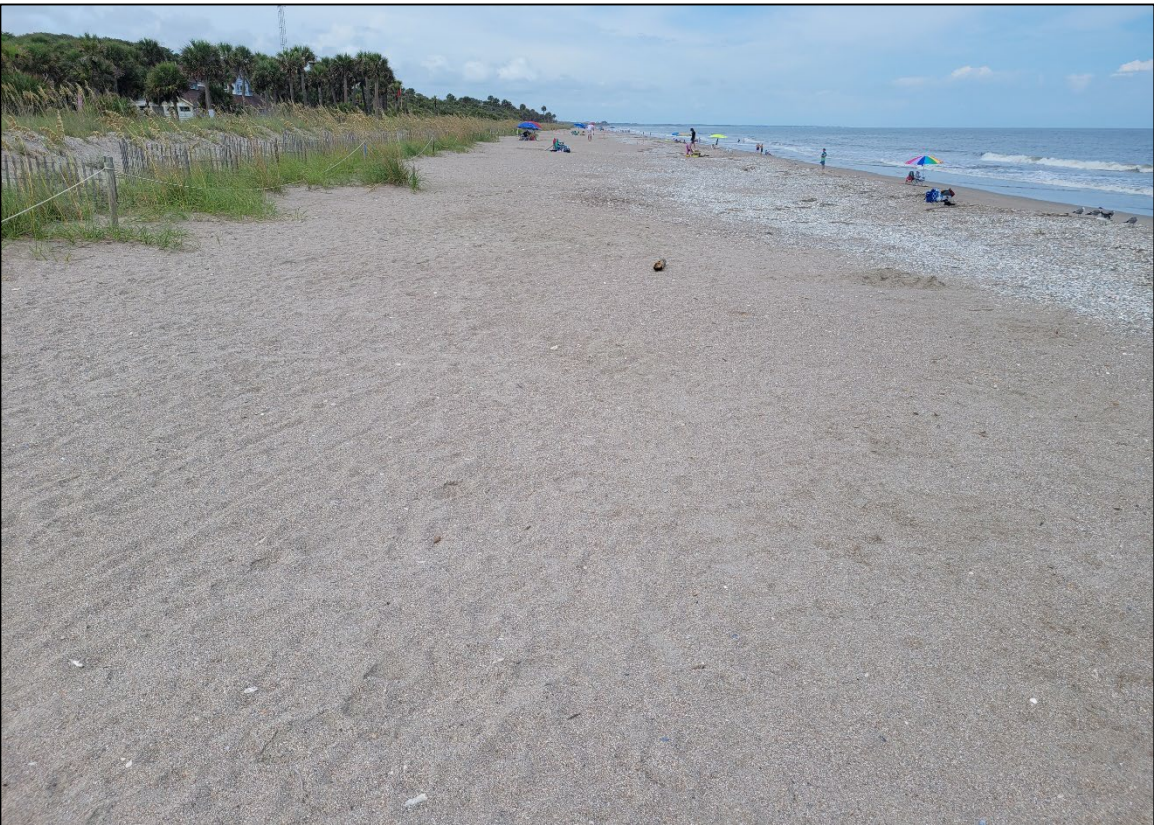
FIGURE 4.4. [UPPER] Upcoast 1 in July 2021. This reach has accreted since nourishment in 2006, transitioning from a washover barrier to a stable beach with a growing dune ridge. [LOWER] Upcoast 2, taken from just north of the Pavilion in July 2021.

Upcoast 2 gained ~197,000 cy of sand from December 2016 to April 2017 (nourishment at 181,728 cy plus natural changes). Between April 2017 and July 2020, the reach lost ~127,700 cy (~14.0 cy/ft/yr). A significant portion of this change occurred between June 2018 and October 2018, when the annualized erosion rate was 21.8 cy/ft/yr. During that period, the reach lost ~20,000 cy (7.3 cy/ft) in just four months while hurricanes *Michael* and *Florence* impacted Edisto Beach. From July 2020 to July 2021, the annualized rate of loss was lower (~16,800 cy, or -5.9 cy/ft/yr). The reach still holds ~52,500 cy (18.8 cy/ft) more sand than the before-nourishment condition in December 2016.

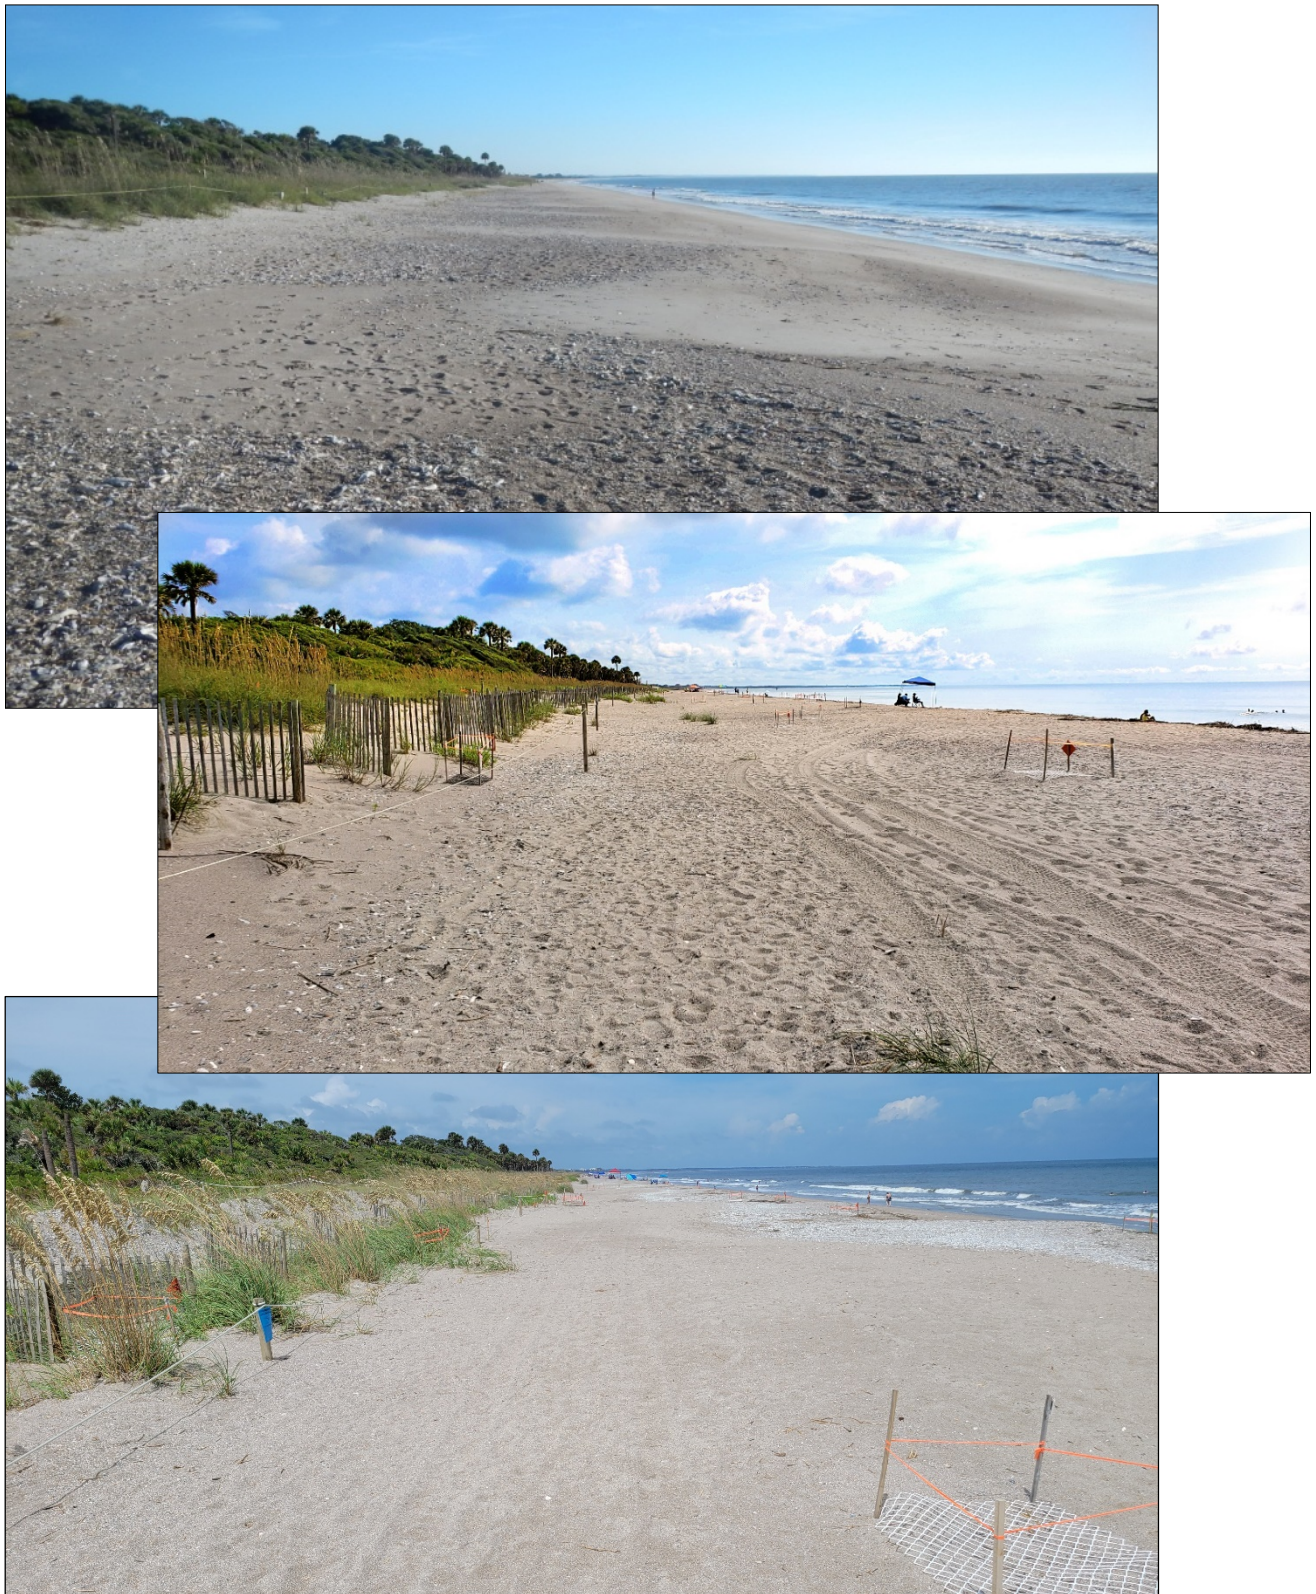
FIGURE 4.5. [UPPER] View north from State Park station -600 in October 2016, just after Hurricane *Matthew*. [MIDDLE] View north from State Park station -600 in July 2019. [LOWER] View north from State Park station -600 in July 2021. Since Hurricane *Michael*, relatively calm conditions have allowed dune vegetation to begin expanding seaward beyond the sand fencing established in conjunction with the beach renourishment project. As of July 2021, a ~3 to 4-ft-high foredune had accreted amongst maturing stands of sea oat and bitter panicum. This indicates the dune is stabilizing.

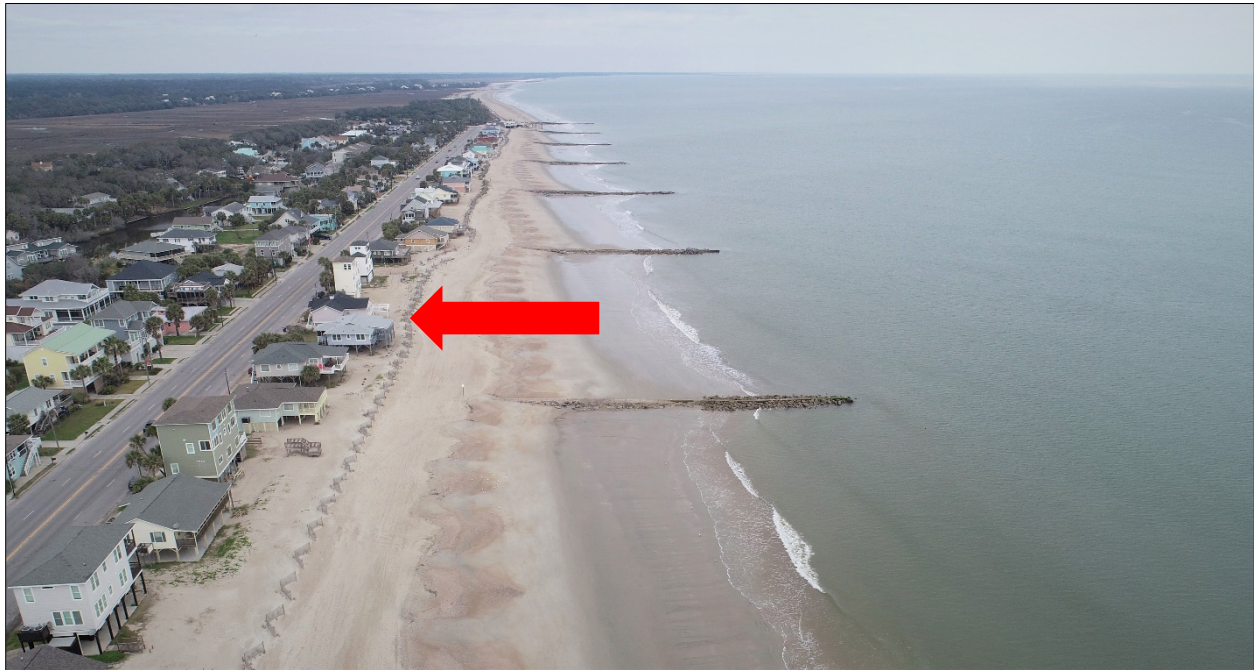
FIGURE 4.6. [UPPER] Aerial image of Reach 1 in January 2019. Cells 1–4 near the top of the image have the narrowest post-nourishment beach with less of a buffer between houses and the water. [LOWER] Aerial image of Reach 1 in August 2021. A dune restoration project completed in January-February 2021 is visible, along with re-established dune grasses between properties and the beach. The red arrow highlights the same property in both images. [Photos by D Giles]

Within individual groin cells, the southern-most profiles tended to lose the most volume between July 2020 and July 2021. The average losses along the southern-most profiles were ~7.8 cy/ft, while the central profiles in each groin cell lost an average of ~4.3 and the northern profile gained ~2.4 cy/ft, respectively. This is because prevailing summertime winds and waves along Edisto Island are from the south resulting in localized sand deficits on the north side of individual groin cells. If surveys are completed in the winter months, the opposite effect would be expected wherein the northward-directed drift would accumulate on the south side of each groin cell. Groin Cells 1, 2, 6, 7, and 8 lost the most volume from July 2020 to July 2021, with Groin Cells 2 and 7 losing more than 10.0 cy/ft. These cells were all included in the January-February 2021 dune restoration project.

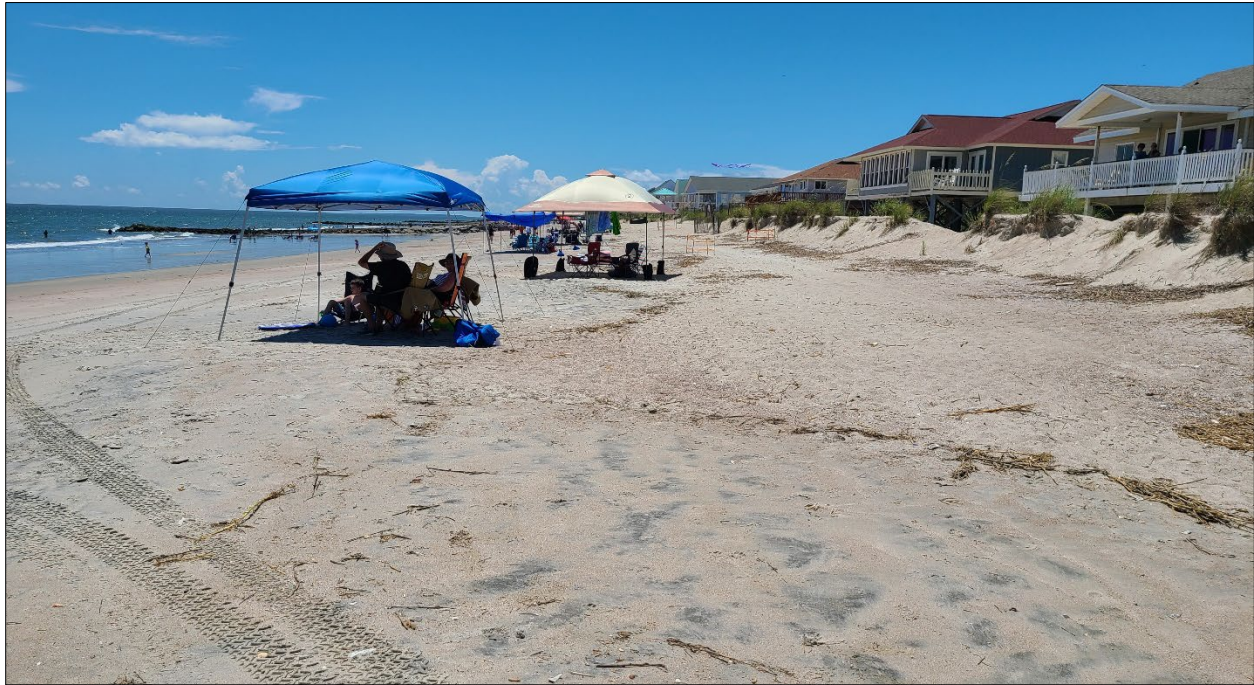
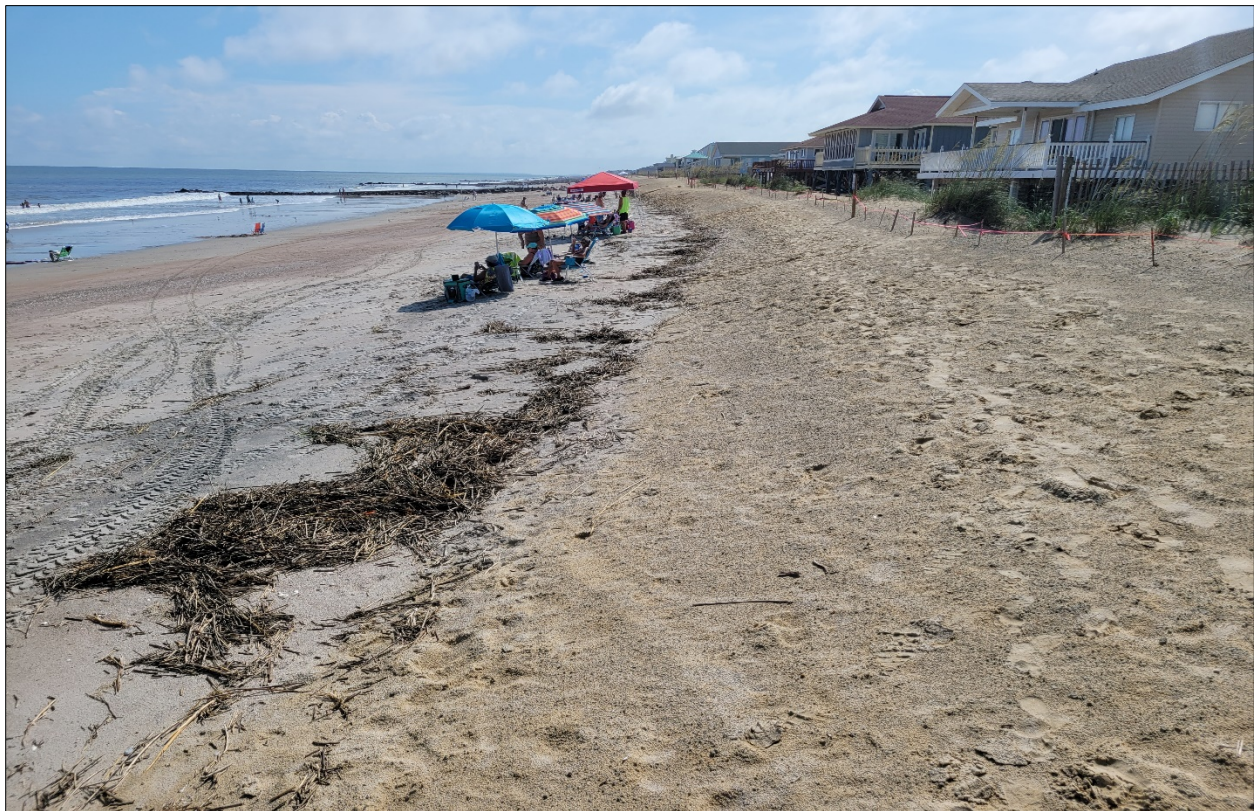
FIGURE 4.7. [UPPER] Cell 3 in July 2020 — the 2017 project was followed by sand fencing and vegetation plantings, which helped spur the initial stages of dune growth (seen on the right side of the frame). The wrack line located along the dune toe is evidence of high-water conditions reaching the dune ridge recently. **[LOWER]** Cell 3 in August 2021 — the darker-colored material on the right-hand side of the image is from the January-February 2021 dune restoration project, which used upland material to re-establish a protective storm berm and foredune. [Photos by D Giles]

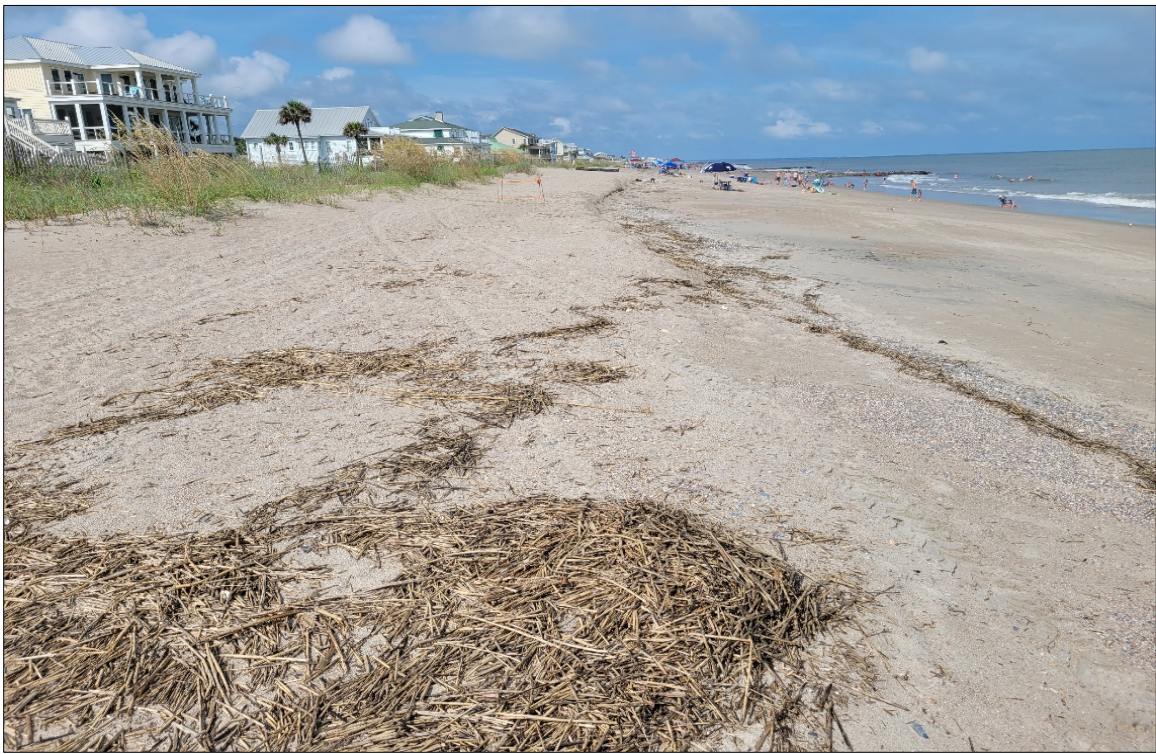
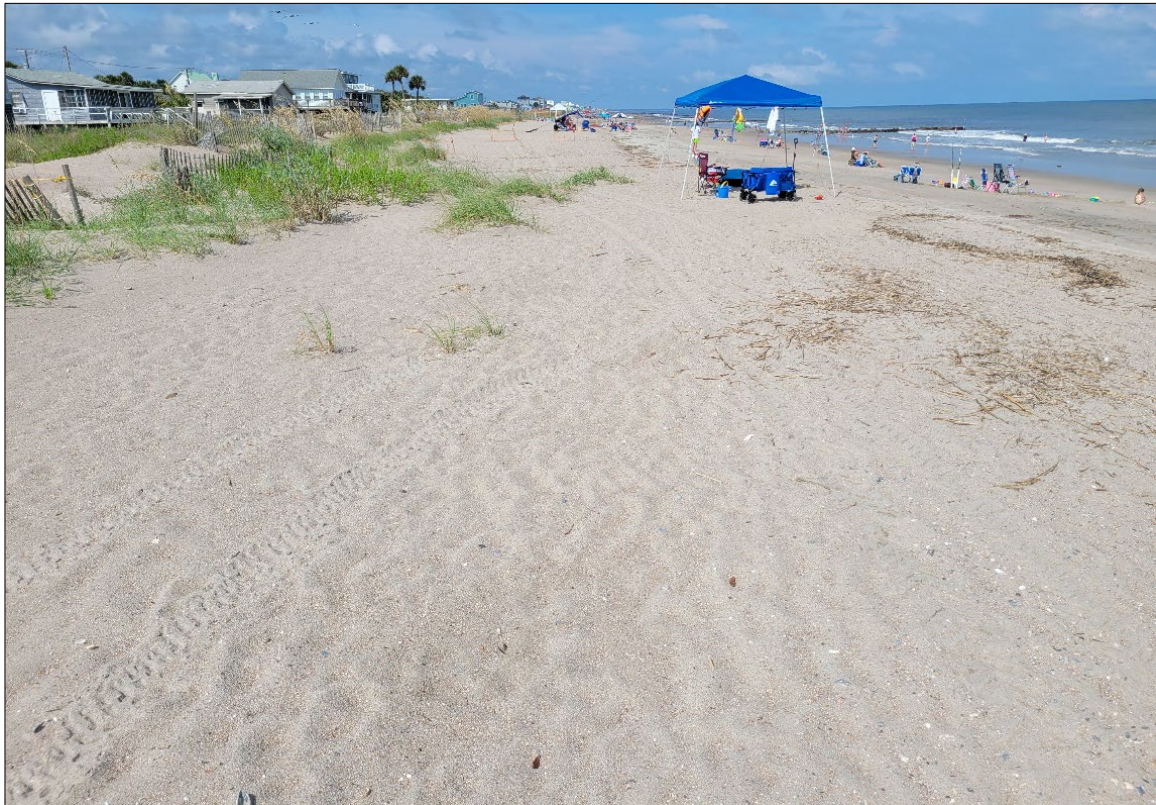
FIGURE 4.8. [UPPER] Ground image of Reach 2 in July 2021, taken just south of Groin 15 (Byrd St.). [LOWER] Looking north from Groin Cell 11. This is the northern limit of the densely-vegetated dunes which extend to The Point and along the Inlet shoreline to the west. Since project completion, sand fencing has helped trap sand and encourage plant growth. With a wide dry beach remaining, further dune growth is expected over the next couple years along this portion of the beach. [Photos by D Giles]

Reach 2 spans ~3,000 ft and includes Cells 11–15 (Fig 4.8). This reach lost ~20,700 cy between July 2020 and July 2021 but retained ~109,500 cy (35.7 cy/ft) more than was surveyed in December 2016. Similar to Reach 1, little dry beach was present along Reach 2 at high tide before nourishment, offering no storm protection and little recreational area at high tide (Fig 4.9). The present condition remains similar to the post-nourishment condition with a wider dry beach than the pre-nourishment condition in most cells. This is a transitional zone between areas of the beach with relatively little dune protection and an area with relatively substantial vegetated dunes between houses and the beach.

Again, the southern-most profiles tended to lose the most volume between July 2020 and July 2021. The average losses along the southern-most profiles were ~11.3 cy/ft, while the northern and central profiles in each groin cell gained an average of ~2.0 and ~6.9 cy/ft, respectively. This is because prevailing winds and waves along Edisto Island are from the south during the summer months, resulting in localized sand deficits on the northern side of individual groin cells. A winter-time survey would probably show the opposite effect with accumulations of sand on the southern side of each groin cell. Groin Cells 11 and 15 lost the most volume from July 2020 to July 2021.

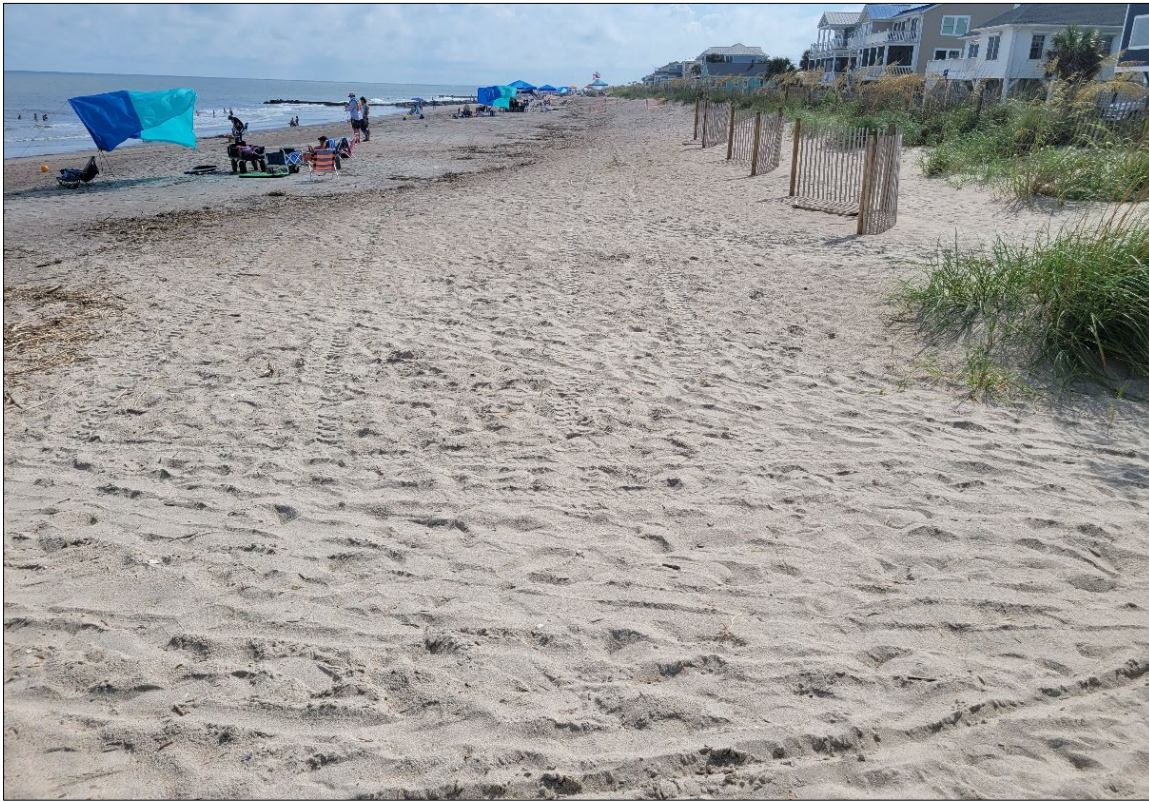
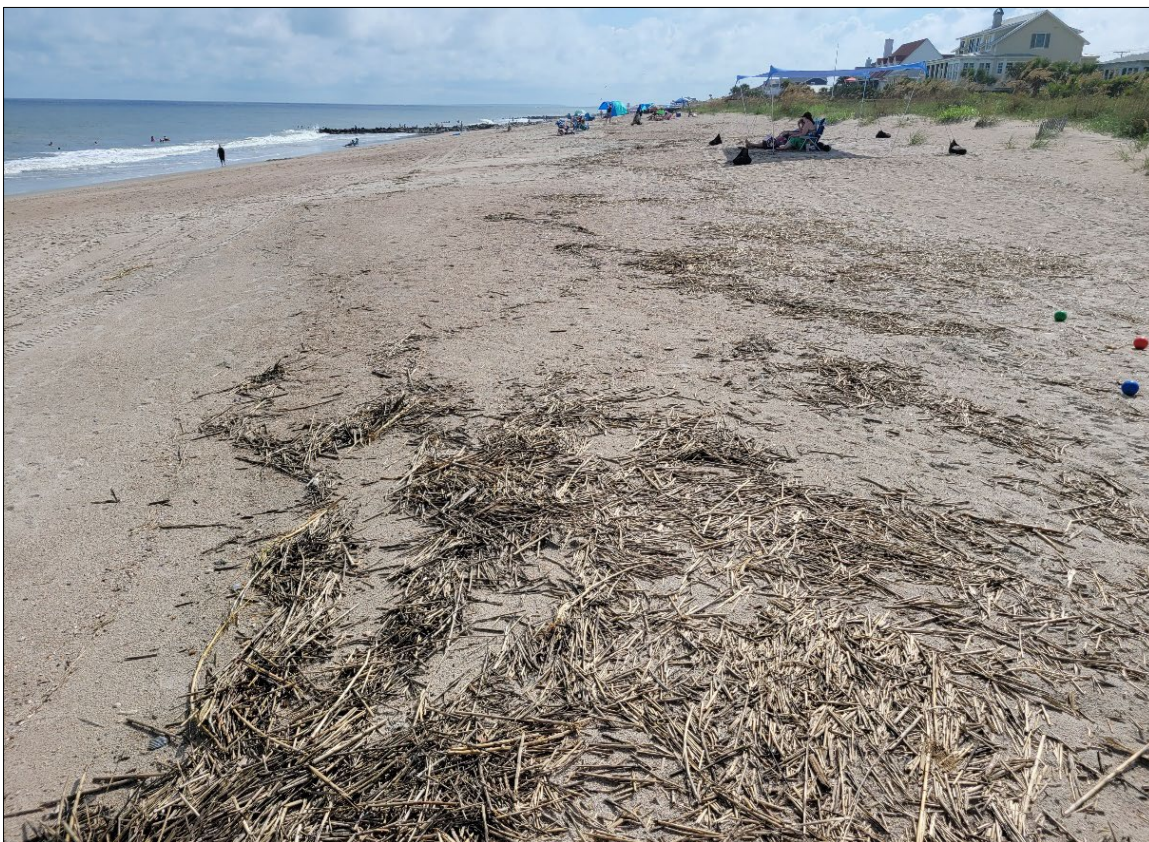
FIGURE 4.9. [UPPER] Although Cell 12 has lacked significant dunes in many of the recent surveys (particularly since 2015), there is now a small dune ridge growing with vegetation; some pioneering grass species have even begun to colonize the upper dry beach (highlight), indicating a healthy sandy supply and elevation. The beach remains wider than before construction. [LOWER] Cell 15 has larger dunes, so houses are sufficiently set back from the beach. [Photos by D Giles]

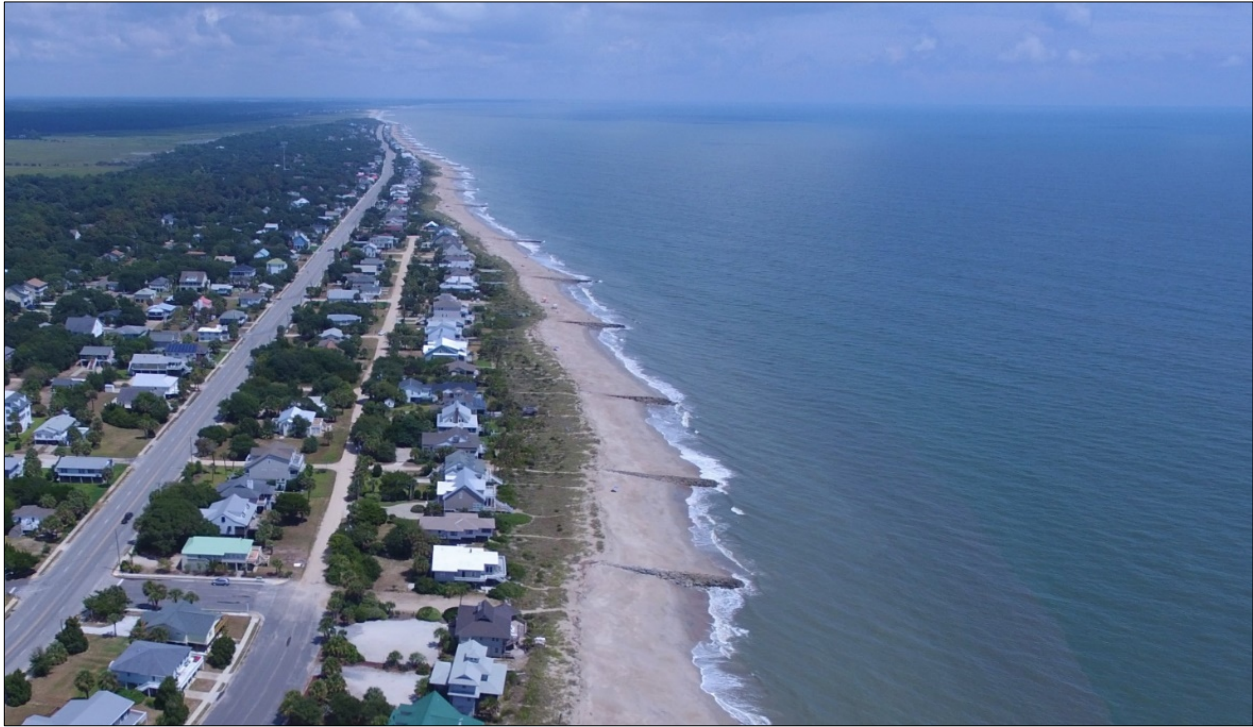
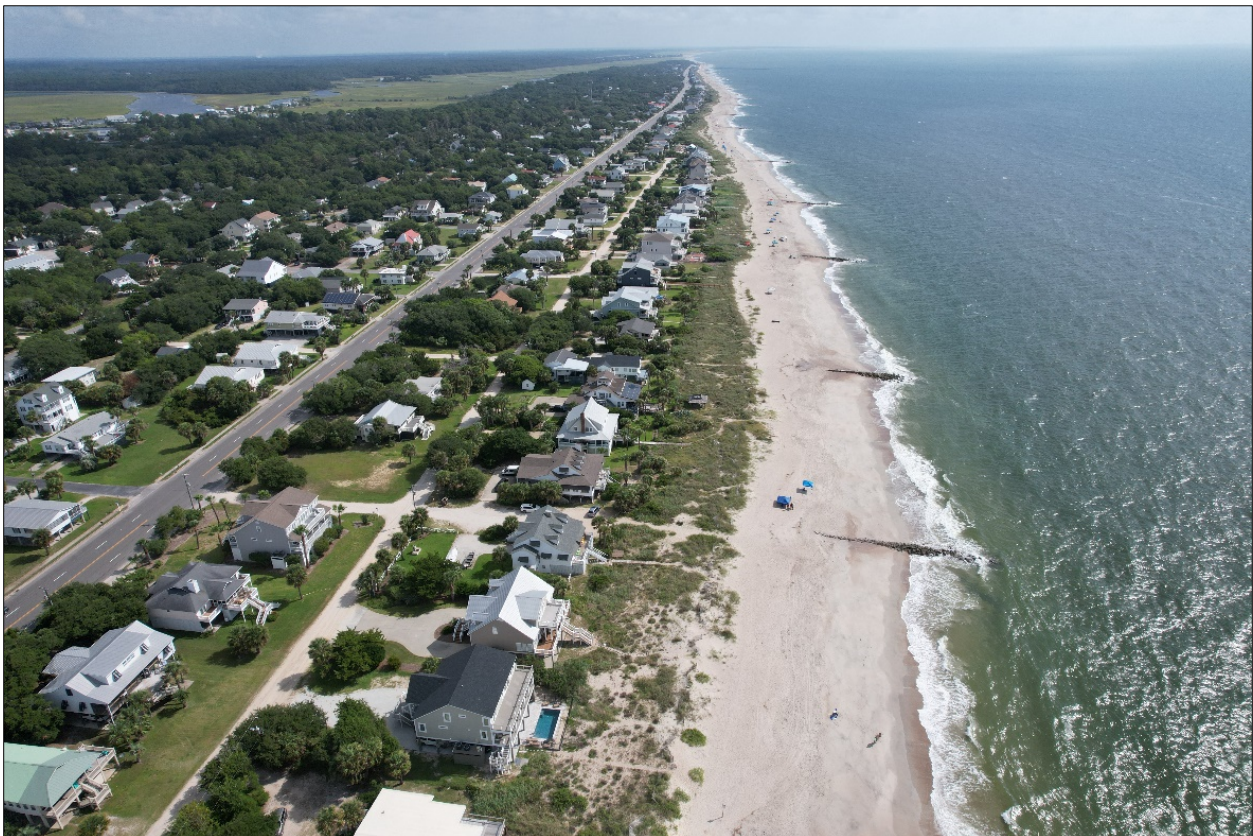
FIGURE 4.10. [UPPER] January 2019 aerial showing Reach 3, which has the greatest setbacks and vegetated buffers of any ocean-facing area along Edisto. Groin 25 is in the foreground. [LOWER] As of August 2021, Reach 3 has remained one of the healthiest portions of Edisto Beach since project completion. Groin 24 is in the foreground [Photos by D Giles]

Erosion trends along Reach 3 since the 2017 project have mirrored those in Reach 2, with the higher volume losses (~75,400 cy, or 6.5 cy/ft/yr) between April 2017 and July 2019 and lower volume losses from July 2019 to July 2020 (losing only ~1,300 cy, or -0.2 cy/ft/yr). However, from July 2020 to July 2021, erosion increased to ~25,520 cy (-4.9 cy/ft/yr). Earlier losses (pre-July 2019) may have been related to adjustment of the fill template following project completion, similar to the trends observed elsewhere along the project area. Most of the groin cells within Reach 3 lost sand between July 2020 and July 2021. However, Groin Cell 20 gained ~1,200 cy (+1.8 cy/ft) over that period. No other groin cell gained volume from July 2020 to July 2021 (see Fig 2.3a).

Despite recent erosion, on average Reach 3 contains 20.0 cy/ft more sand than the pre-nourishment condition (December 2016), which translates to the cells retaining between ~11 and ~82 percent of the nourishment fill. Retention is greater along the southern portion of the reach (Cells 19–23), although these cells lost more volume than others between July 2020 and July 2021. Overall, the reach has lost a total of 100,900 cy (-19.8 cy/ft) of sand since nourishment in 2017 and contains ~101,600 cy (20.0 cy/ft) more sand than the pre-nourishment condition. This is equivalent to ~52 percent of the nourishment volume remaining on the beach above -15 ft NAVD. Photos (Figs 4.11–4.12) show that all properties maintain a vegetative buffer between houses and the active beach.
