**Edisto Beach
Annual Beach & Inshore Survey**

2021
MONITORING REPORT

**2017 BEACH RESTORATION AND
GROIN LENGTHENING PROJECT
Edisto Beach, Colleton County (SC)**

SURVEY REPORT NO 4
Annual Beach and Inshore Surveys
Assessment of Beach and Groin Conditions

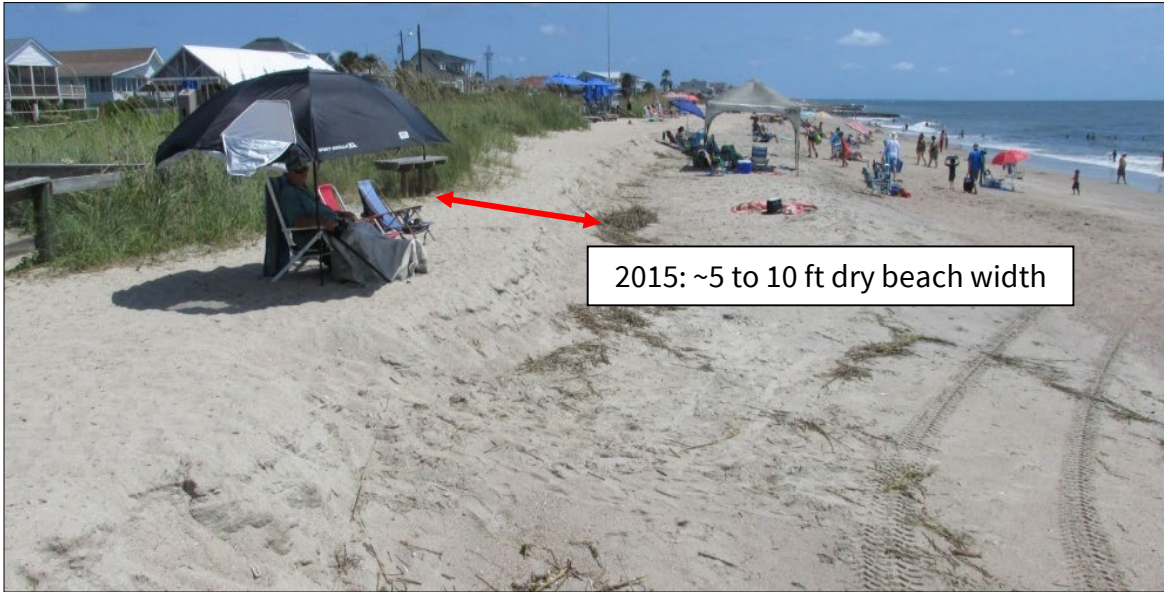
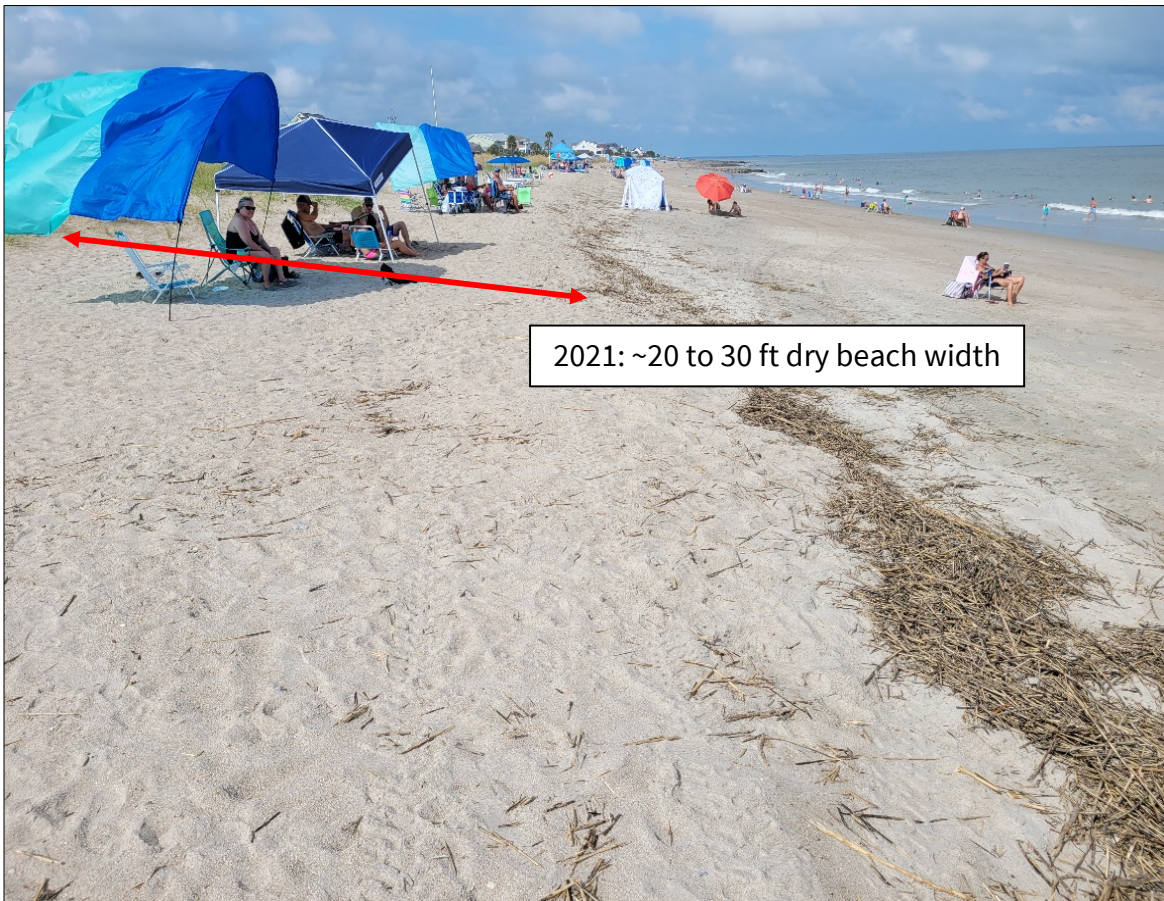
FIGURE 4.11. [UPPER] Cell 20 looking north in August 2015, before nourishment. [LOWER] Cell 20 looking north in July 2021. Although the dune is not fully visible in the lower photograph, the relative positions of the wrack line in each photo highlight the expansion in dry beach area since project completion. [Photos by D Giles]

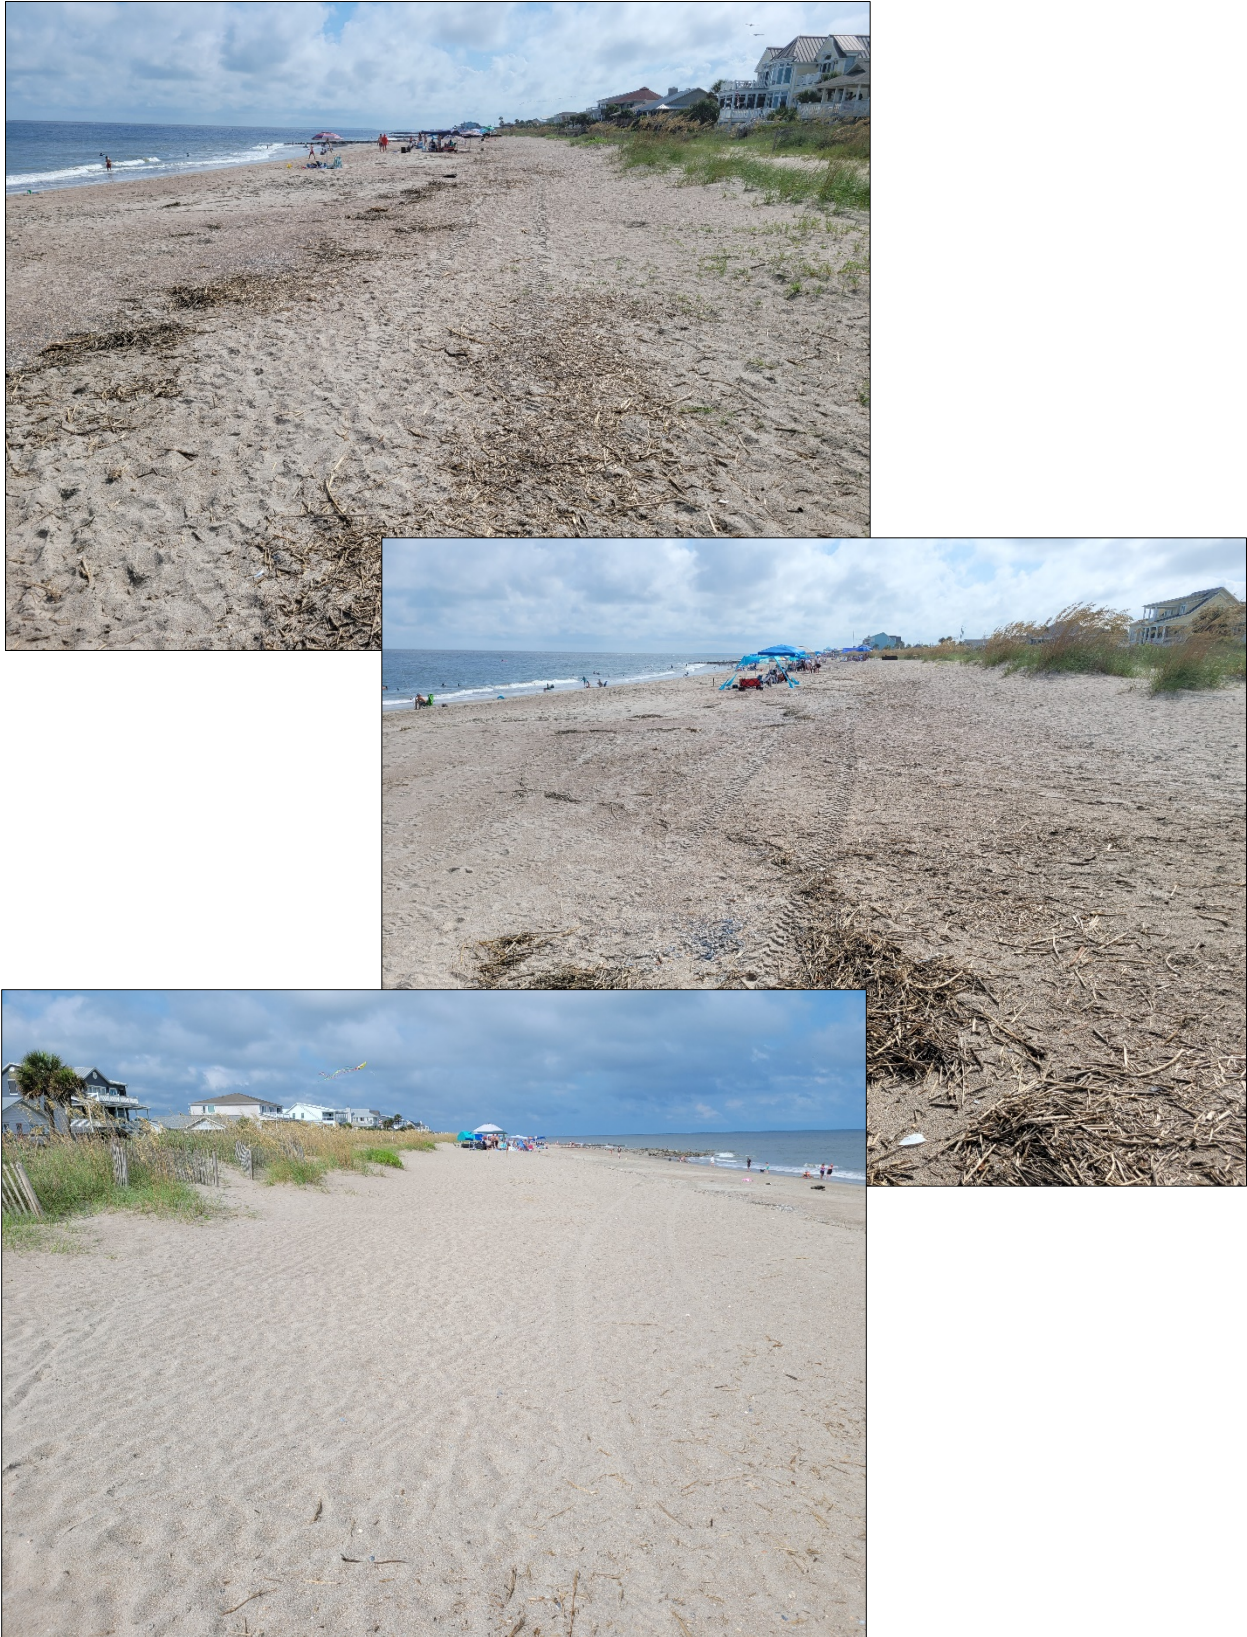
FIGURE 4.12. Reach 3 — July 2021. All cells in Reach 3 have adequate widths of vegetated buffers; however, dune elevations remain low. **[UPPER]** Cell 17 looking west. **[MIDDLE]** Cell 19 looking west. **[LOWER]** Cell 23 looking east. [Photos by D Giles]

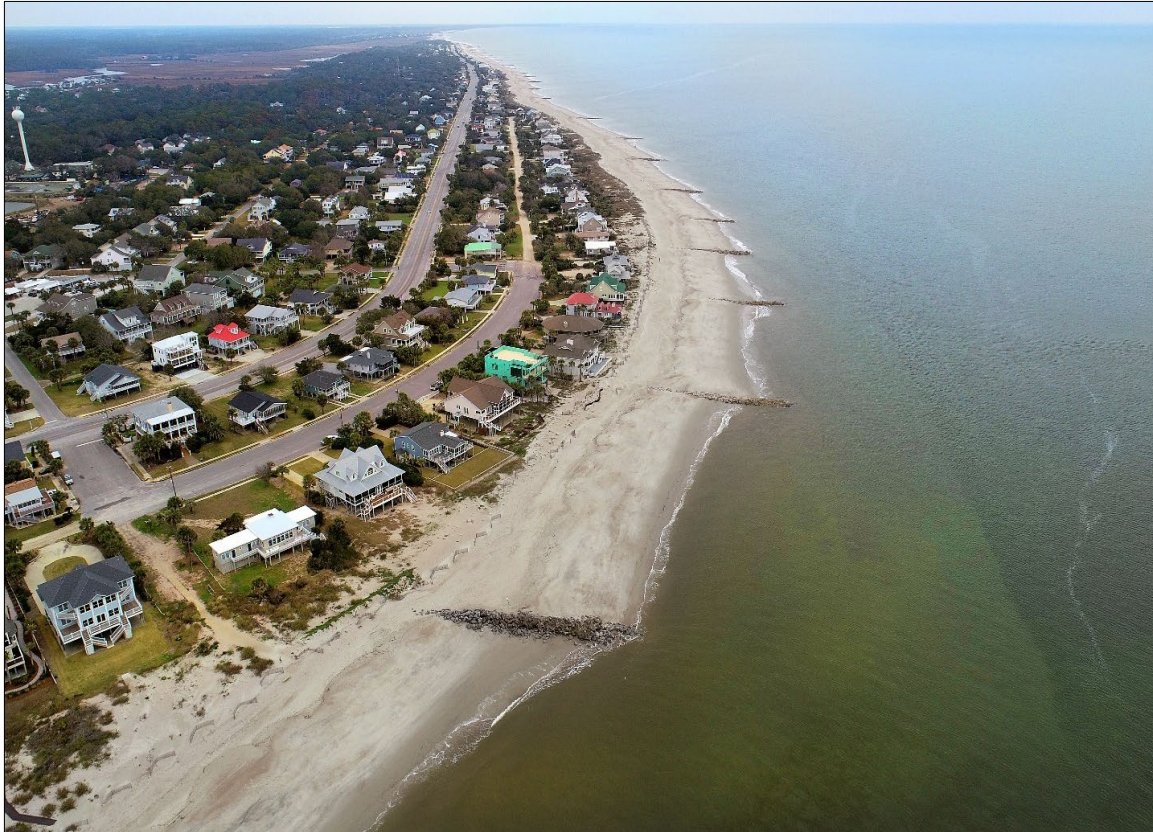
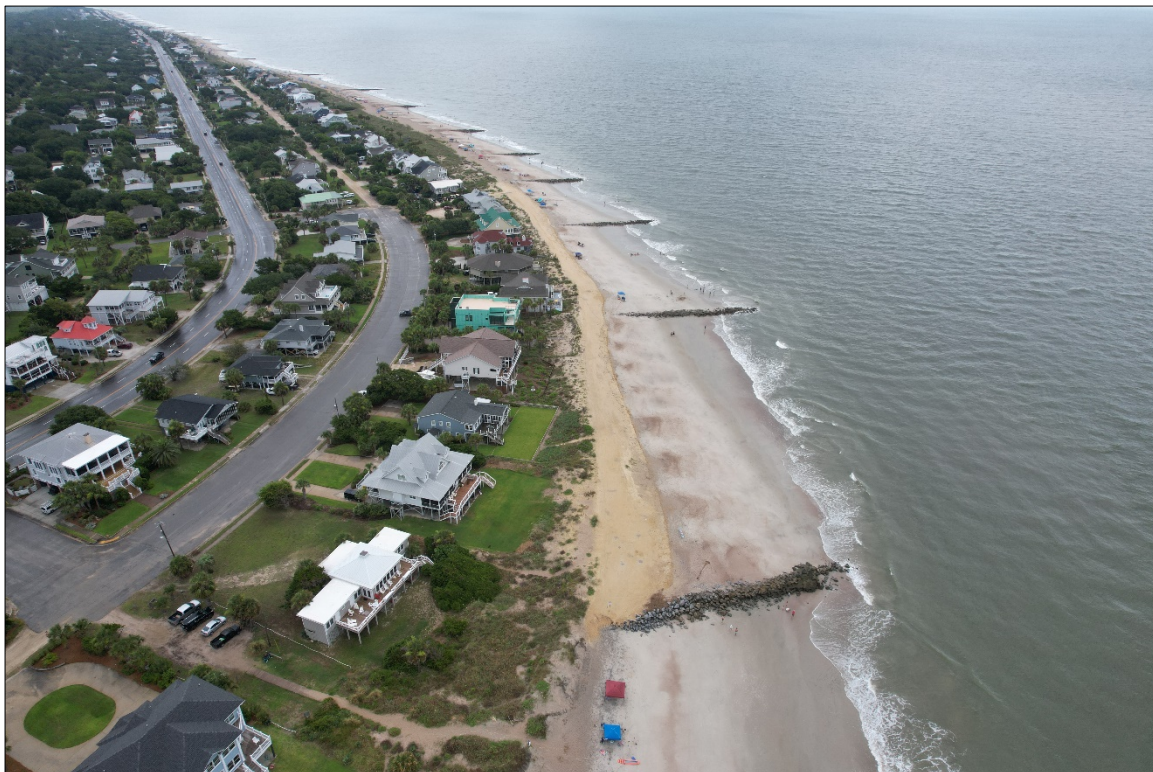
FIGURE 4.13. [UPPER] Aerial view of Reach 4 in January 2019. Groin 28 is in the foreground. [LOWER] The same section of shoreline in August 2021. The beach has equilibrated since the 2017 project with a wider dry sand beach than before construction. The sand used for the dune restoration project is visible. [Photos by D Giles]

Reach 4 represents the southern taper section of the 2017 nourishment project and includes Cells 24–27 (Fig 4.13). This area is often referred to as “The Point” because it encompasses the southern tip of Edisto Beach, where the beach turns toward the north-northwest. Houses located in Cells 26 and 27 have narrower and lower dunes compared to other homes in the area (Figs 4.14–4.15), especially those further around The Point. This places houses in Cells 26 and 27 closer to the beach and increases their risk of storm or erosion damage. The 2017 nourishment represented an increase of ~25–60 cy/ft for each cell.

The reach still retains ~15,700 cy (11.3 cy/ft) more sand than the pre-nourishment condition surveyed in December 2016. This is equivalent to ~11 percent of the nourishment fill remaining in the project area above closure depth (–15 ft NAVD).

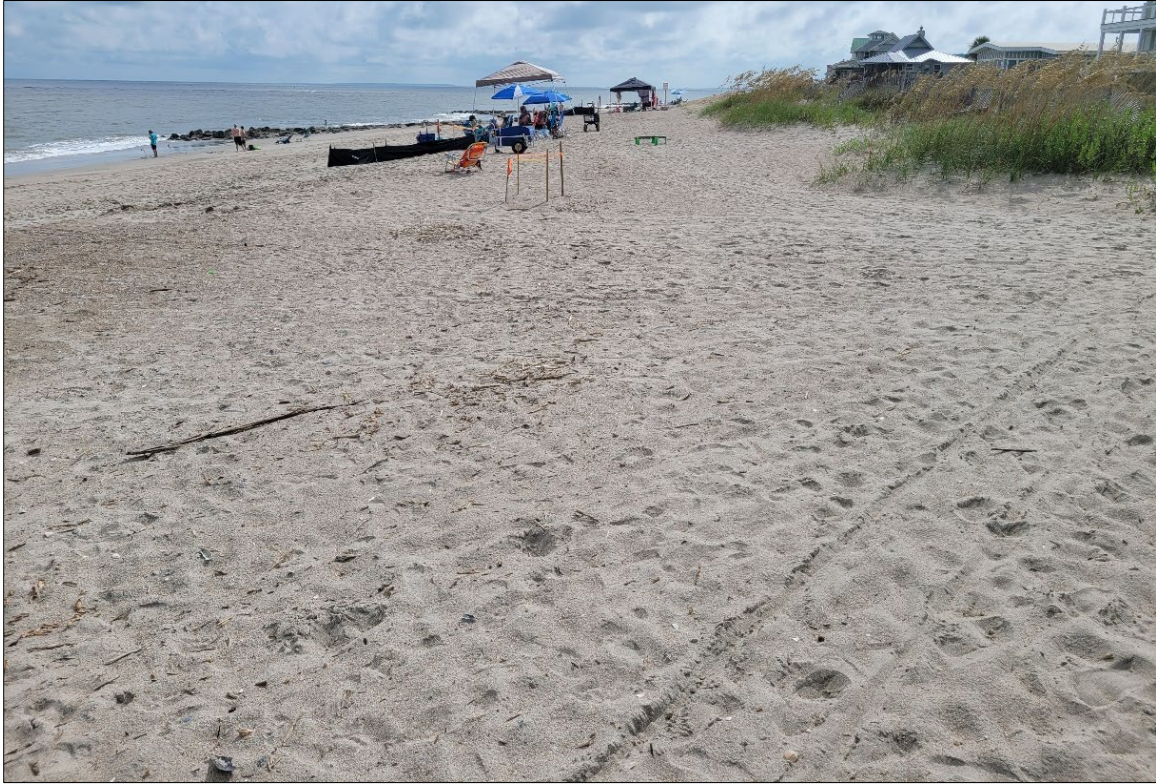
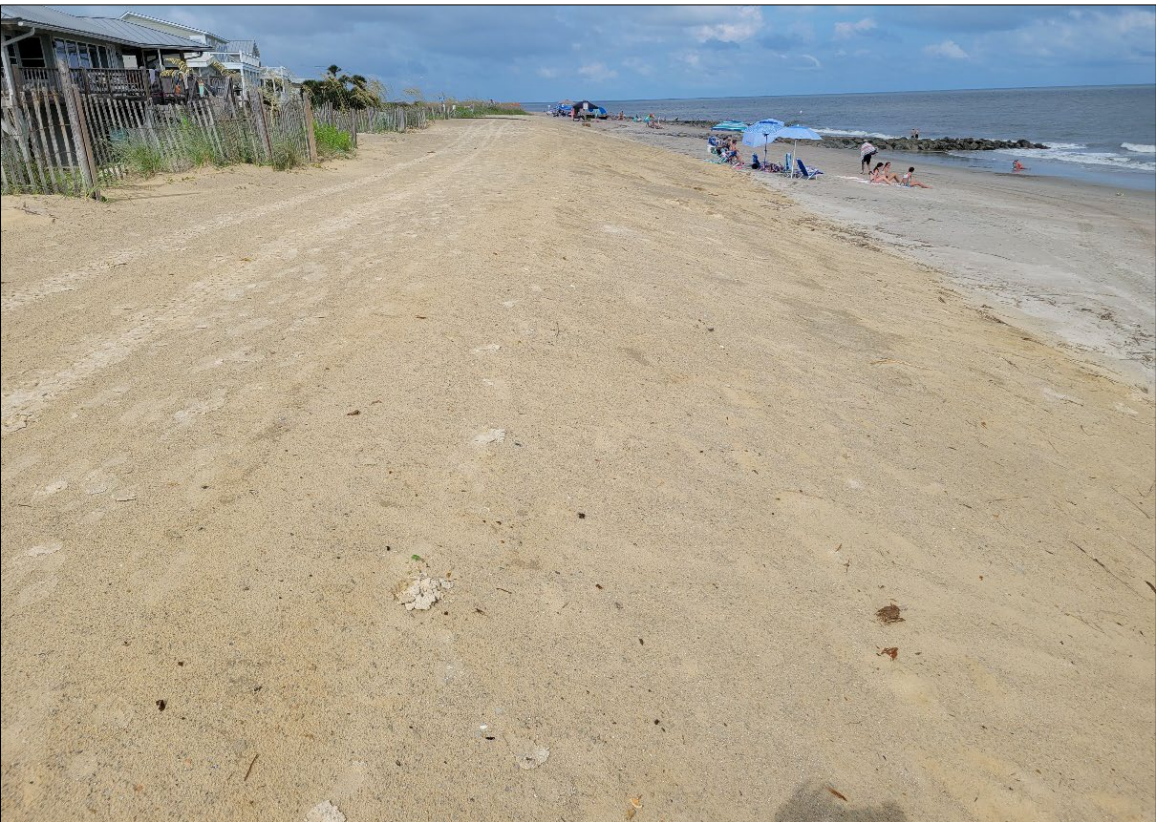
FIGURE 4.14. Representative photos of Reach 4 in July 2021 showing (upper) Cell 24 and (lower) Cell 26. [Photos by D Giles]

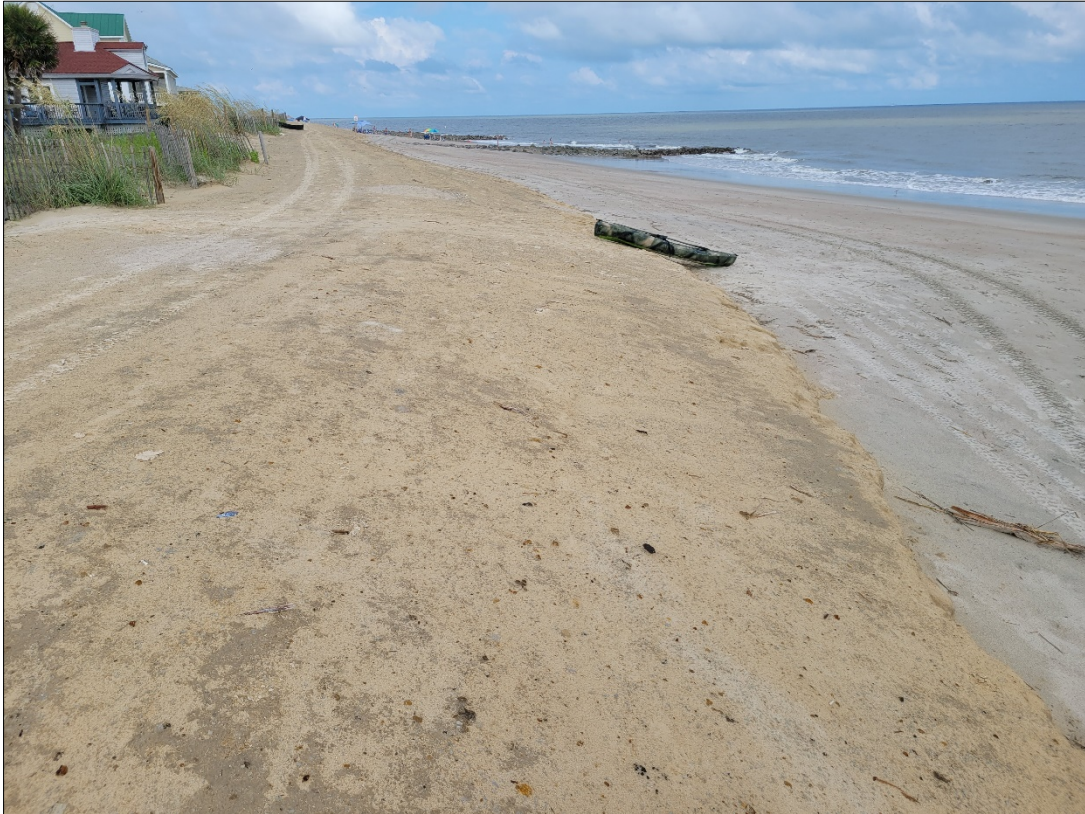
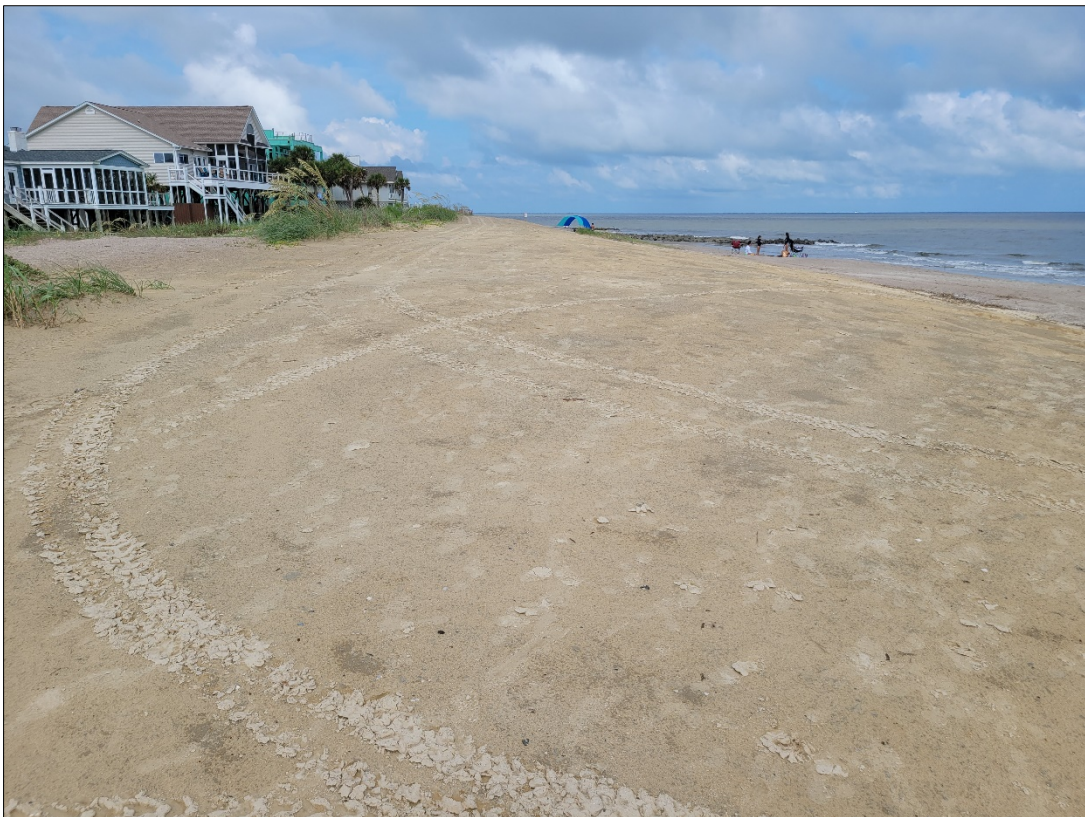
FIGURE 4.15. Representative photos of Reach 4 in July 2021 showing (upper) Cell 27 and (lower) Cell 28. [Photos by D Giles]

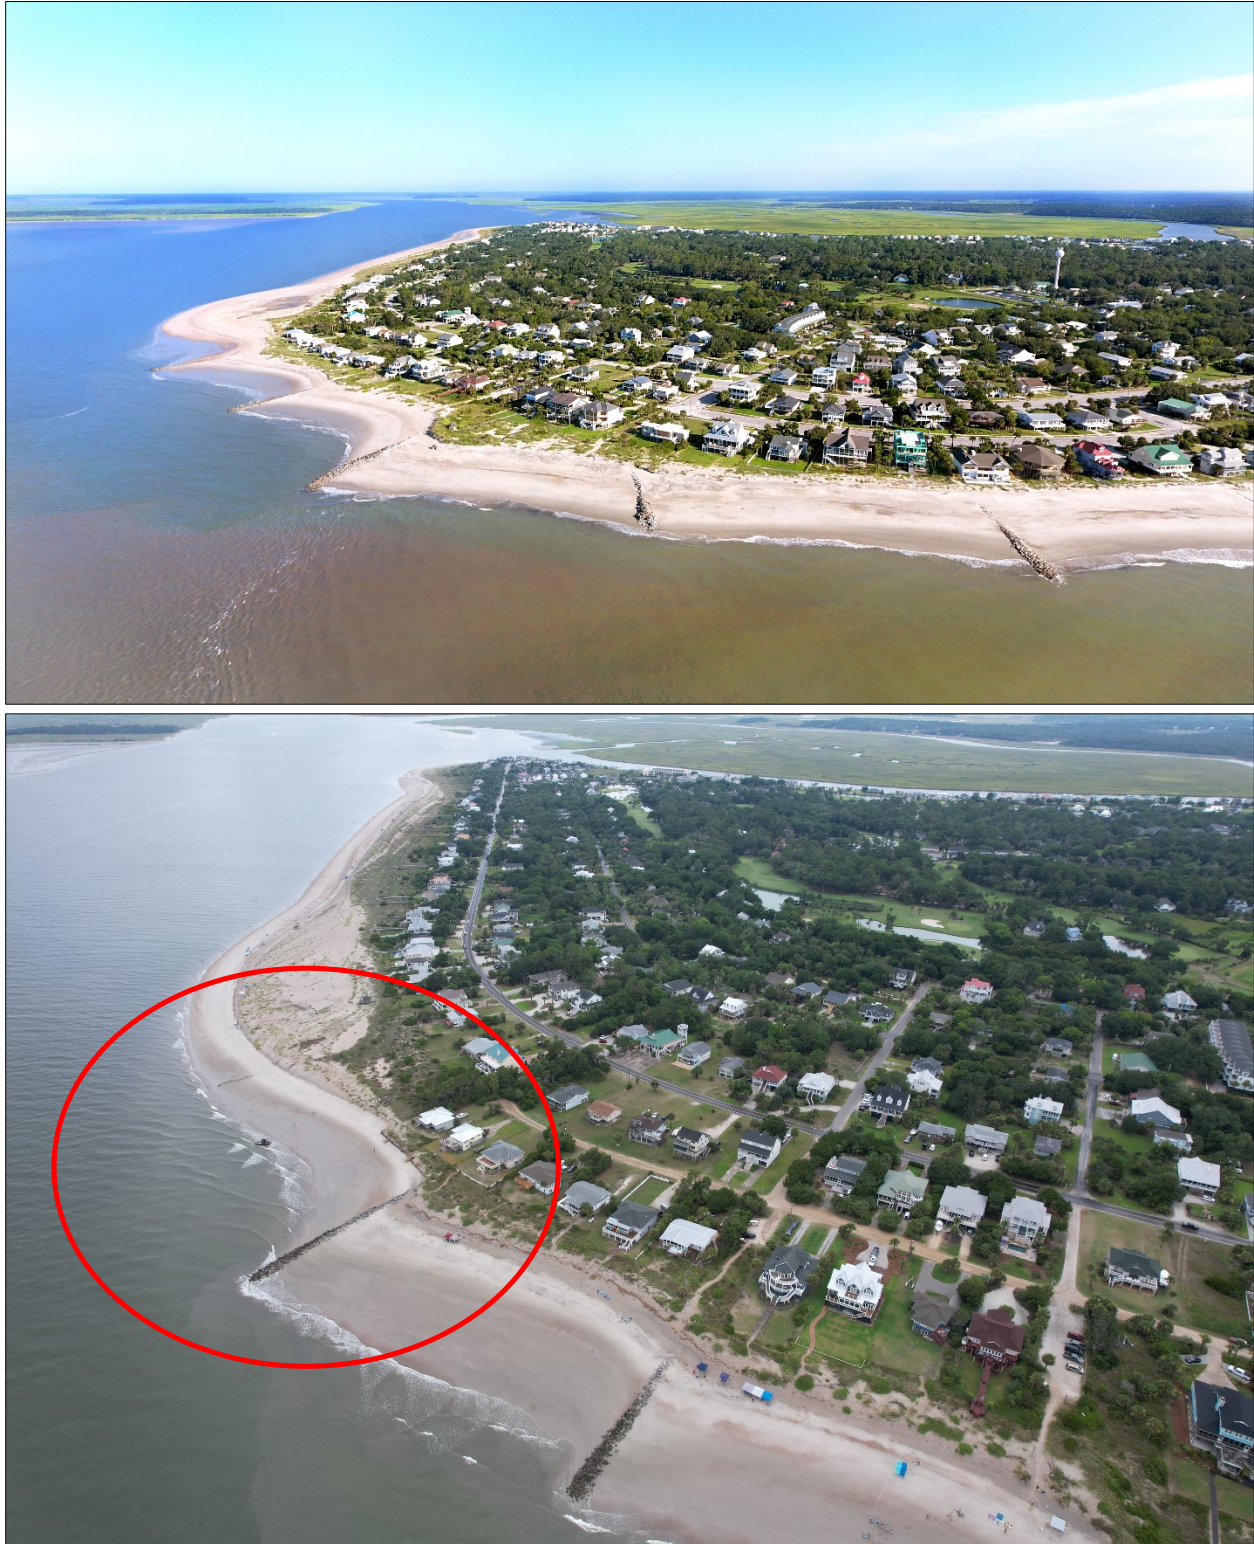
FIGURE 4.16. [UPPER] The downcoast reaches in July 2019. A considerable volume of nourishment sand has made its way around the corner of the shoreline and created a bulge in the beach around the western end of Point St. **[LOWER]** Reach 4 and downcoast reaches in July 2021. Nourishment sand has continued to move through the groin field to the downcoast reaches, maintaining the prominent bulge along the inlet shoreline, however an erosional arc at groin 31 (highlighted) has resulted in a narrower beach and exposure of a protective wall. [Photos by D Giles]

One recent notable change along the Downcoast Reaches has been the increased exposure of Groins 31 and 32 (Figs 4.16 and 4.17). Waves of sand moving downshore from the project reaches have provided excess volume for the Downcoast Reaches, but these temporary increases in volume can also create erosional hot spots that may be exacerbated when hardened structures become exposed. A bulkhead just south of Groin 31 was exposed by ~3 to 4 ft in July 2021, and Groin 32 is no longer buried in beach sand. The combination of an exposed bulkhead and groin in close proximity may lead to enhanced erosion during high-water or storm events; however, this is somewhat difficult to predict with very much precision. What is guaranteed is that as Groin 32 becomes more exposed, it will begin trapping beach sand from moving downshore along South Edisto Inlet.

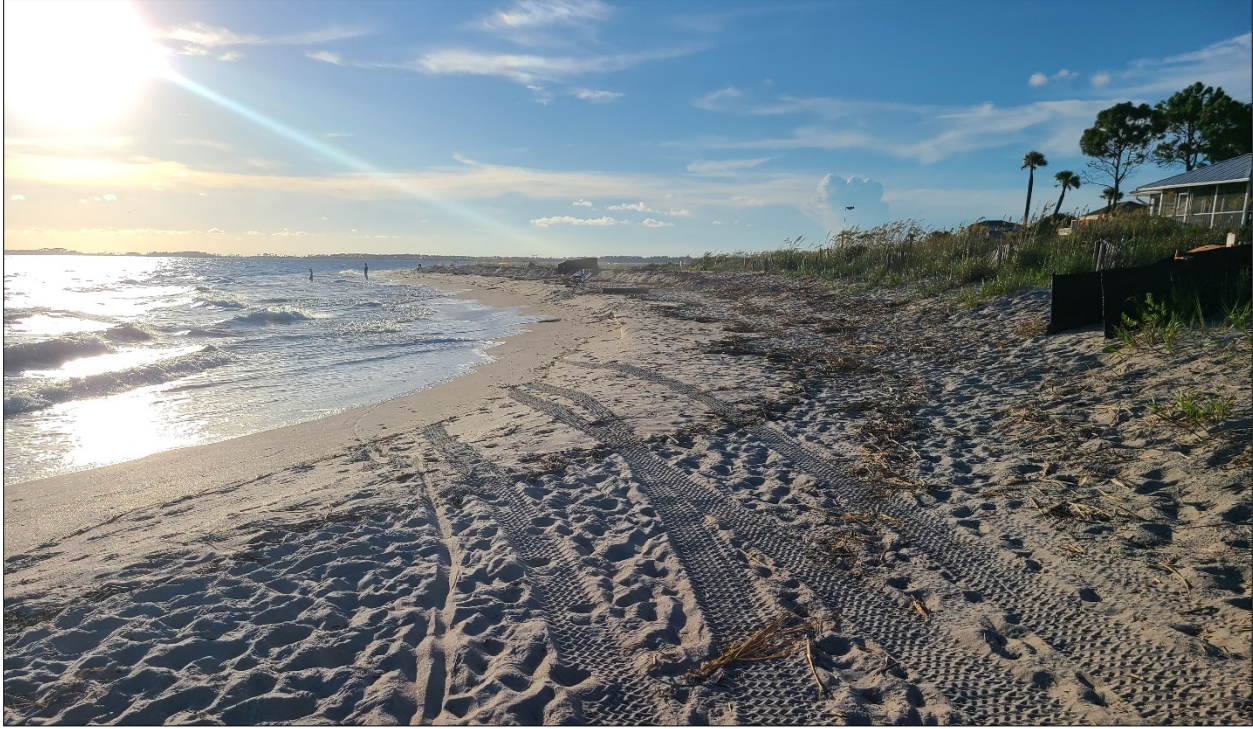
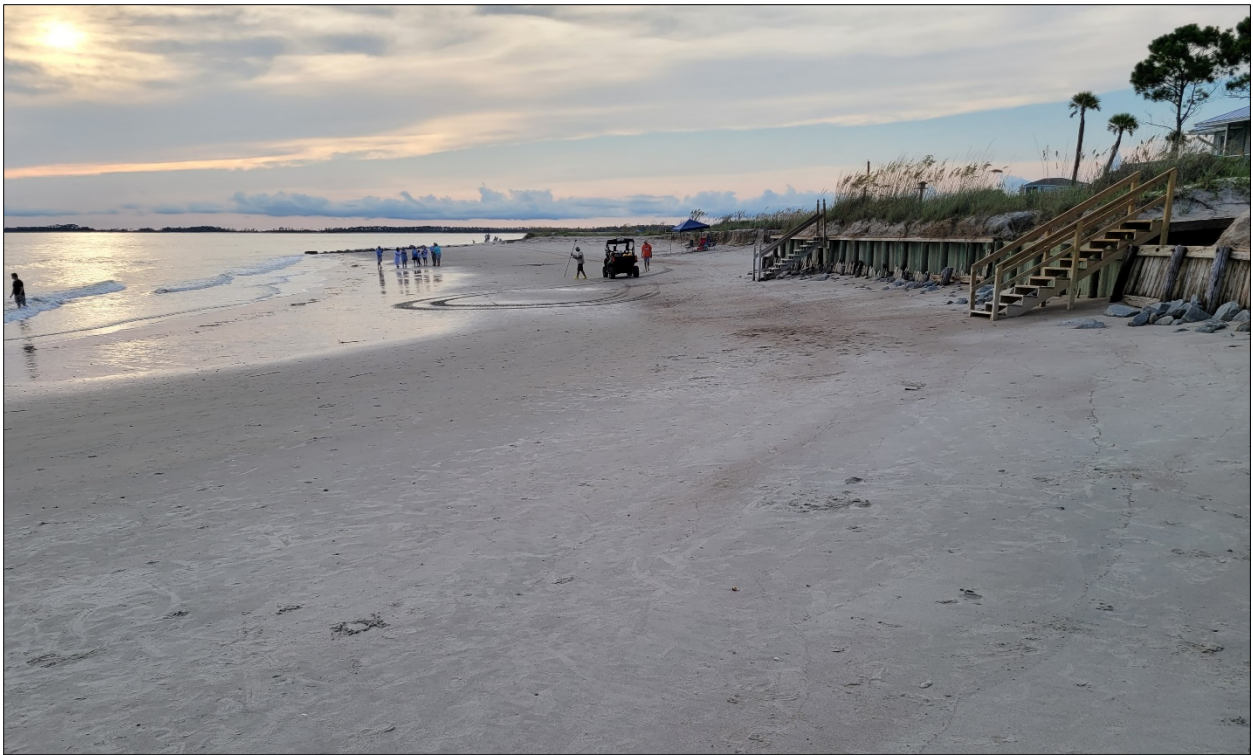
FIGURE 4.17. [UPPER] View west from Groin 29 in July 2020. [LOWER] The same area in July 2021. The erosional arc extending inland on the downdrift side of Groin 31, is more pronounced this year such that a low timber revetment is now exposed to wave action at high water conditions. [Photos by D Giles]

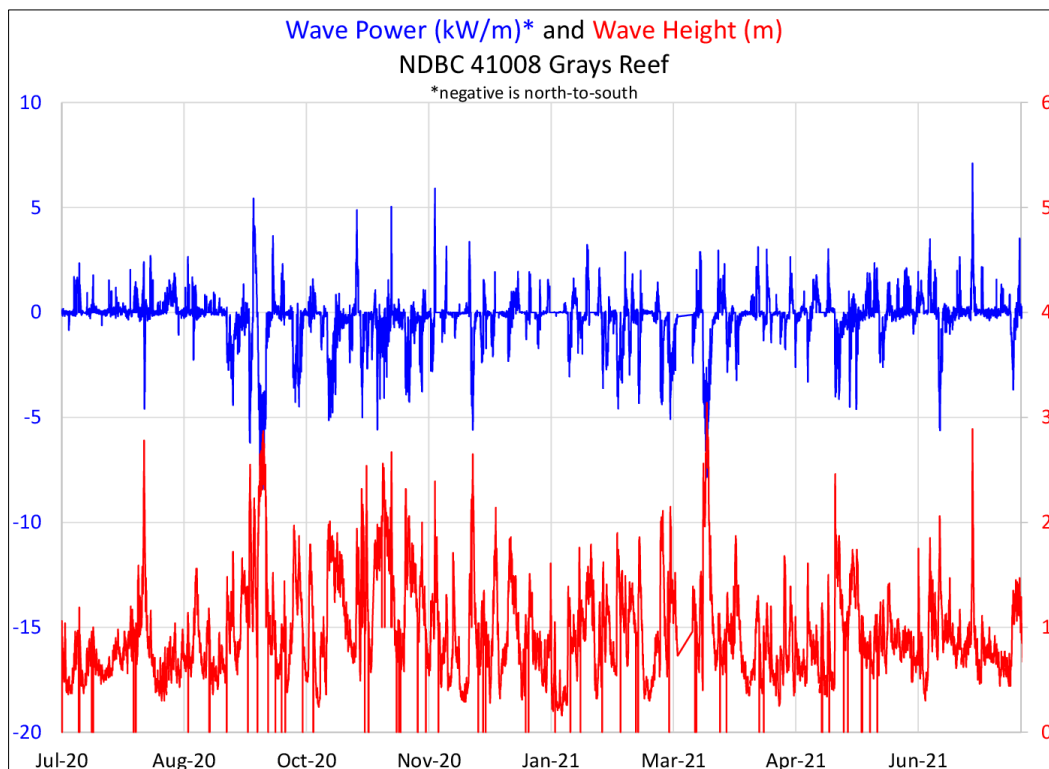
FIGURE 5.3. Wave power (in kW/m) and wave height (in m) for NDBC 41008 from July 2020 to July 2021. Wave power is a useful parameter for determining the relative magnitude and direction of wave energy in an alongshore direction along a beach. Positive values indicate waves move from south to north (ie – northerly transport), while negative values indicate predominance of north-to-south (ie – southerly transport).

The most powerful waves from July 2020 to July 2021 exhibited ~8 kW/m in a southerly direction, while the most powerful northerly-directed wave was ~6 kW/m (Fig 5.3). The average power of a northerly-directed wave from July 2020 to July 2021 was 0.6 kW/m, while the average southerly-directed wave power was 0.9 kW/m. These values are nearly identical to those observed from 2009 to 2021. This suggests sediment transport rates during the survey period from July 2020 to July 2021 were near average compared to the previous decade – a conclusion corroborated by the volume results presented herein.

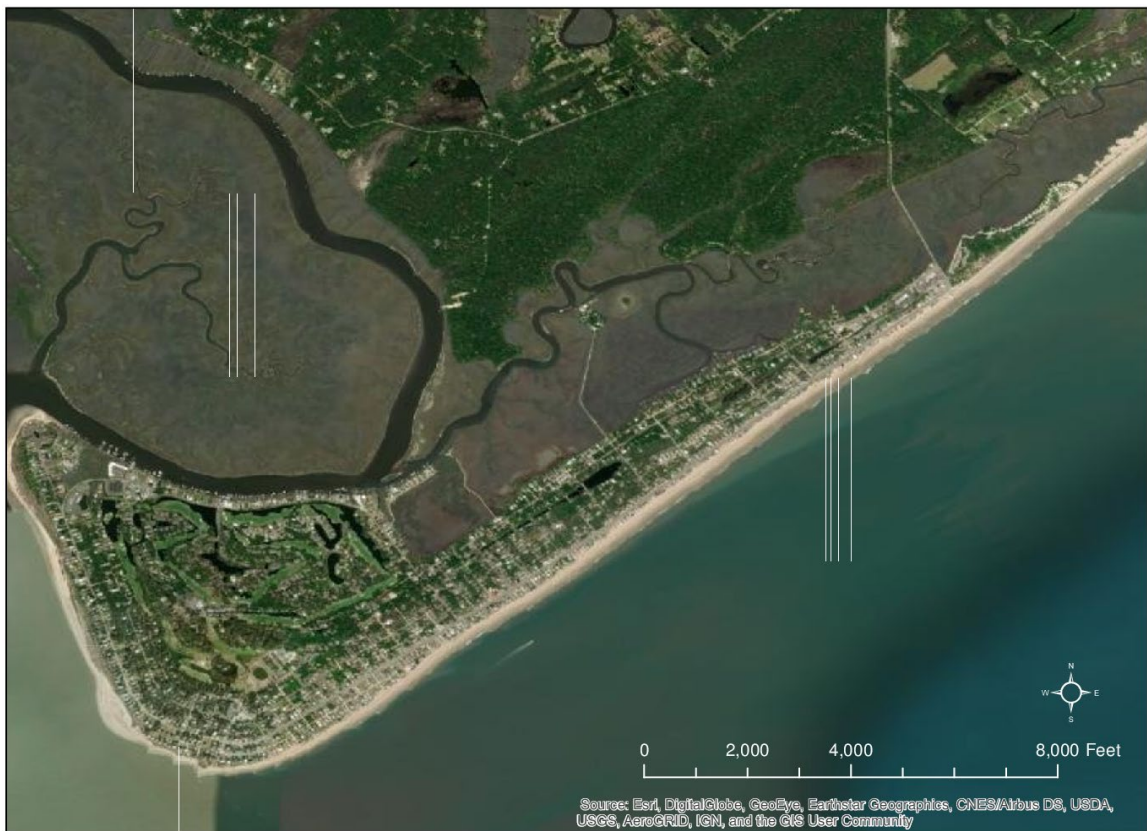
FIGURE 5.5a,b. Sea level inundation models around Edisto Beach generated using data from NOAA (<https://coast.noaa.gov/digitalcoast/tools/slr.html>). Shades of maroon, red, orange, and yellow are used to signify SLR of 1, 2, 3, and 4 ft above present-day MHHW.

NOAA provides a 'Sea Level Rise Viewer' (SLRV; see <https://coast.noaa.gov/digitalcoast/tools/slr.html>) to help people identify local variations in flood impacts under different SLR scenarios. This tool allows users to specify water levels and generate inundation maps showing MSL and depth in previously dry areas. Figure 5.5b shows example results for scenarios of MHHW plus 1 ft, 2 ft, 3 ft, and 4 ft SLR for Edisto Island and surrounding areas using data gathered from the SLRV website. The NOAA viewer is a handy tool to see what SLR scenarios start to impact a particular property.

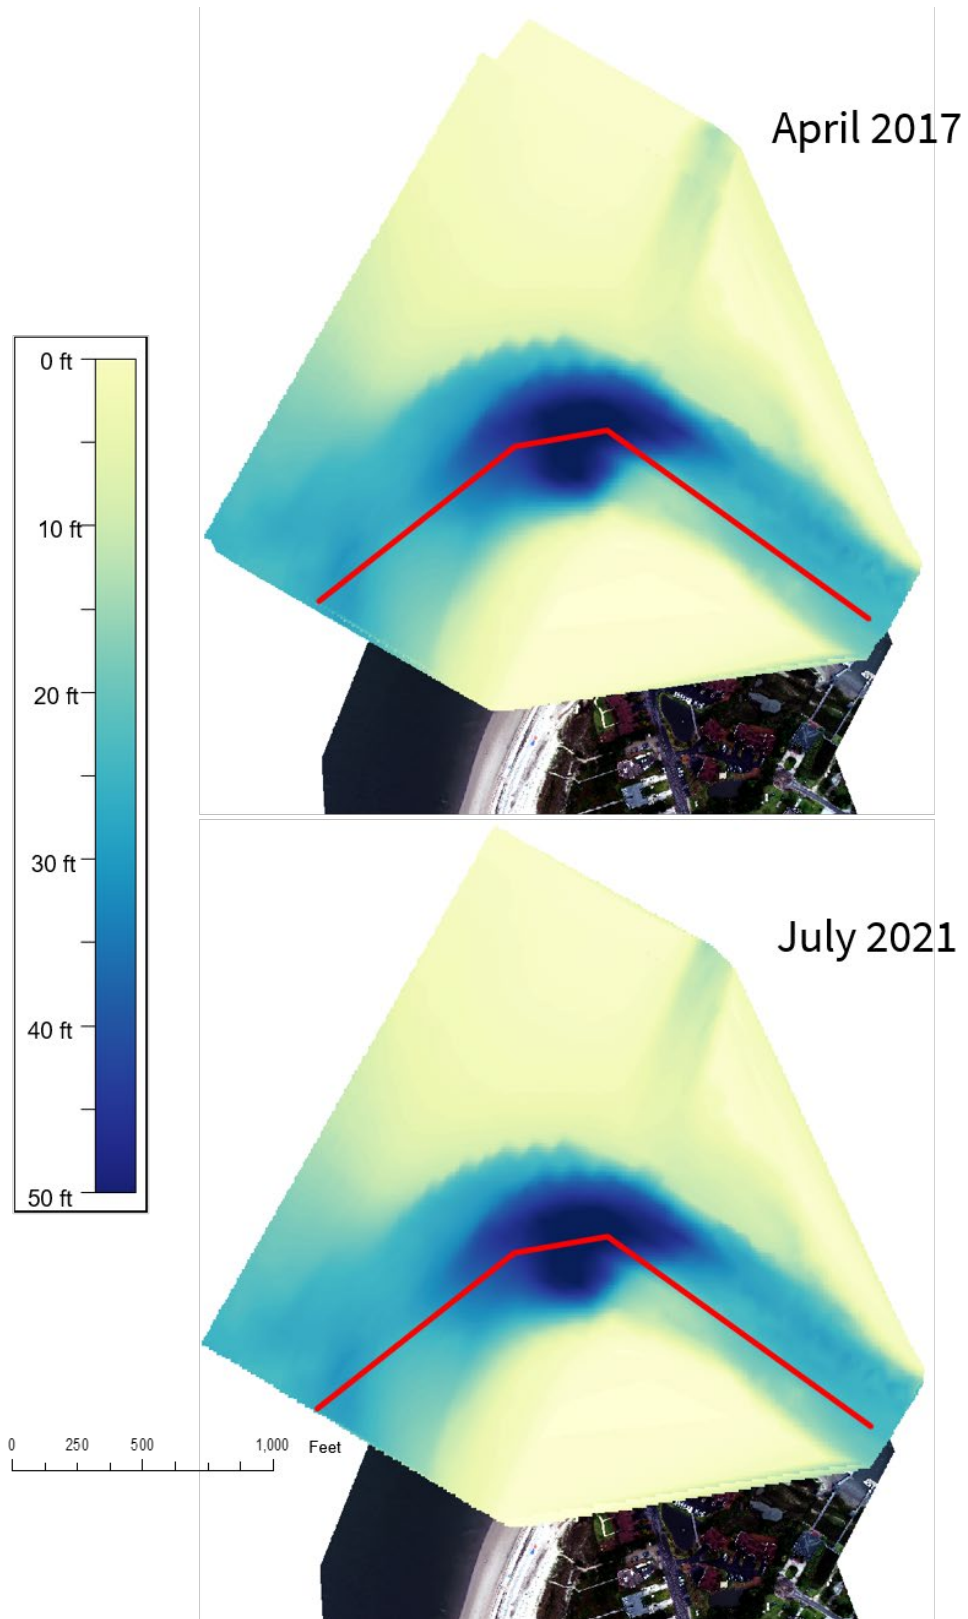
FIGURE 6.1. Changes in bathymetry at the mouth of Big Bay Creek between 2017 and 2021 were relatively minor. The darkest area near the center of each panel is a ~50-ft-deep hole where tidal scour has eroded the creek bed. This hole consists of approximately 5 acres of bottom below -30 ft NAVD. While the size of the hole has remained almost constant between surveys, the southwestern face has shifted ~100 ft northwest from 2017 to 2021. This change is not necessarily related to the 2017 project, and could just as easily be due to natural hydraulic shifts from year to year.

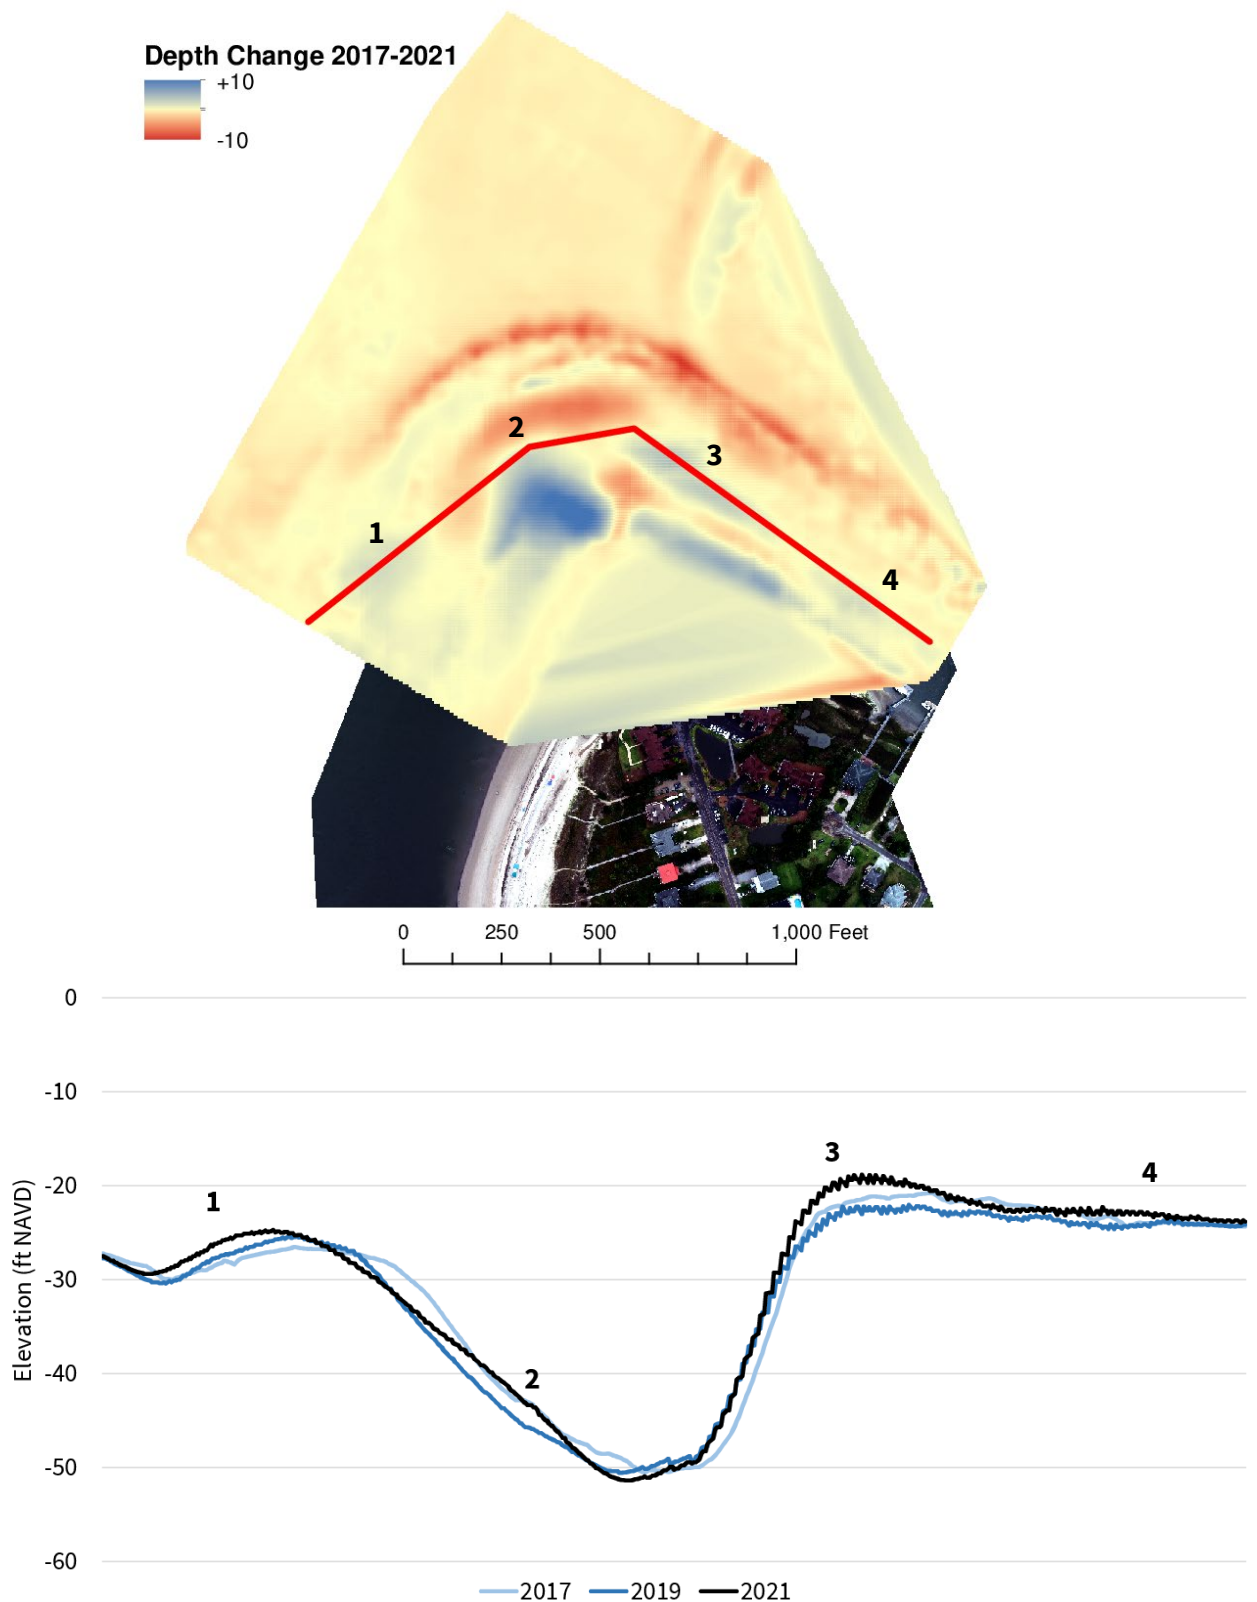
FIGURE 6.2. [UPPER] The difference in depth from 2017 and 2021 can be mapped similar to a DTM, so that red areas indicate erosion and blue areas indicate accretion. [LOWER] The bathymetric data collected along the red line can also be plotted against one another so that subtle changes in bottom elevation are easier to see. In general, there has been modest deposition along the southwestern face of the channel mouth hole ('2'), as well as at the channel mouth itself ('3'). Some erosion has also been measured along the northern edge of the channel (shown in red above).
