**ASSESSMENT OF THE GROIN FIELD AND
CONCEPTUAL PLAN FOR GROIN LENGTHENING
EDISTO BEACH SOUTH CAROLINA**

TECHNICAL REPORT

Assessment of the Groin Field and Conceptual Plan for Groin Lengthening at Edisto Beach, SC

Coastal Science & Engineering (CSE)
PO Box 8056 Columbia SC 29202-8056

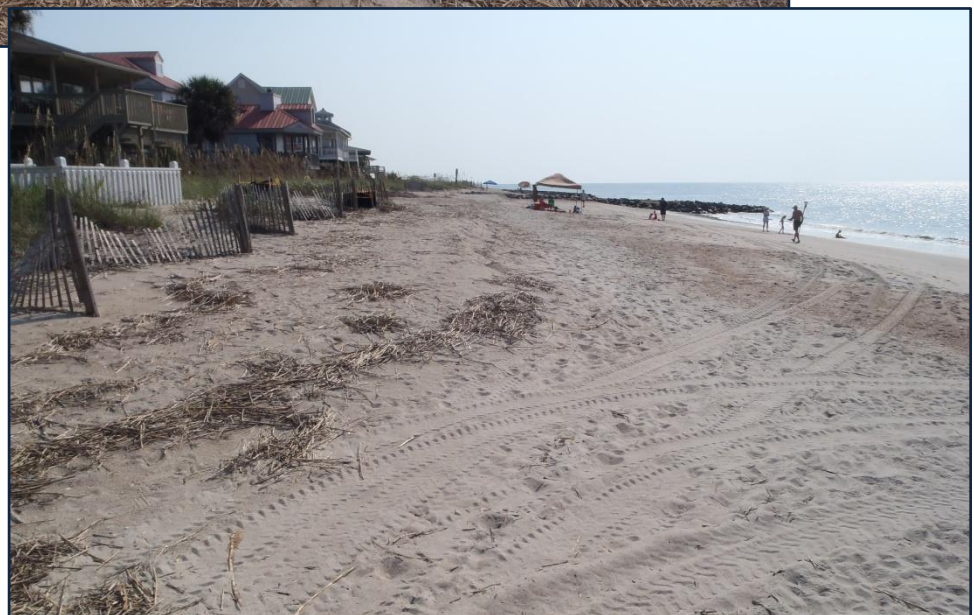
FIGURE 1.

Ground photos taken on 14 August 2012 showing variable conditions with respect to existing homes along (upper) cell 5, 0.5 mile from the pavilion, (middle) cell 15 at Nancy Street, and (lower) cell 26 at the Point.

Along the northern end of the island, homes are situated at the edge of a narrow, dry-sand beach with a negligible vegetative buffer and no dune protection (Fig 1). About 1.5 miles from the pavilion (near Groin 15 – Byrd Street), the beach is wider, and there are low vegetated dunes fronting homes. A 25–50 foot (ft) vegetation buffer persists along most properties from Groin 15 to Groin 24.

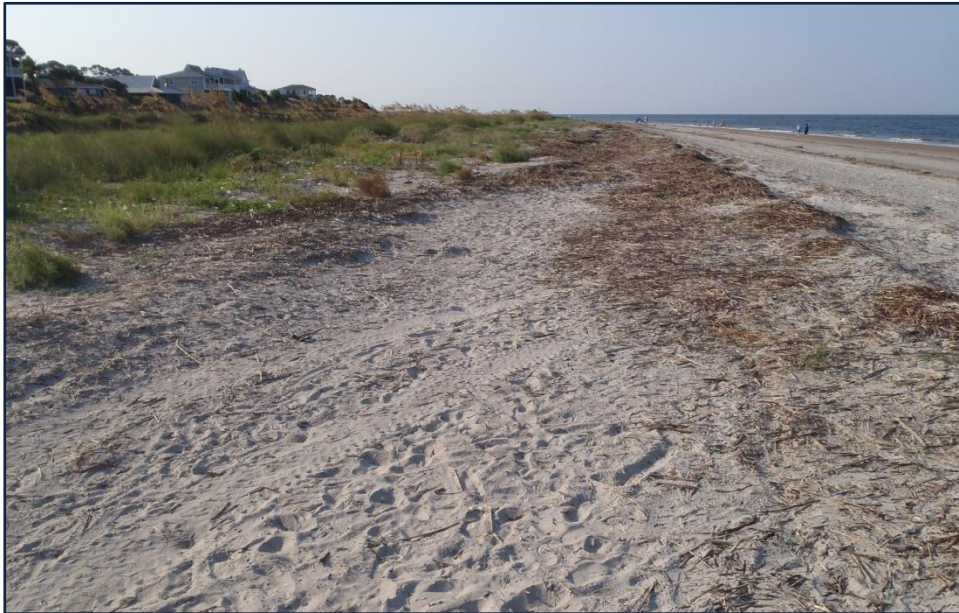
FIGURE 2.

Much of the sand lost along the oceanfront has accumulated down-coast along the St. Helena Sound shoreline of Edisto Beach.

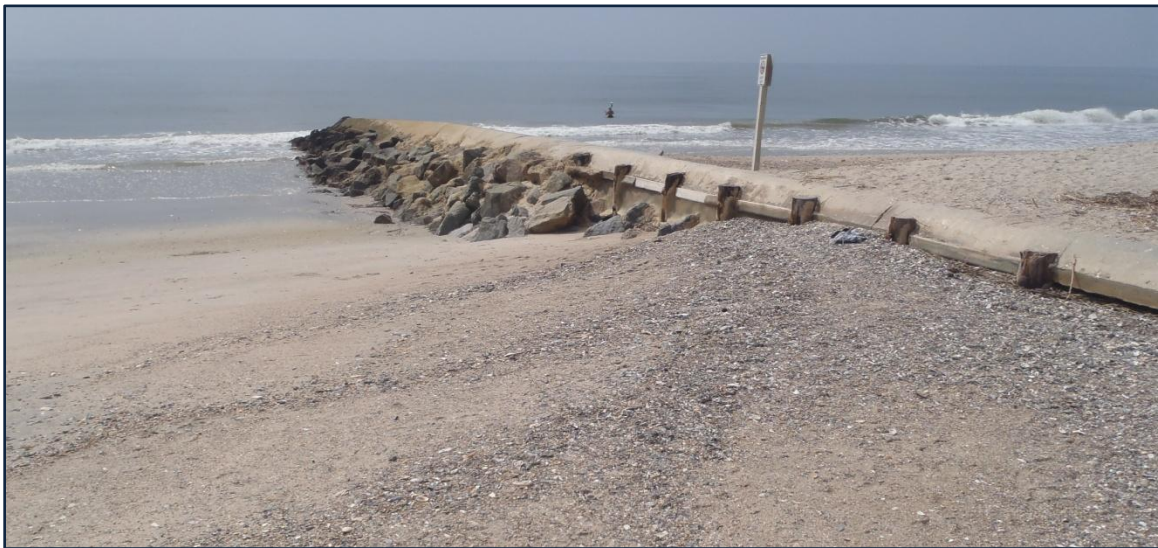
FIGURE 3. Groin 8 at low tide (14 August 2012) showing original timbers (1950s) capped by retrofitted concrete cap (ca 1997). Seaward quarry-stone section was restacked and grouted in 1995. The landward end slopes at ~1 on 50 while the seaward section slopes at ~1 on 20, with the crest terminating about 4 ft above mean low water in this case.

The trapping capacity of groins is a function of length, height, and spacing (ASCE 1994, Kraus et al 1994, USACE 2002, Basco & Pope 2004). When Edisto’s timber groins were built, the seaward ends were higher than present conditions and, possibly in some cases, longer. As they deteriorated and were rebuilt (1995), functionality declined relative to the original condition. Sand-trapping capacity decreased and the equilibrium profile within each groin cell receded landward, leaving a narrower beach. Maintenance efforts to date have been designed to maintain the structure profiles, using grout to hold smaller-than-ideal rock units in place. This has also created “impermeable” structures which lose less sand through gaps between rocks. Efforts by the Town of Edisto Beach have included addition of concrete caps on top of the groins which incrementally increase trapping capacity* (see Fig 3).

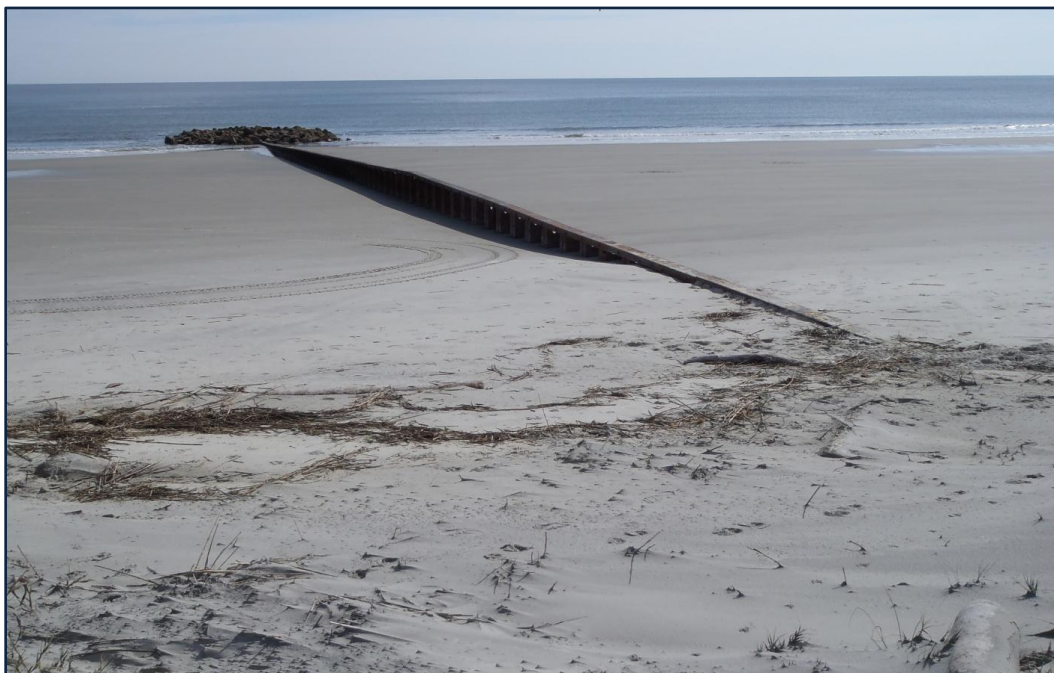
FIGURE 4. A Hunting Island (SC) groin built in 2007 showing the three recommended sections which are designed to follow the natural slope of the beach: upper dry beach section (berm), sloping wet-beach section (beach face), and low-tide section (low-tide terrace). Note the broad apron of loose armor stone at the head of the structure placed to reduce scour. This functions as a “T-head” and is considered to improve the performance of the groin.

Few groins in the US follow modern design guidelines for the profile (ASCE 1994, USACE 2002). Six groins at Hunting Island (SC) are among the installations that incorporate the three sections recommended (Traynum et al 2010). At Hunting Island, where the wet-sand beach is wider and flatter than at Edisto, groins are ~450 ft long. The “berm” sections are typically about 150 ft long; the sloping beach-face sections are about 225 ft long; and the low-tide terrace sections are about 75 ft long with a broad apron of loose quarry stone at the head of each groin. This profile places more of the structure below the high watermark and tends to reduce the reveal above the sand level (Fig 4). Based on present design guidance, **retrofits of existing groins should seek to achieve the three recommended sections to the extent practicable.**

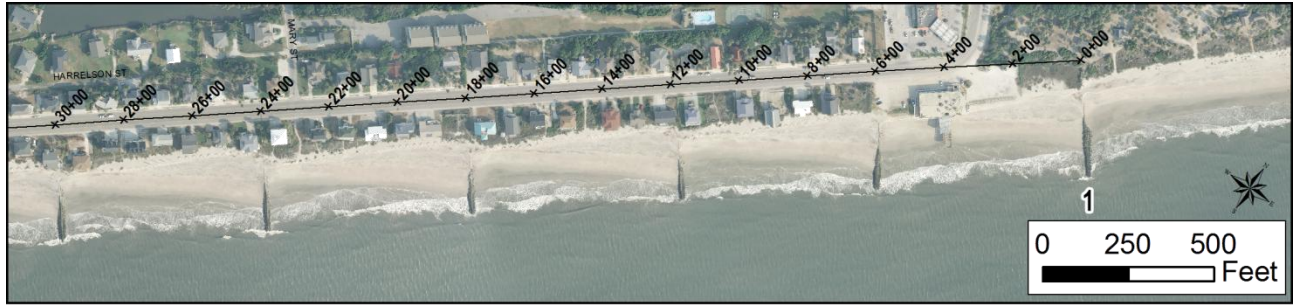
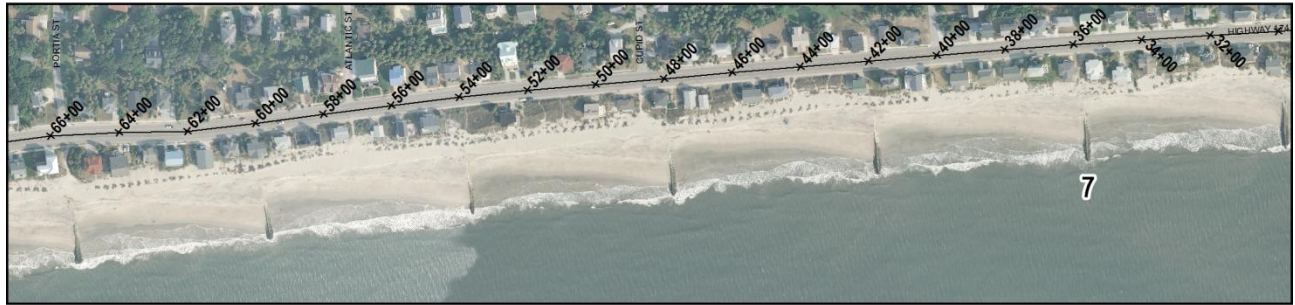
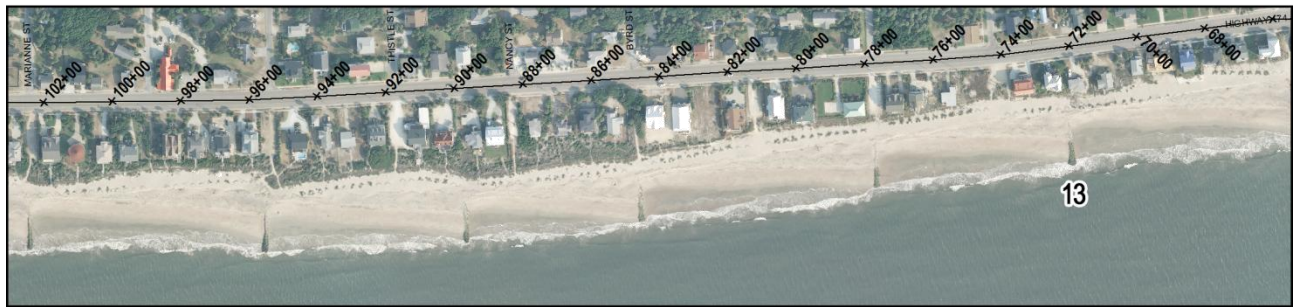
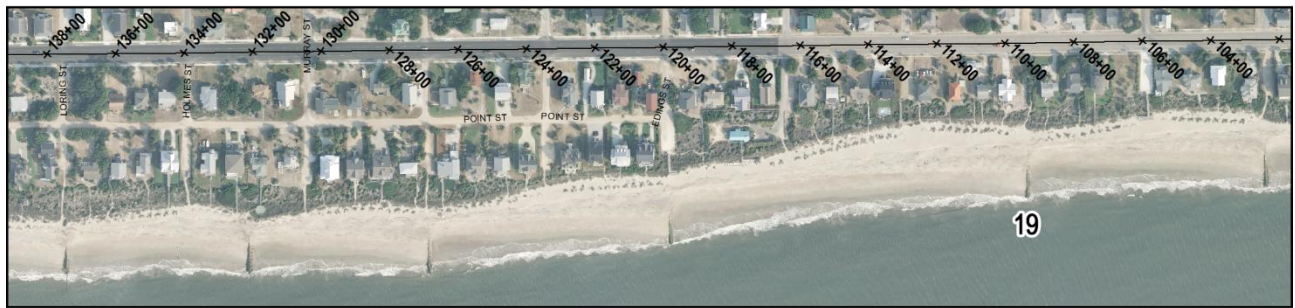
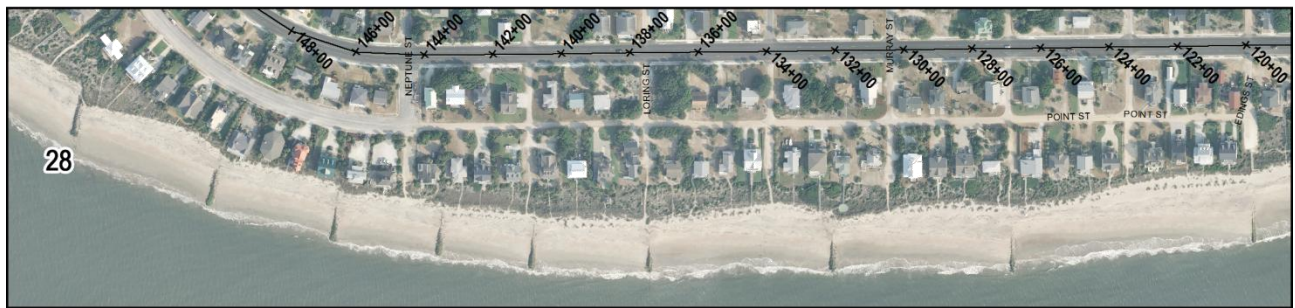
FIGURE 5. Reference baseline running along the centerline of Palmetto Boulevard. The baseline begins at Groin 1 (station 0+00) and extends to the southwest ~15,000 ft to Groin 28.

The 2011 aerial imagery was used to define a reference baseline along the visible centerline of Palmetto Blvd. This baseline essentially is the same as the baseline used during monitoring surveys, except for a few minor adjustments along the 100 block and around the Point Street area (herein “the Point”). The baseline defines the starting point (0 feet–ft) for beach profiles and also defines the distance alongshore of each groin [ie – Groin 1 is at the start of the baseline (station 0+00), and Groin 2 is at station 6+15 (615 ft along the baseline from the starting point)]. The baseline is shown in Figure 5.

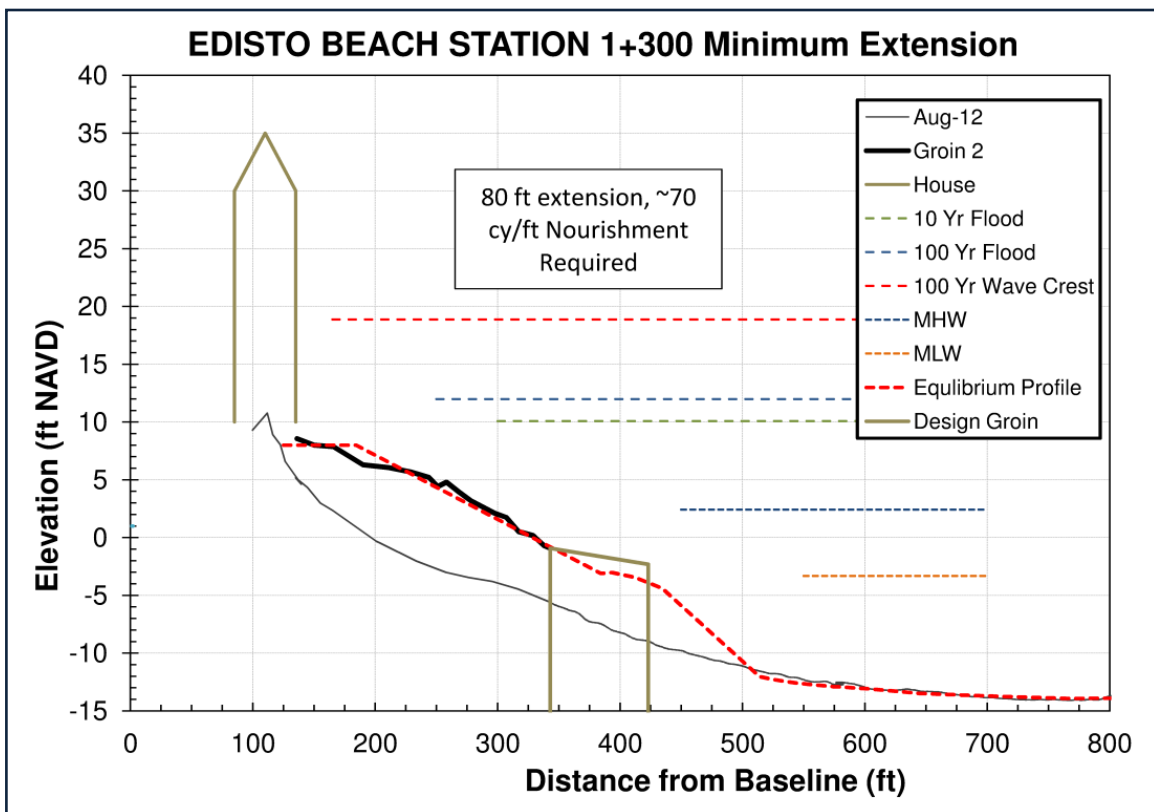
FIGURE 6.

[UPPER] Methodology for Scenario 1, where groin lengthening is determined by comparing conditions at each groin with the condition of Groin 16 (shown).

The critical measurement is X_i , the averaged distance from the house to the groin reference point.

[LOWER] Example Scenario 1 from Groin 2, which would require an ~80 ft extension and ~70 cy/ft nourishment to achieve conditions similar to Groin 16.

The reference baseline was used to calculate the setback of each oceanfront house as well as the distance to the stable vegetation and the July 2012 mean-low-water (MLW) contour in front of each house. This produced a table of values for each house from which the width of stable vegetation and the beach width (from each house to MLW) could be extracted. These values were averaged for all houses within each groin cell to provide a representative condition for each cell/groin pair. While seasonal sediment transport patterns are significantly different at Edisto, CSE assumed for this study that the dominant transport is to the south, therefore, a groin will protect the beach on the northern side (updrift side). For example, the average width of vegetation at **cell 15** (between Groins 15 and 16) is assumed to be controlled by the length of **Groin 16**. The baseline was also used for creation of groin profiles so that the beach condition could be related to each groin profile. An example from Groin 16 is shown in Figure 6.

From these data, it is possible to relate each groin condition to that of Groin 16. These distances represent the minimum required groin lengthening to match the current condition of cells 15 and 16 (Fig 6, lower). CSE assumed that there is a 40-ft minimum extension threshold* to reach before the effort would be cost effective. Extensions which were calculated to be less than 40 ft were lengthened to a minimum of 40 ft for cost estimating.

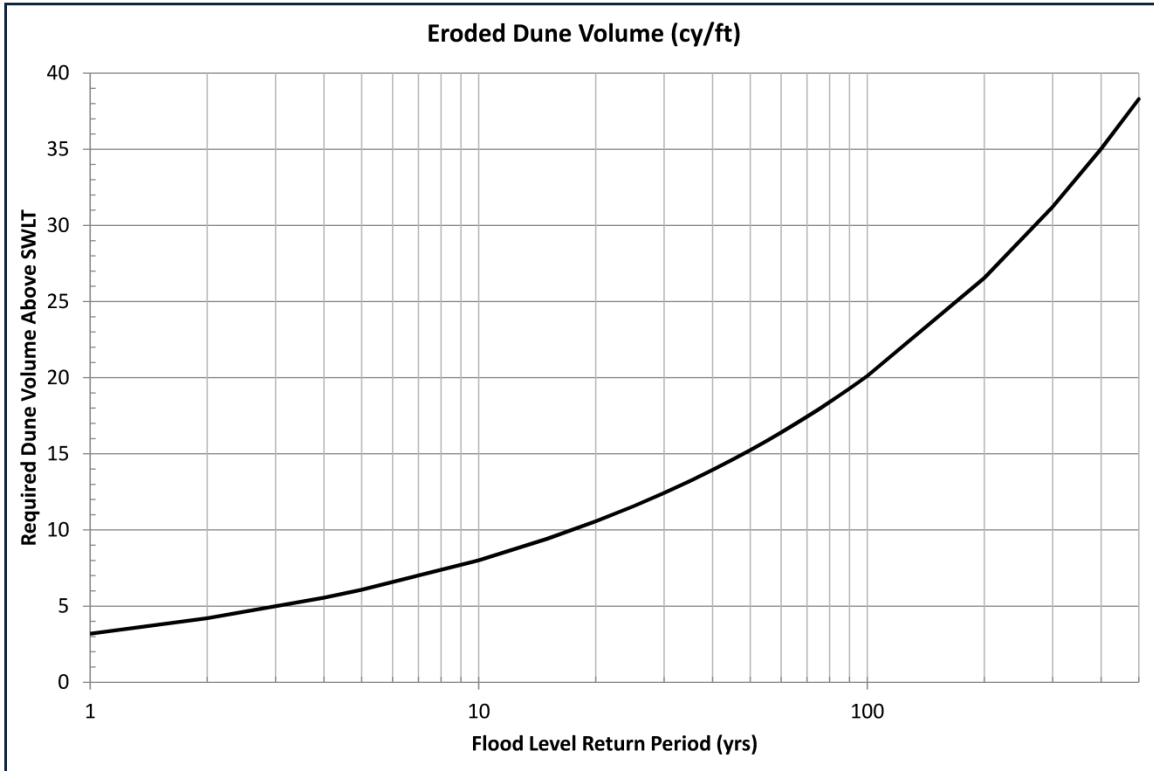
FIGURE 7. FEMA dune criteria for storm protection for a given flood-level return period (T). Volumes are above the stillwater elevation for the flood level (SWL_T). For Edisto Beach, the 10-year SWL_T is 10.1 ft NAVD. Recommended dune volumes increase geometrically as the desired level of protection rises.

For example, the 10-year storm event ($SWL_T = 10.1$ ft) yields a cross-section of 216 ft² which is equivalent to 8 cy/ft. A 25-year storm would require a dune cross sectional area of 312 ft² (11.6 cy/ft) above the 25-year stillwater elevation. A common dune size used by FEMA for community ratings is for the 100-year flood level, which yields a dune volume of 540 ft² (20 cy/ft) above the **100-year stillwater flood level**. Flood elevations were obtained from the FEMA Flood Insurance Study for Colleton County (SC) and Incorporated Areas (7 November 2001).

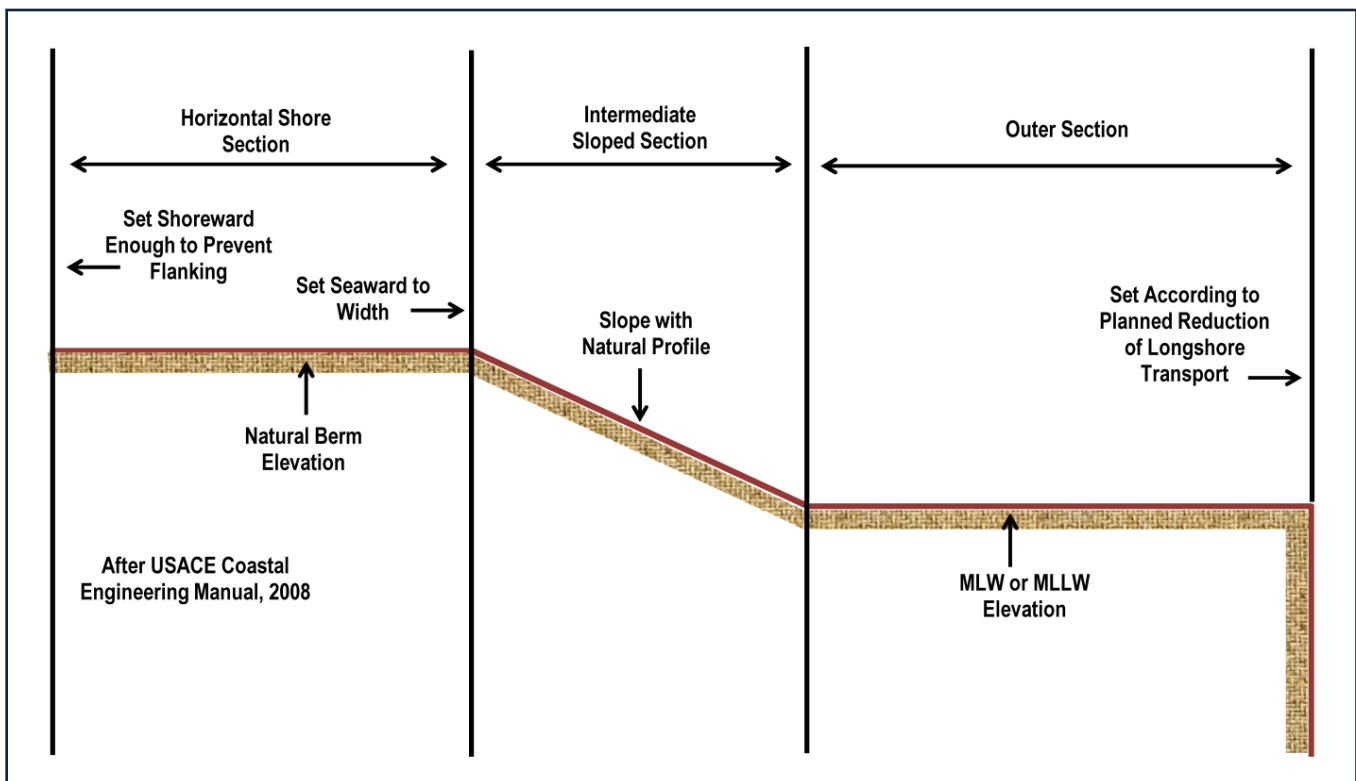
FIGURE 8. Schematic of a recommended “template” groin profile with sloping section and horizontal outer (low-tide terrace) section (after ASCE 1994, USACE 2008). Groins at Hunting Island (Traynum et al 2010) are among the few installations in the United States which incorporate all three sections. Repairs to groins at Edisto Beach in 1995 improved the intermediate sections to approximate mid-tide level, but did not complete the full sloped section or any of the outer section.

Groin-lengthening recommendations for this method were determined by measuring the distance from the end of the existing groin to the end of the sheet-pile section of the new groin. An additional measurement was the required retrofit distance, which is the length of the existing groin seaward of the +5.5 ft contour. This section of existing groin would require some type of alteration to elevate the crest to match the ideal groin (new) profile.

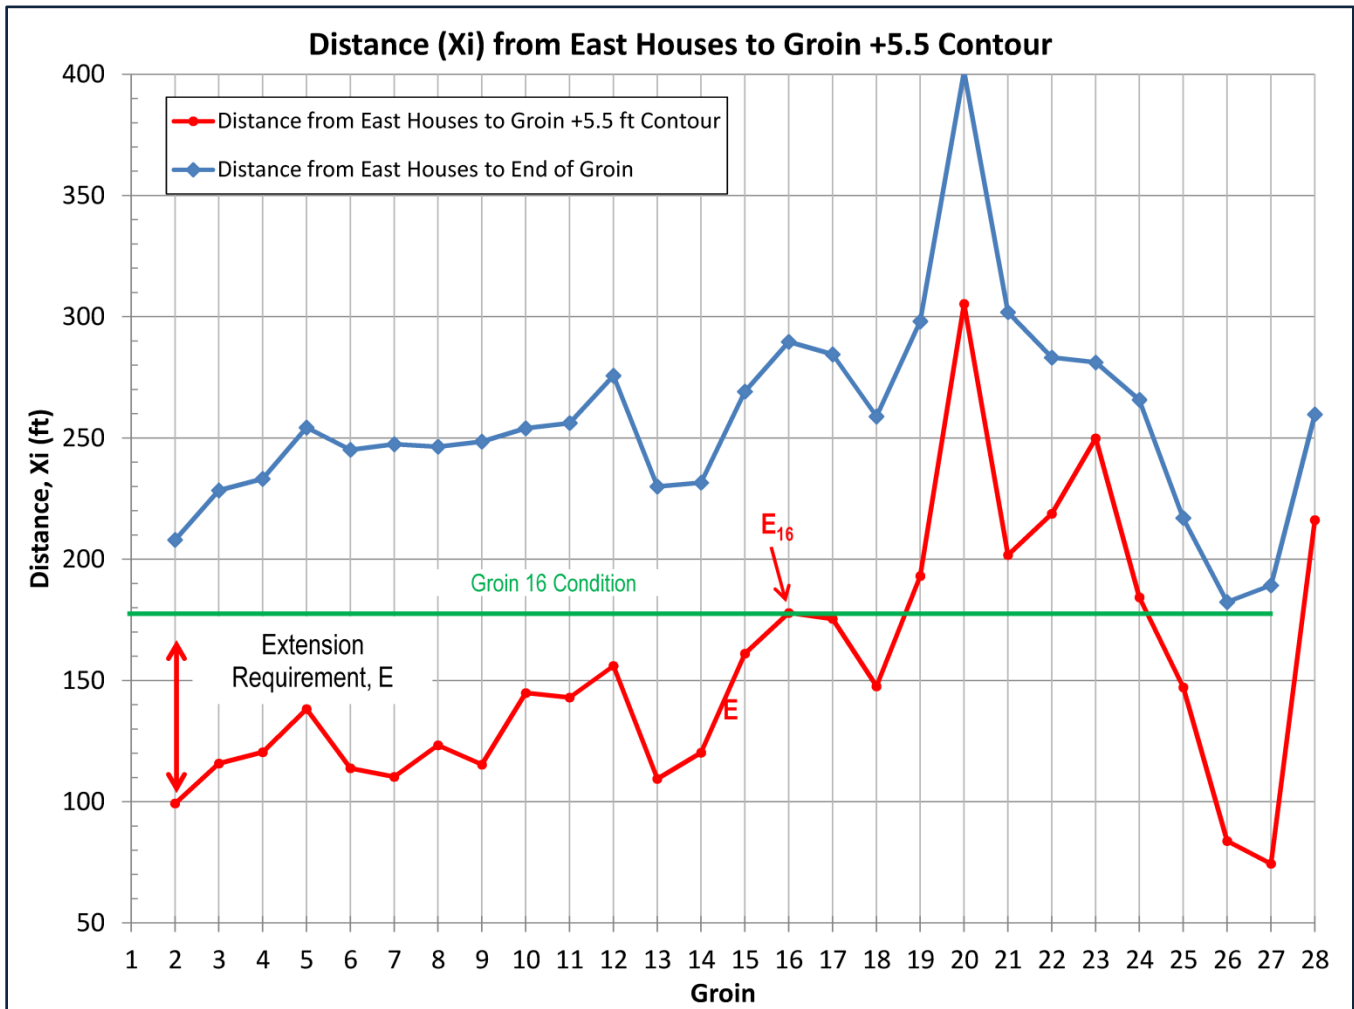
FIGURE 9. Graph showing the average distance from updrift houses (on the north side of a groin) to the +5.5 ft contour of the groin. This value was compared for each groin to that of groin 16 (green line), which has a target minimum vegetative buffer between the houses and the ocean. The distance between the red and green lines is the required extension to match the groin 16 condition (where the red line is below the green line, the groin must be extended). The seaward end of each groin is the blue line.

E ranged from 80 ft to -127 ft (values below zero represent conditions exceeding the present condition of Groin 16) as shown in Figure 9.

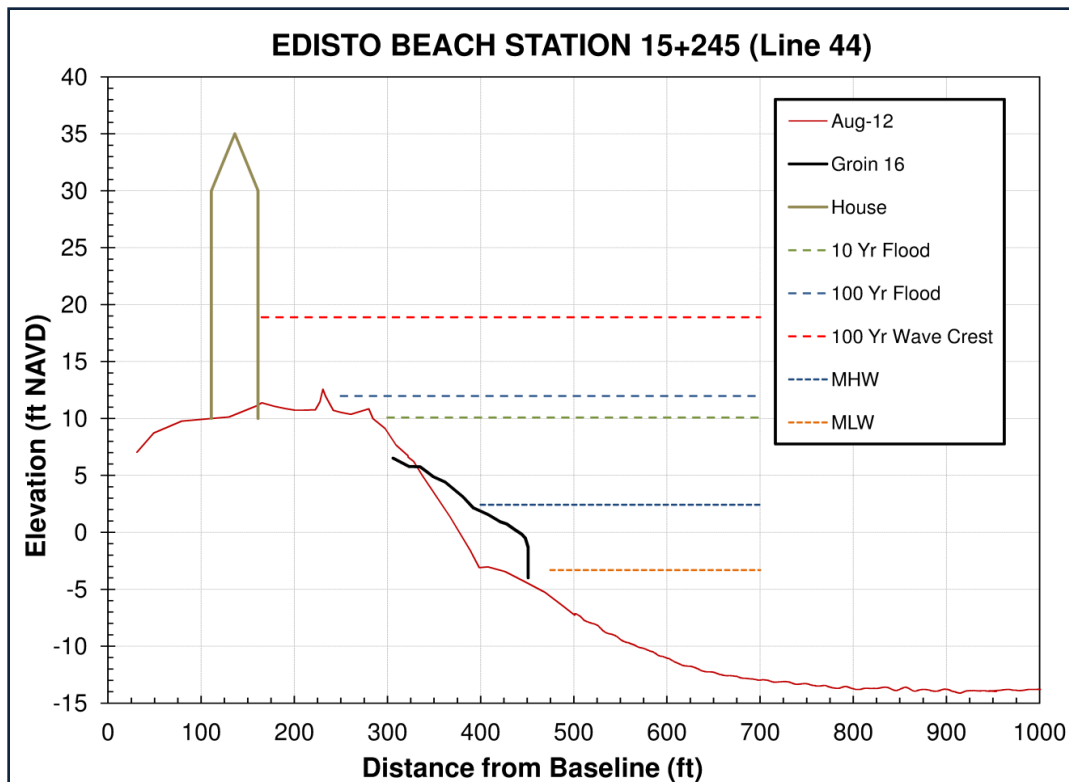
FIGURE 11. Reference water levels for Edisto Beach (SC). The example house is for illustrative purposes only and is not drawn to actual dimensions.

For Edisto Beach, only the 10-year and 100-year flood elevations were available from the FEMA Flood Insurance Study (FEMA 2001). The 10-year flood elevation (stillwater) is 10.1 ft NAVD (11.1 ft NGVD), while the 100-year flood elevation is 12 ft NAVD (13 ft NGVD) (Fig 11). These elevations represent the stillwater elevations (not including waves) which have a 10 percent and 1 percent chance of occurring during any year (10-year and 100-year floods, respectively). If the effect of waves is included, then the 100-year flood elevation along the open coast “V-zone” rises to 18.9 ft NAVD (19.9 ft NGVD).

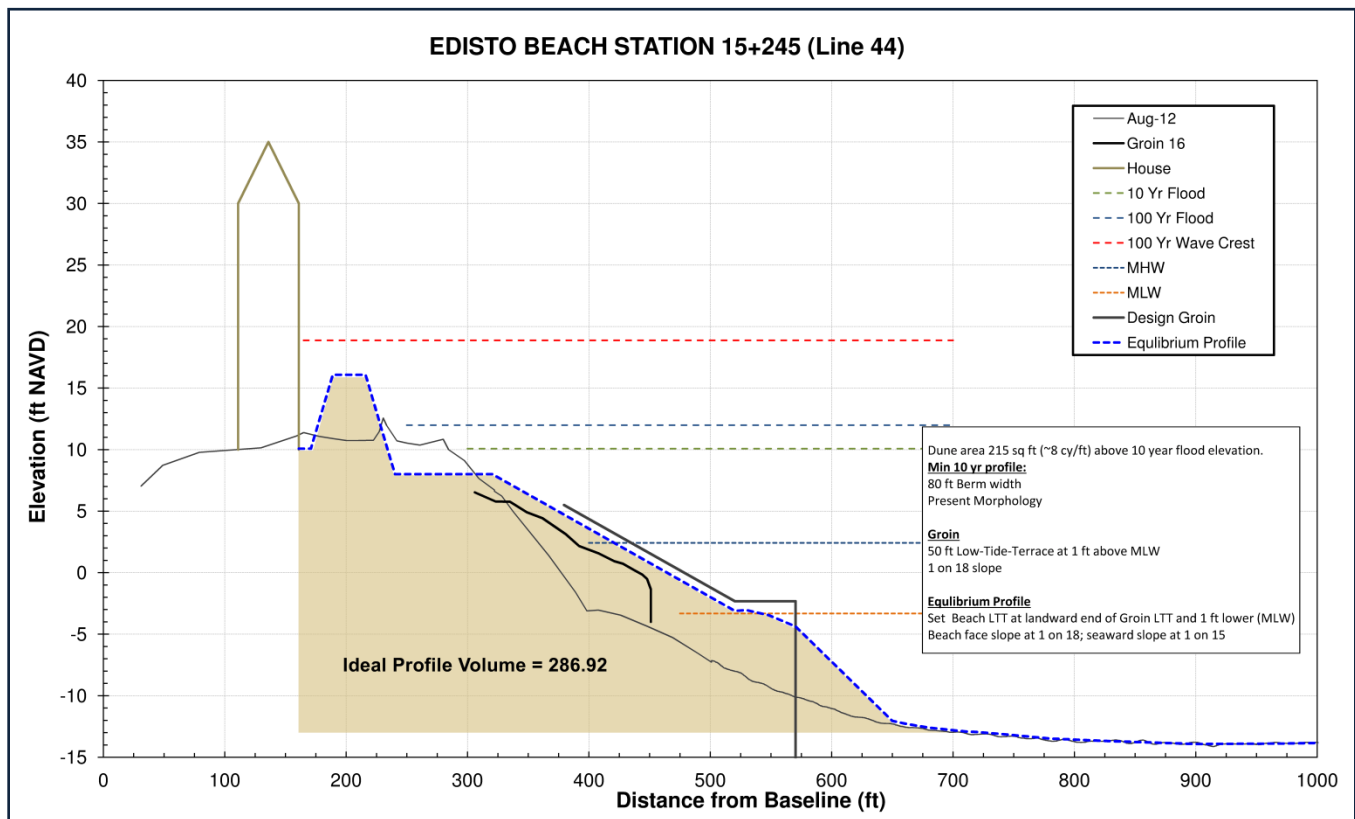
FIGURE 12. Ideal profile (blue dashed line) of the center of groin cell 15 (between Groins 15 and 16) compared to the August 2012 condition. The ideal profile volume (cy/ft) indicated provides a target volume to maintain via nourishment which is in excess of the expected trapping capacity of the groin.

The resulting ideal profile volume between the house and the -13-ft depth contour (~700 ft from the baseline) is ~287 cy/ft. The nourishment volume to achieve the ideal is the difference between the existing profile and the ideal cross-section (converting the area difference to a unit volume difference and applying that volume over the length of the cell, or to the next available profile). Figure 12 shows the profile for the center of cell 15 and the crest of Groin 16. Under Scenario 2, a “10-year” dune would raise backshore elevations by about 5 ft above existing ground level. Appendix A includes design profiles for all groins under the Scenario 2 methodology.

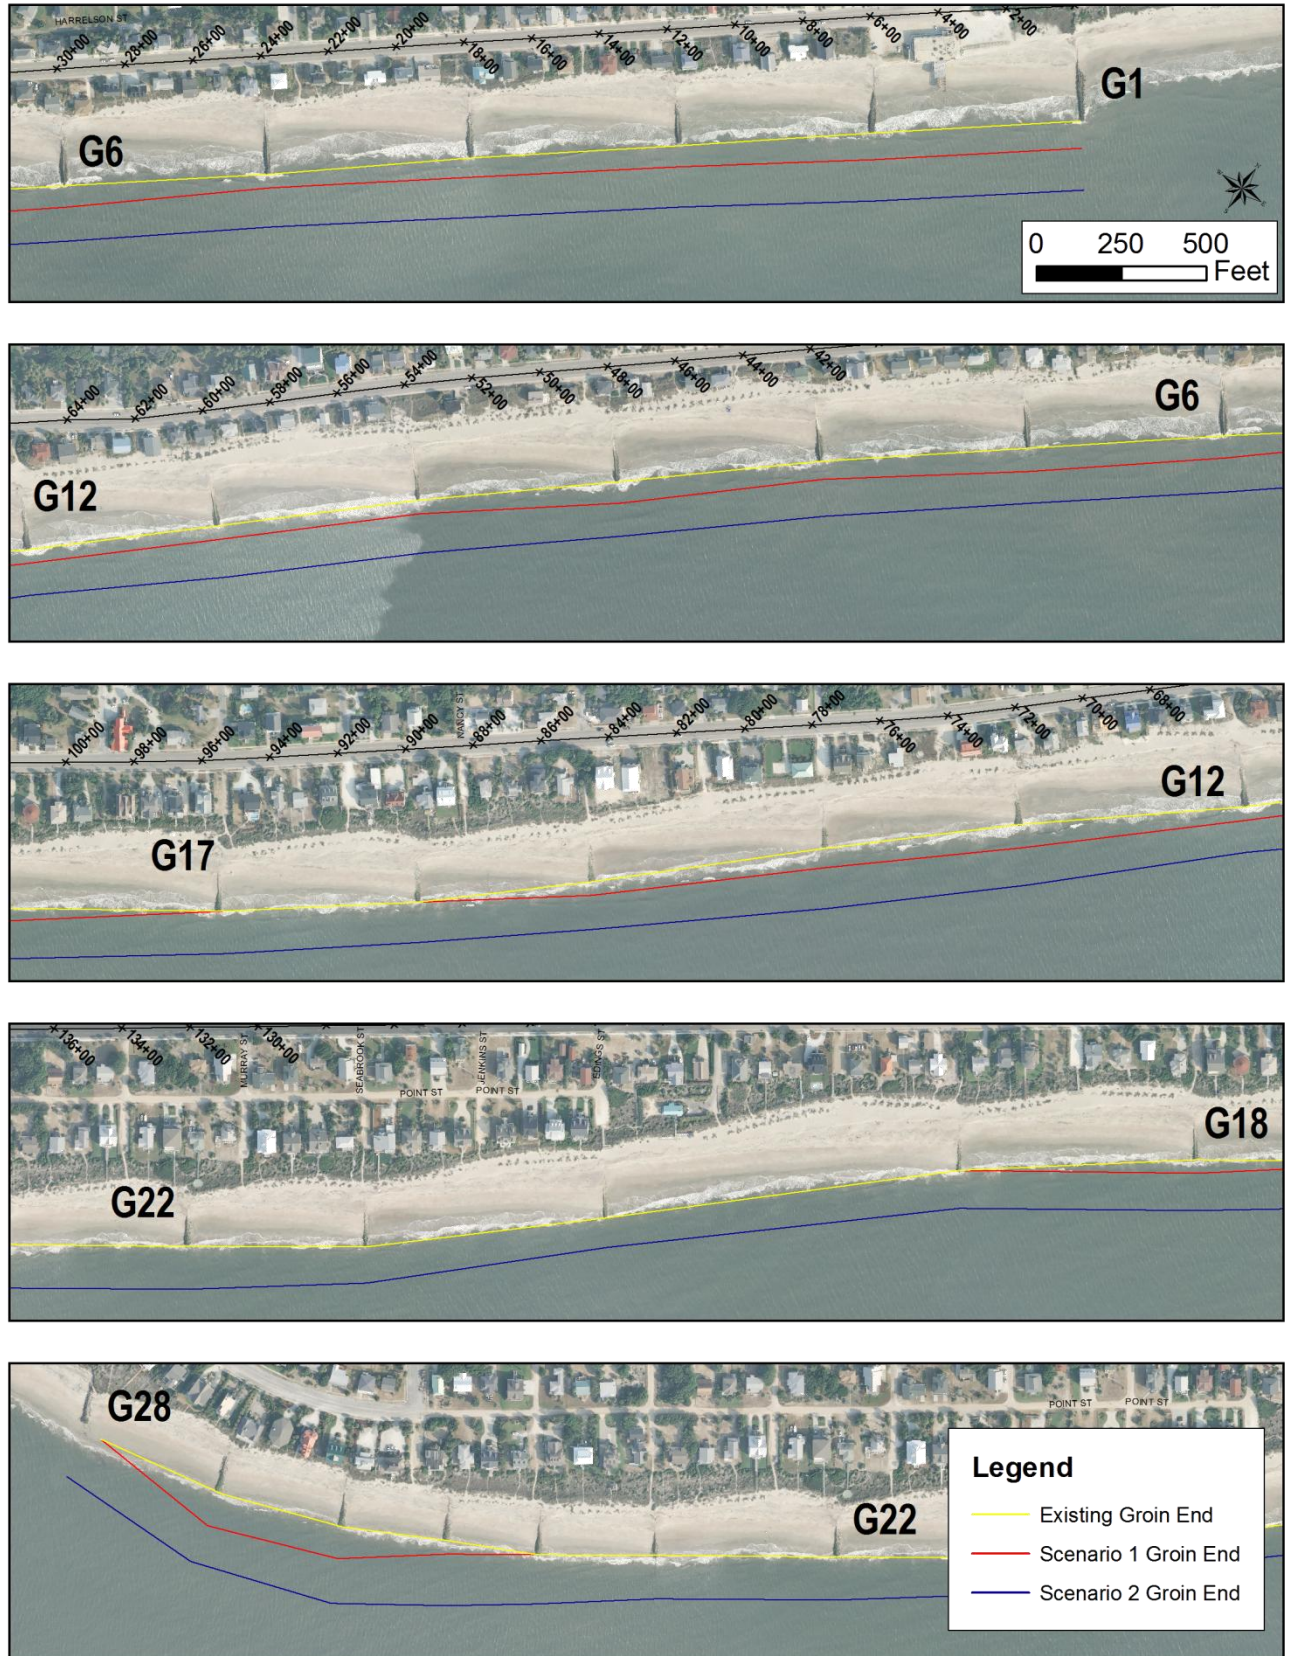
FIGURE 14. Alignment of groin ends under lengthening Scenario 1 and Scenario 2. Where the red line is missing, no groin extension would be completed under Scenario 1.

Figure 14 shows the alignment of groin ends under Scenario 1 and Scenario 2 superimposed on rectified aerial photography. Both lines have the effect of evening the seaward limit of the groins compared with existing conditions, although some variability remains under Scenario 1 due to the “40-ft” threshold applied. Scenario 2 provides a nearly uniform offset between existing houses in each cell and the new ends, with the Groin 20 length (84 ft addition) interpolated between those of Groin 19 and Groin 21.

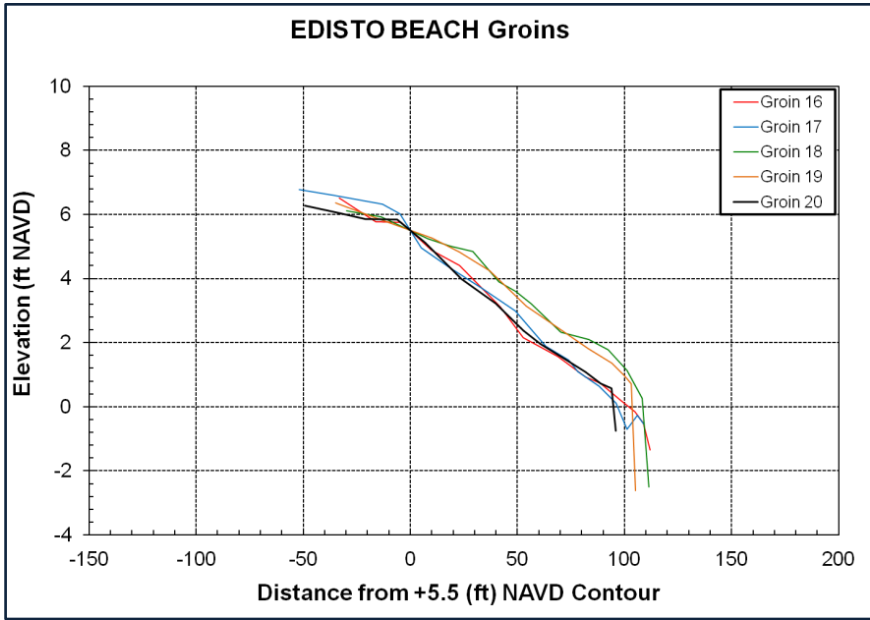
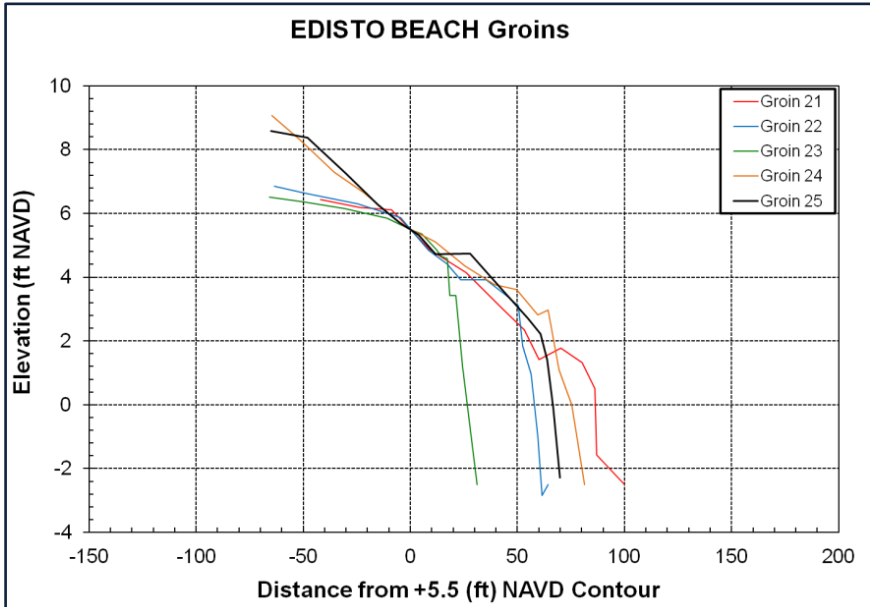
FIGURE 16.

Note the much lower profiles along Groins 10, 11, and 12 relative to the other groins.

The seaward ends of each groin profile superimposed at the +5.5-ft NAVD contour.

Figures 15 and 16 show the variations in each groin profile with respect to the +5.5-ft contour. Each profile is overlaid using the +5.5-ft contour as the zero distance. Lengths, elevation at the seaward end (head), and cross-sectional areas (unit volumes) seaward of the +5.5-ft contour are given in Table 3. Elevation at the head and distance to the end provide simple measures of which groins are likely to present a greater cross-section across the littoral zone. The computed cross-sections quantify the differences.
