RE: Hurricane *Dorian* Beach Damage Assessment [CSE 2485]

Title: Edisto Beach Management Program

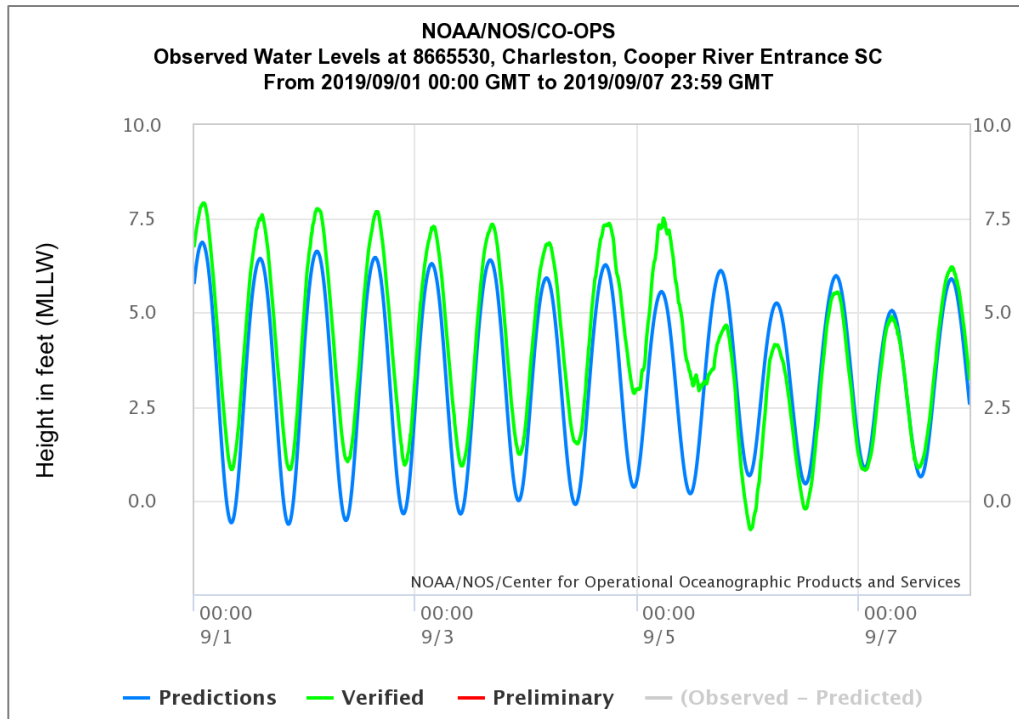
Figure 1 shows the water levels measured at Charleston Harbor during the storm event. The tide elevations were running higher than predicted prior to the storm (over +7.0 ft MLLW), then sharply decreased when the storm passed on the 5 September when the tide was nearly 2 ft below the predicted level. Water levels returned to normal conditions by 7 September.

FIGURE 1. NOAA water level data from Charleston Harbor, SC.

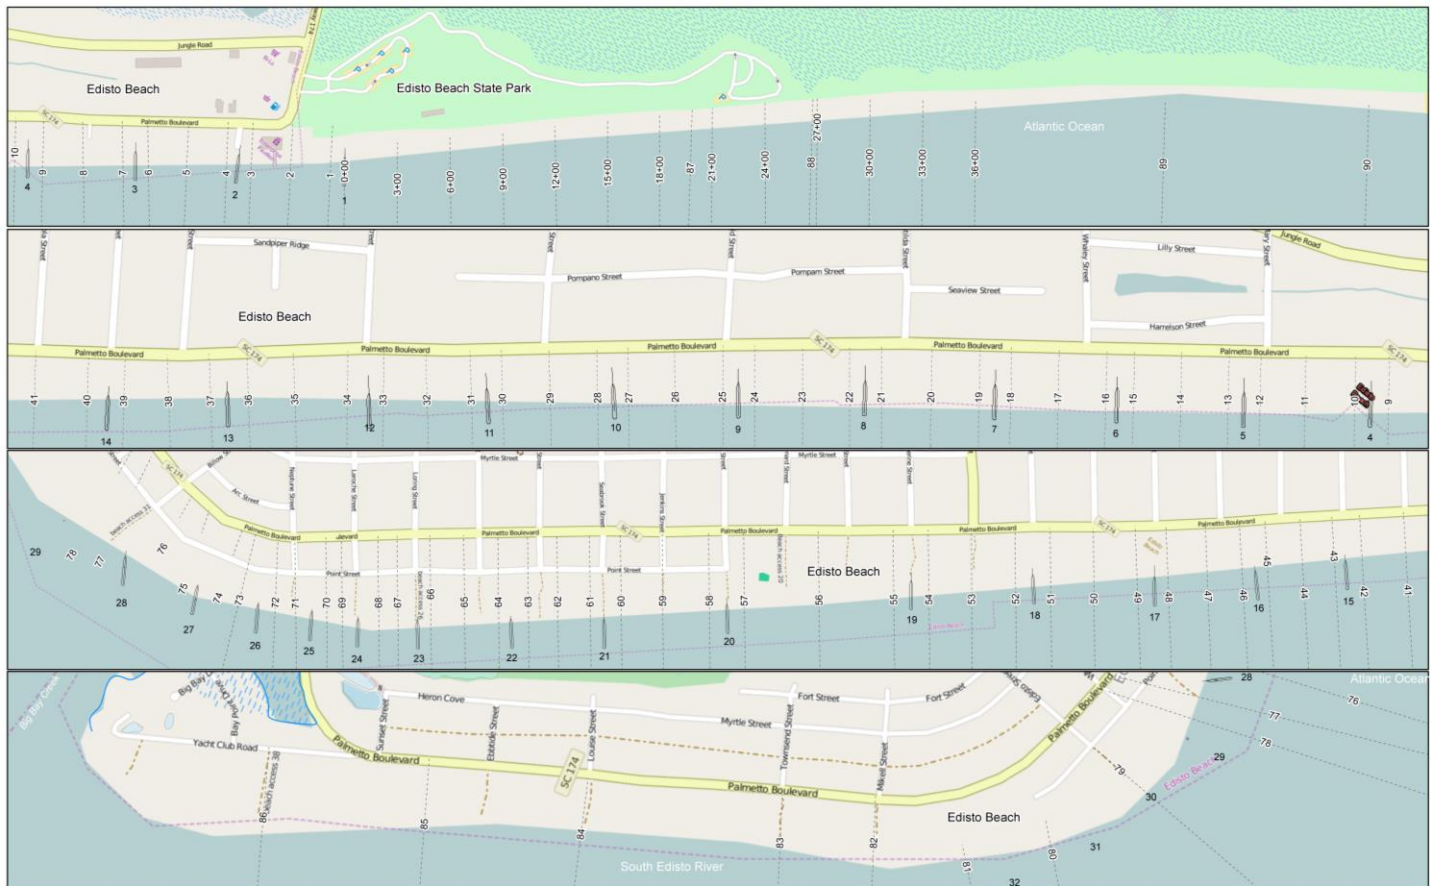
CSE completed a post-storm survey to document changes to the beach profile and volume losses on 9 September 2019. Profiles were obtained from the landward sand limit to ~1,500 ft offshore (well beyond the local depth of closure). Profiles were obtained in each groin cell and at 600 ft spacing in the Edisto Beach State Park (Figure 2). The surveyed area encompassed the shoreline between the northern end of the state park camping area to South Edisto River, which includes all areas filled during the 2017 Edisto Beach Nourishment Project and has previously been determined to be a qualifying “engineered beach” by FEMA. The post-storm survey data are compared to a recent comprehensive monitoring survey CSE completed for the Town of Edisto Beach in late July 2019 that included profiles at the same locations as the post-storm survey.

FIGURE 2. Location of beach profiles (dotted lines) surveyed annually and following Hurricane *Dorian*. See the line numbers in the Table 2.

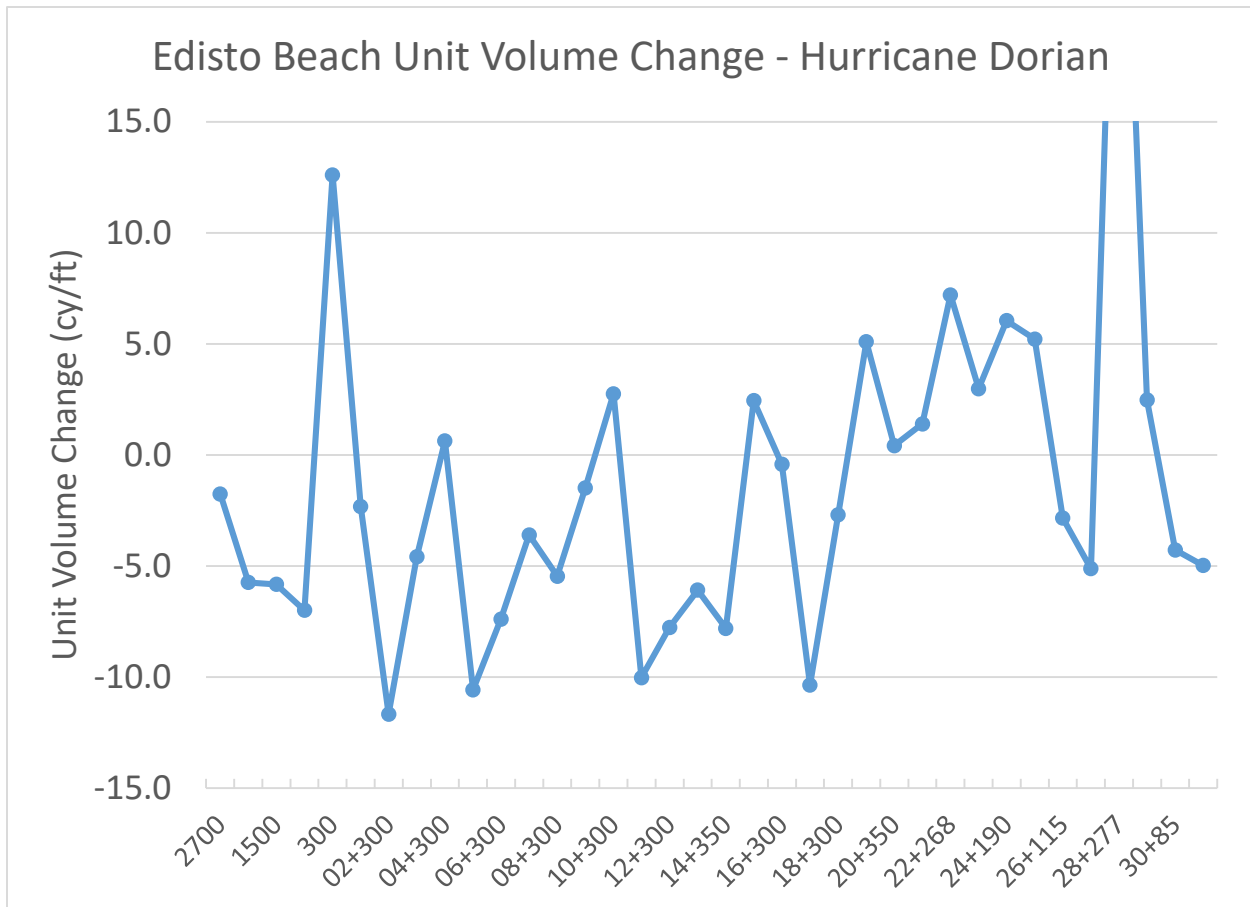
Table 2 provides volume change values for each profile and sums for the Town’s engineered beach area (Reach 1 through Reach 4). Overall, the engineered beach lost 34,383 cy of sand to closure depth (-14 ft NAVD). The most significant areas of erosion were along the north end of the Town’s beach, Cells 11 through 14 (600–1000 block), and cell 17. Figure 4 shows the beach unit volume changes in the project area from pre-storm (July 2019) and post-storm (September 2019). The Town’s portion of the recent beach project includes Reaches 1–4 (Lines 2-80).

FIGURE 4. Beach volume changes occurring during Hurricane *Dorian*.

The total volume loss for the storm (34,383 cy) includes background erosion. The project area averages a loss of 41,278 cy per year, as determined from total losses between 2006 and 2015. Applying this value over five weeks (the interval between pre- and post-storm surveys), yields a five-week loss of 3,969 cy. Subtracting the background erosion from the measured losses provides a **total storm-induced loss of 30,414 cy.**

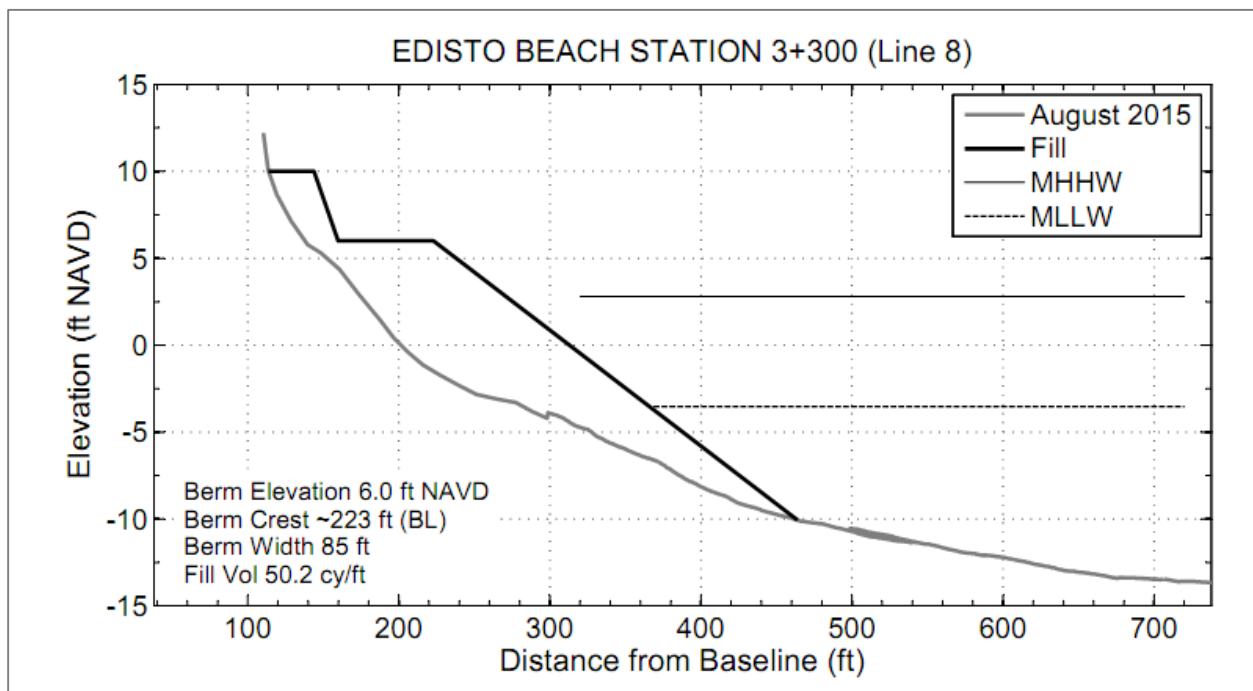
The restoration project will replace sand lost from the design dune and berm constructed in 2017. Figure 5 shows a typical design drawing of the 2017 nourishment project. At this location, the project called for a base quantity fill density of 50 cy/ft with a dune constructed at +10 ft NAVD. Prior to construction, the dune height was increased to +11 ft NAVD and the fill density was increased to ~60 cy/ft due to the impacts of Hurricane *Matthew* in 2016.

FIGURE 5. Typical design profile of the 2017 beach nourishment project at Edisto Beach, SC.

To restore the sand quantity lost from the project area, the Town of Edisto Beach intends to add the same quantity of sand to the beach using sand imported from an upland source. CSE has identified an inland borrow pit within a feasible hauling distance that has sufficient beach compatible sand volume for the restoration effort. The borrow pit is located at 6381 Hyde Park Rd, Ravenel, SC 29470, and has previously been approved by SCDHEC-OCRM for use on the beach. The sand within the borrow source is clean, fine-grained sand with an average grain size of ~0.200 millimeters (mm). The native beach sand was established by sampling four cross-shore locations along the active beach and dune at each groin cell along the Town. The mean grain size for the native beach was 0.487 mm, while the mean grain size for 2017 project borrow area was 0.65-0.72 mm (these numbers were skewed by a few coarse samples). The 2017 post-project beach tested at a mean grain size of 0.508 mm, close to the pre-project condition. The proposed restoration borrow sand is finer than the native beach sand; however, it is within the sand size range typically found along many South Carolina beaches. CSE believes this sand will work well for the scope of restoration considered in this project, which will focus on restoring the dune area. The finer grain size will allow aeolian transport to facilitate dune growth.

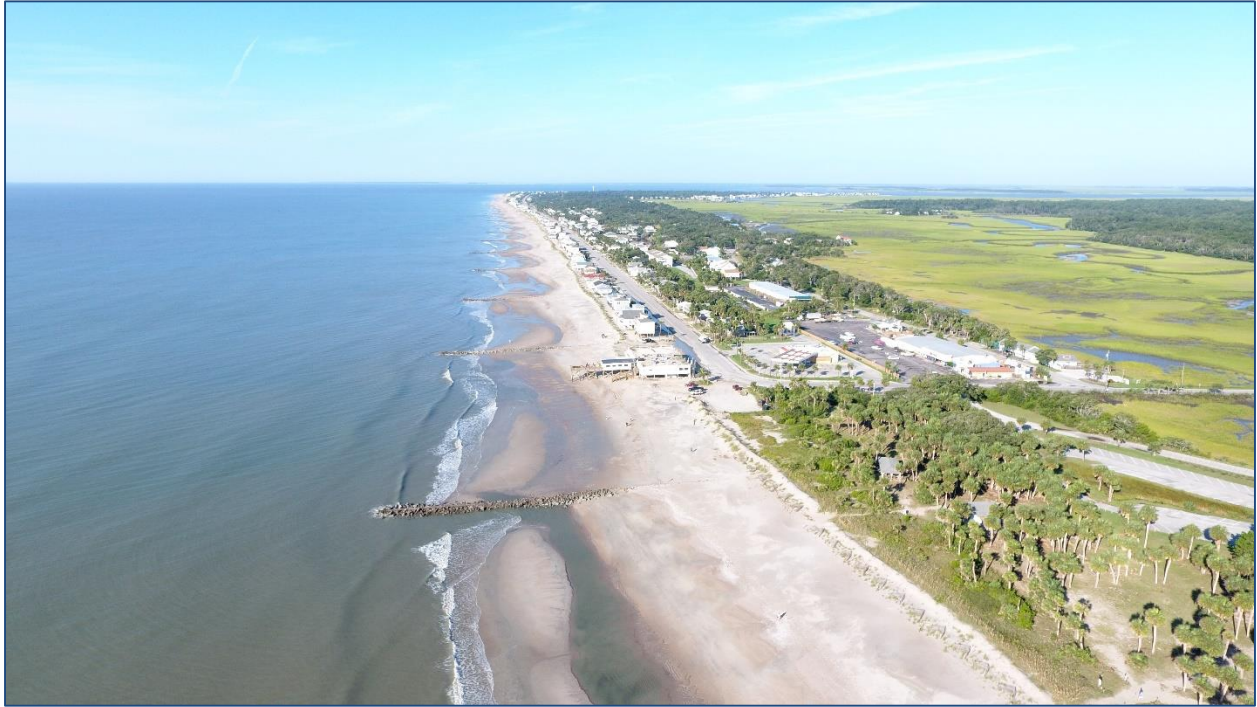
Aerial photo of Edisto Beach following the passage of *Hurricane Dorian*.
