FINAL REPORT

2017 BEACH RESTORATION AND GROIN LENGTHENING PROJECT Edisto Beach Colleton County SC

[CSE-2416FR]

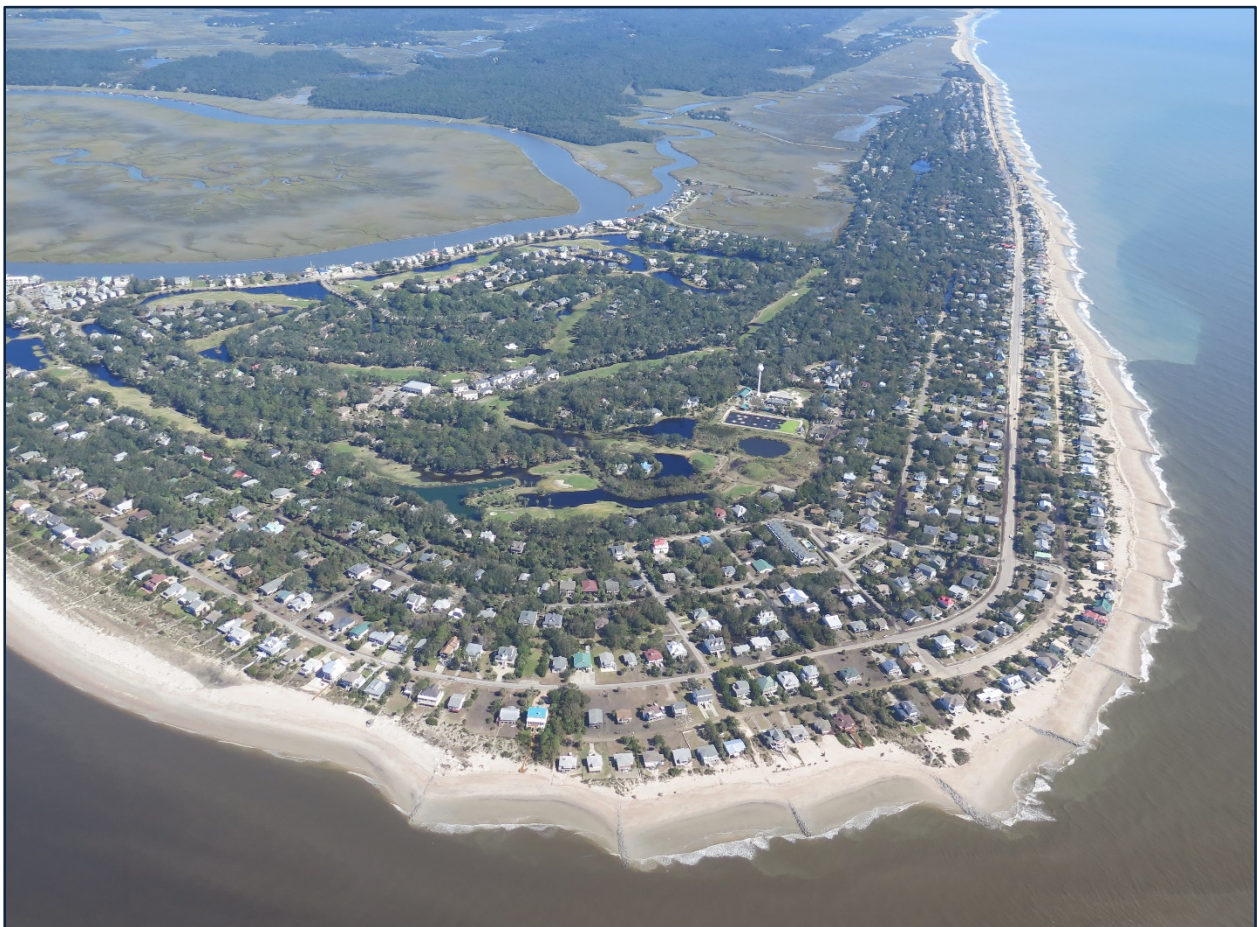
FIGURE 2.1. Aerial image of Edisto Beach in October 2016 following Hurricane *Matthew*.

Edisto Beach is a ~5.8-mile-long barrier island situated on the northern boundary of St. Helena Sound in South Carolina (Fig 2.1). It is bounded by Jeremy Inlet to the northeast and South Edisto River Inlet to the southwest. Edisto Beach makes up the southern half of the larger littoral system which includes Edingsville Beach and Botany Bay. The littoral system encompasses the length between the North and South Edisto Rivers, and there is a general divergence of sediment transport away from the center of the littoral cell (Fig 2.2).

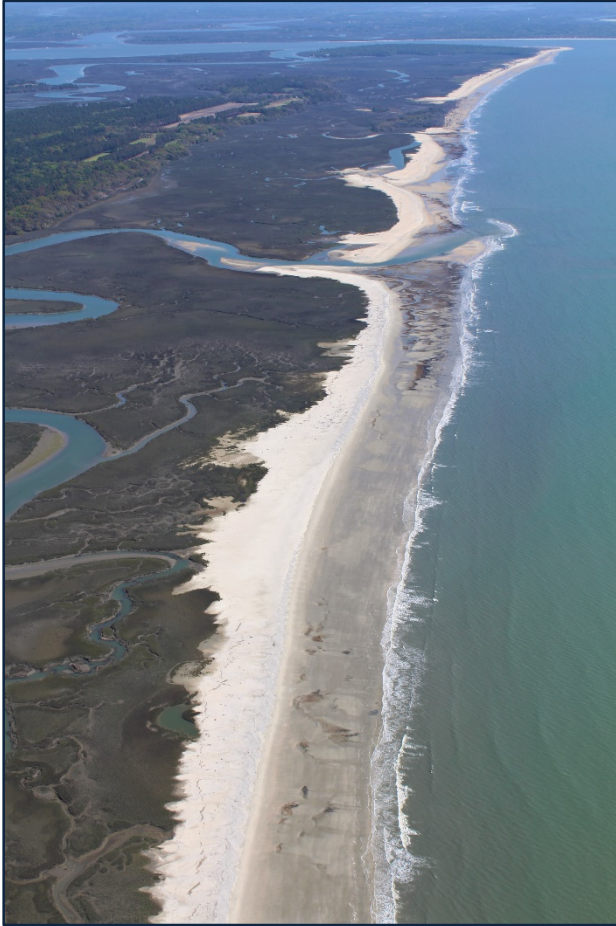
FIGURE 2.3. Aerial image of Edingsville Beach and Botany Bay Island in April 2018. Note exposed marsh on the active beach.

During the past century, depletion of the sand supply along Edingsville Beach and Botany Bay Island has left a low washover beach and exposed marsh at the seaward edge (Fig 2.3). The result is high erosion rates and insufficient downcoast movement of sand toward Edisto Beach. Edingsville Beach (just north of Edisto Beach) has been retreating at upward of 15 feet per year (ft/yr) (Stephen et al 1975, CSE 2003a). Further, the sediments being supplied to Edisto Beach tend to have a high proportion of mud and shells derived from the eroding marsh deposits.

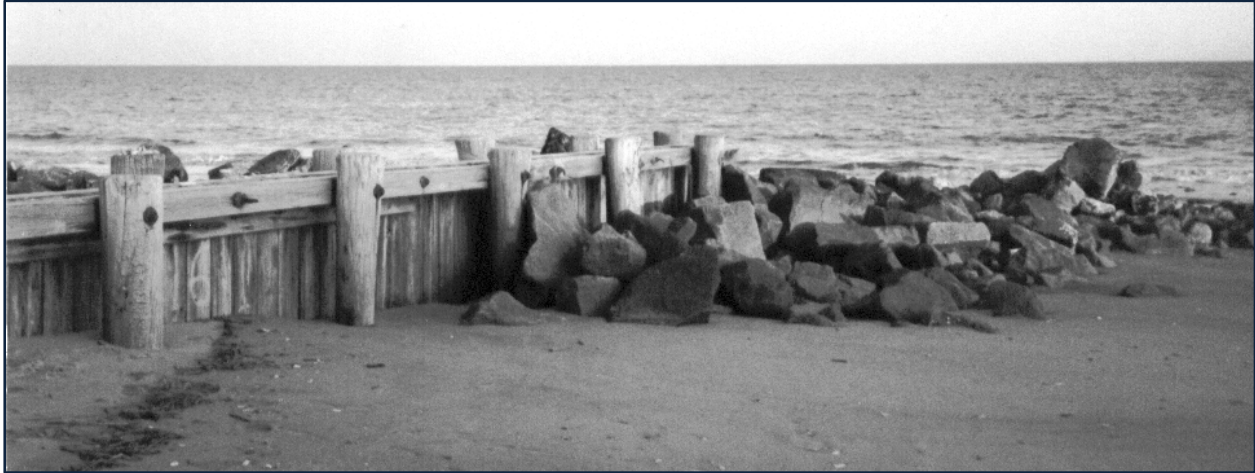
FIGURE 2.4. Typical Edisto Beach (SC) groin prior to the 1995 repair project.

By the 1950s, erosion near the Pavilion (Groin 1) on Edisto Beach reached upward of 10 ft/yr. The downcoast end of Edisto Beach (at “The Point” and along St. Helena Sound) has generally remained stable or accretional during the past century. Erosion along Edisto Beach led to construction of the first groins in 1948 near the Pavilion (Fig 2.4).

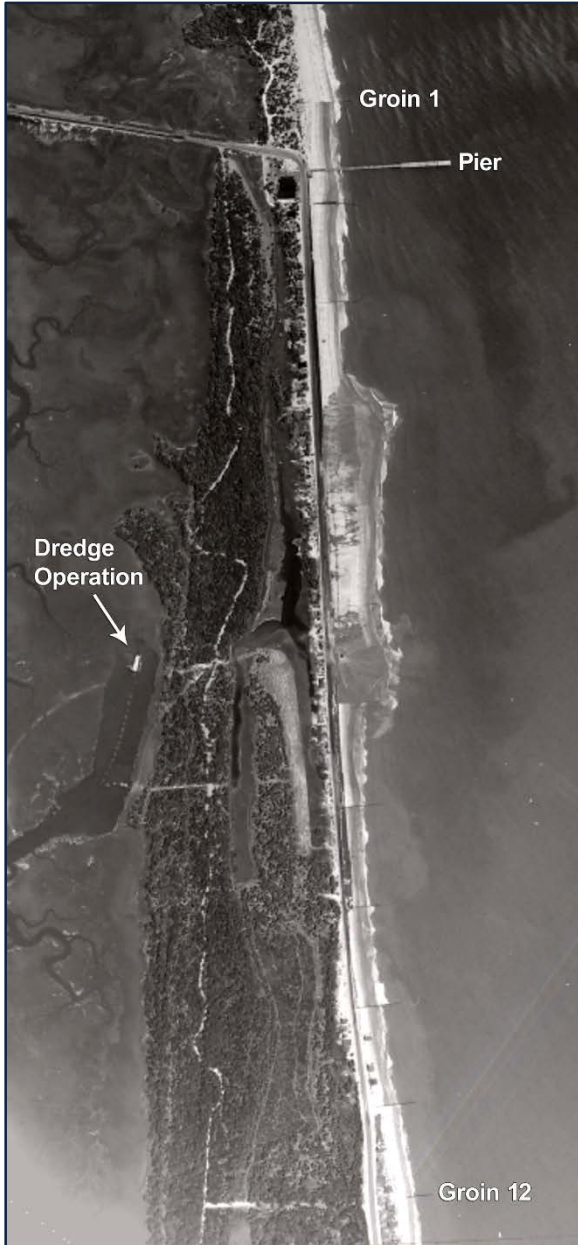
FIGURE 2.5. Aerial image (1954) of Edisto Beach showing the first restoration project. The dredge is visible in the marsh.

In the mid-1950s, erosion near the Pavilion had progressed so far that groins alone were not sufficient to protect Palmetto Boulevard. The South Carolina Highway Department combined groin construction with the first nourishment of Edisto Beach in 1954 using sand, shells, and mud from the marsh behind the island (Fig 2.5). Excavations created the “boat basin” and reclaimed nearly 1.2 miles of shoreline between Groins 1 and 12. Although dredging volumes totaled 830,000 cy, much of the material was unsuitable for the beach, washing away quickly because it was too fine. The coarser sand and broken shells remained, adding to the accumulations of sediment derived from Edingsville Beach.

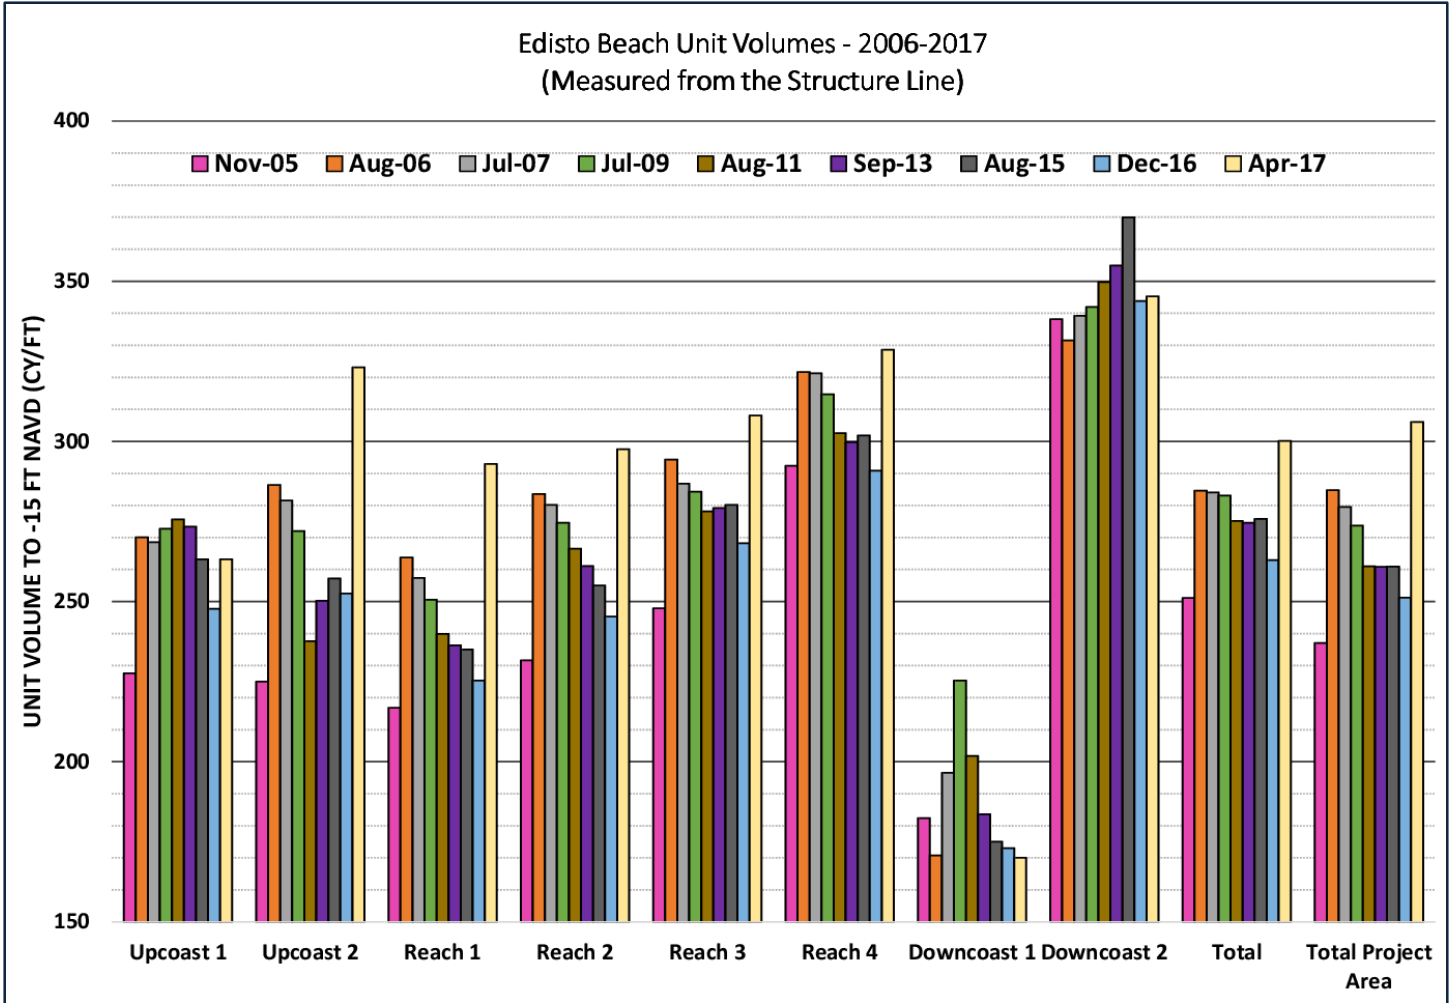
FIGURE 2.7. Unit volumes for each monitoring reach since 2005 at Edisto Beach. Impacts of the 2006 and 2017 nourishment projects are visible. Volumes are measured from the structure line to -15 ft NAVD.

Figure 2.7 shows beach unit volumes for each reach and for the project areas and entire island between 2006 and 2017. The beach volume increase due to the 2006 nourishment is visible in the volume difference between November 2005 (pink) and August 2006 (orange) bars. The 2017 nourishment is shown by the increase between the December 2016 (blue) and April 2017 (yellow) bars.

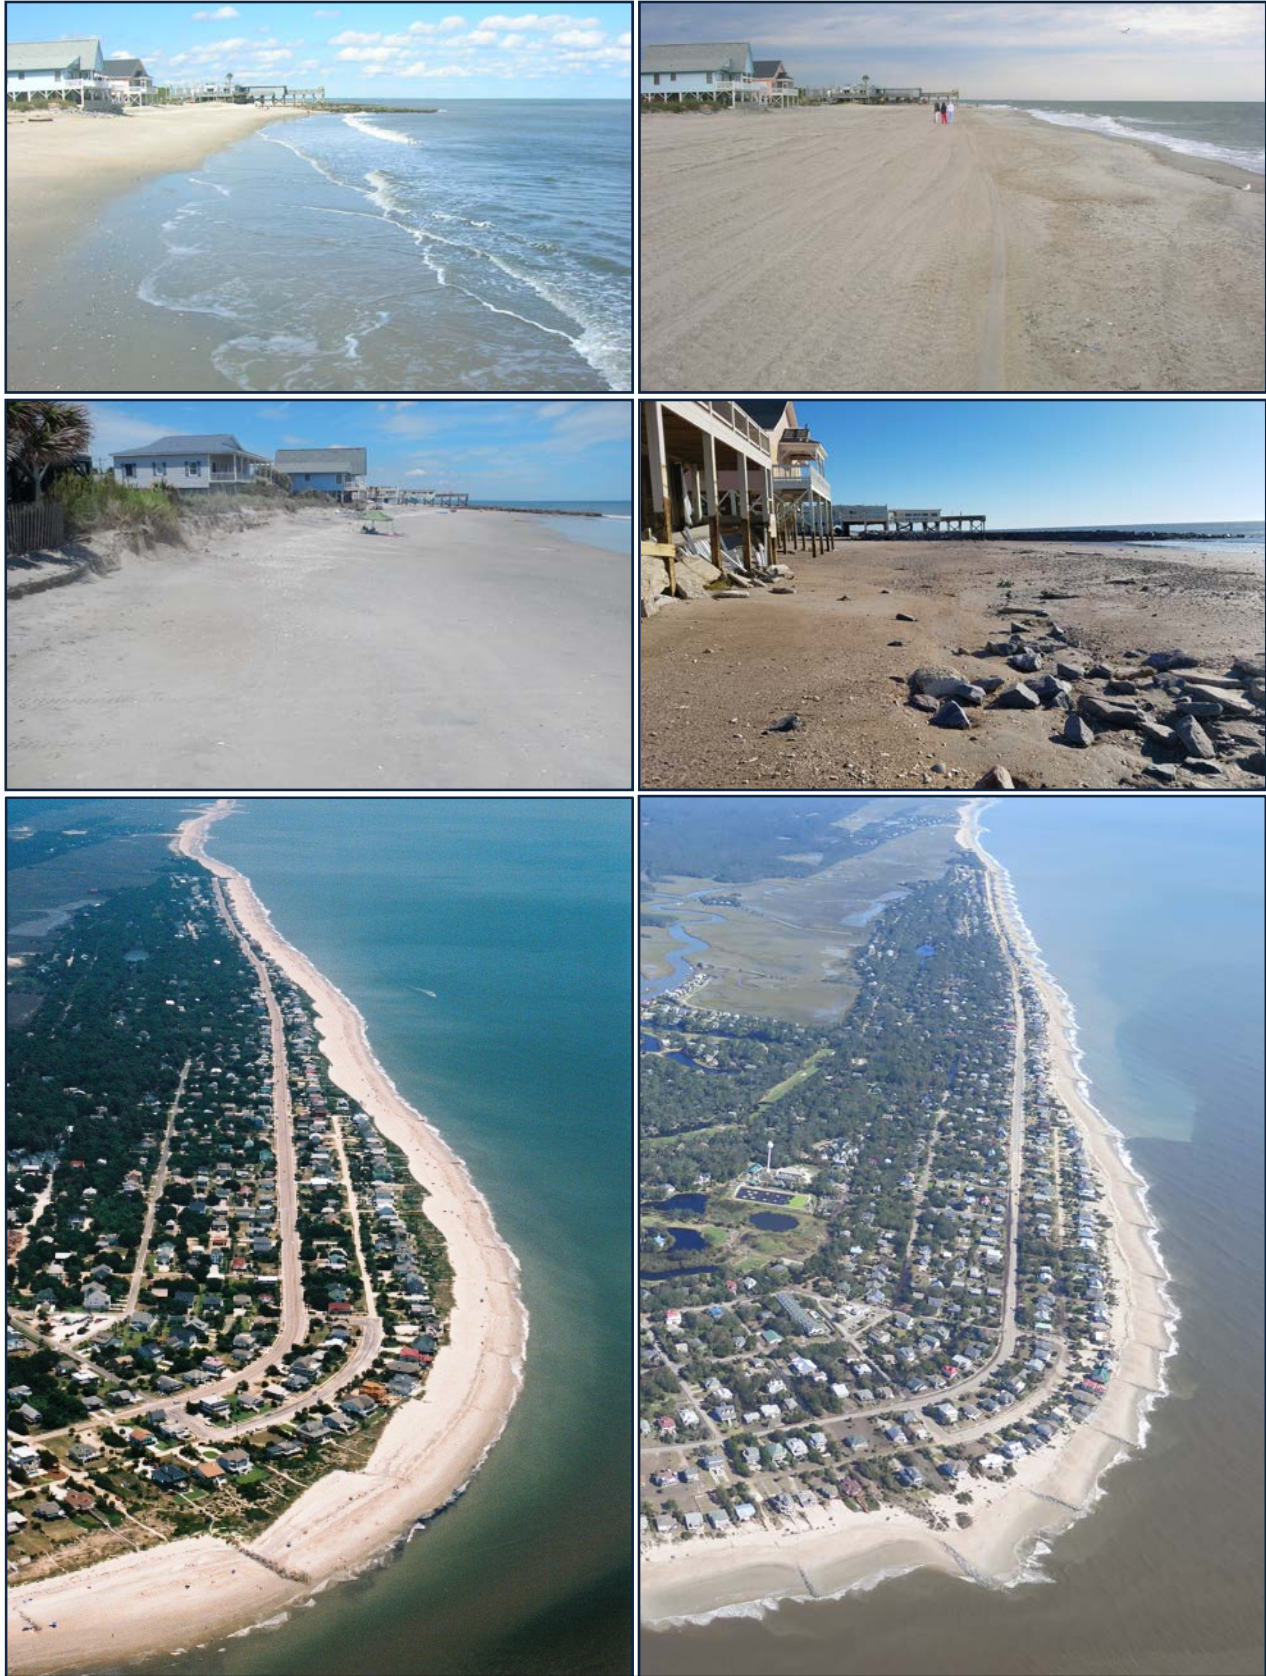
FIGURE 2.9. Image of the beach in the 100 block before (top left) and after (top right) the 2006 project. The middle left and right photos show the same locations in 2016 before and after Hurricane *Matthew*. The aerial photos show the beach after the 2006 project (lower left) and after Hurricane *Matthew* in October 2016 (lower right).

Photos of the beach condition near the 100 block before and after the 2006 project are shown in Figure 2.9 as well as the 2016 pre- and post-*Matthew* conditions. Immediately following nourishment, the majority of the groins were mostly buried by sand. Initial adjustment of the profile led to more exposure of the structures, and over time, additional sand losses resulted in significant exposure of each groin (typically 4–6 ft high). Aerial images show that the first several groin cells had little-to-no vegetative buffer between the houses and the high-tide line by the time Hurricane *Matthew* hit in October 2016. Little dune also existed near the point (cells 25–28).

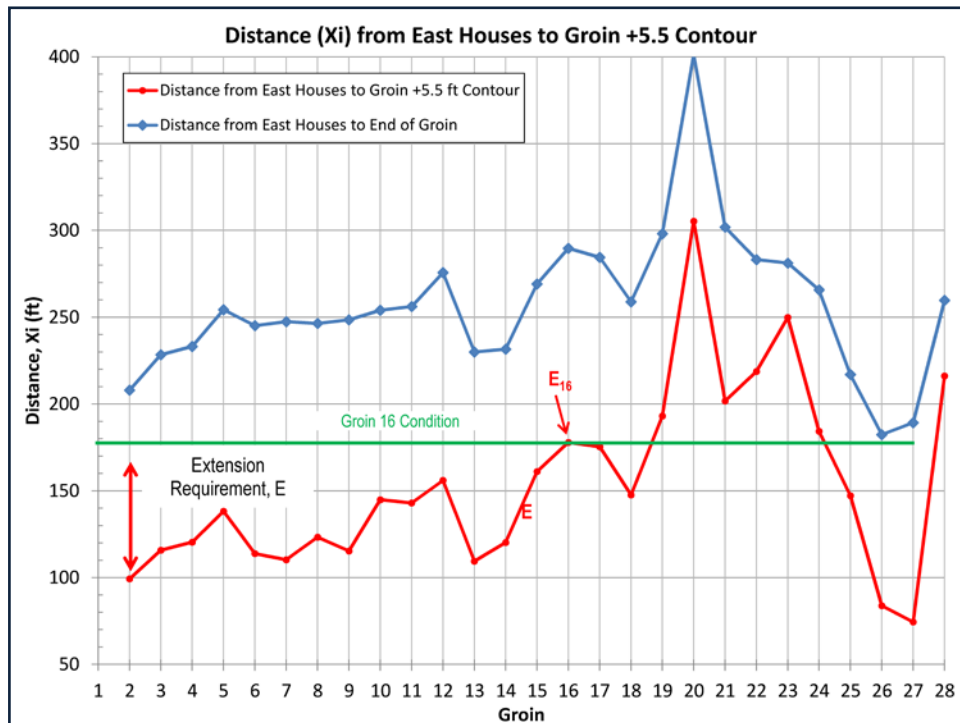
FIGURE 2.10. CSE’s groin-lengthening plan was based on the condition of the beach across the island, comparing an “ideal” area at Groin 16 to other areas.

CSE completed an independent, groin-lengthening feasibility study in 2013 (CSE 2013a,b), obtaining two alternatives for lengthening. One alternative was based on an ideal beach profile (similar in nature to the USACE method, but using a more substantial beach profile), while the other was based on comparison of the widths of vegetated areas and existing groin conditions (Fig 2.10).

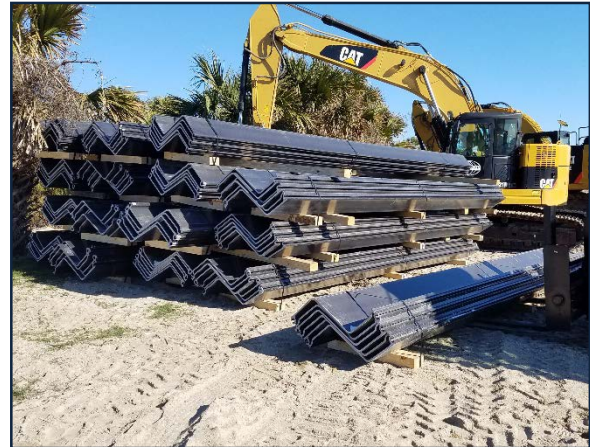
FIGURE 2.13. Staging of UC95 composite sheet piles.

The Town received bids for steel and composite sheet pile, electing to use the composite sheets for increased longevity and reduced maintenance of the piles (Fig 2.13). The sheets were model UC-95 from Crane Materials International (Atlanta GA). Each sheet was 20 ft long with a 17-inch width and 30-inch longitudinal run (meaning each pair of sheets creates a 60-inch length of wall). The sheeting is 9/16-inch-thick, fiberglass-infused vinyl that will not rust as steel sheets are prone to do. Sheets are connected via integrated channel locks running the vertical length of each sheet.

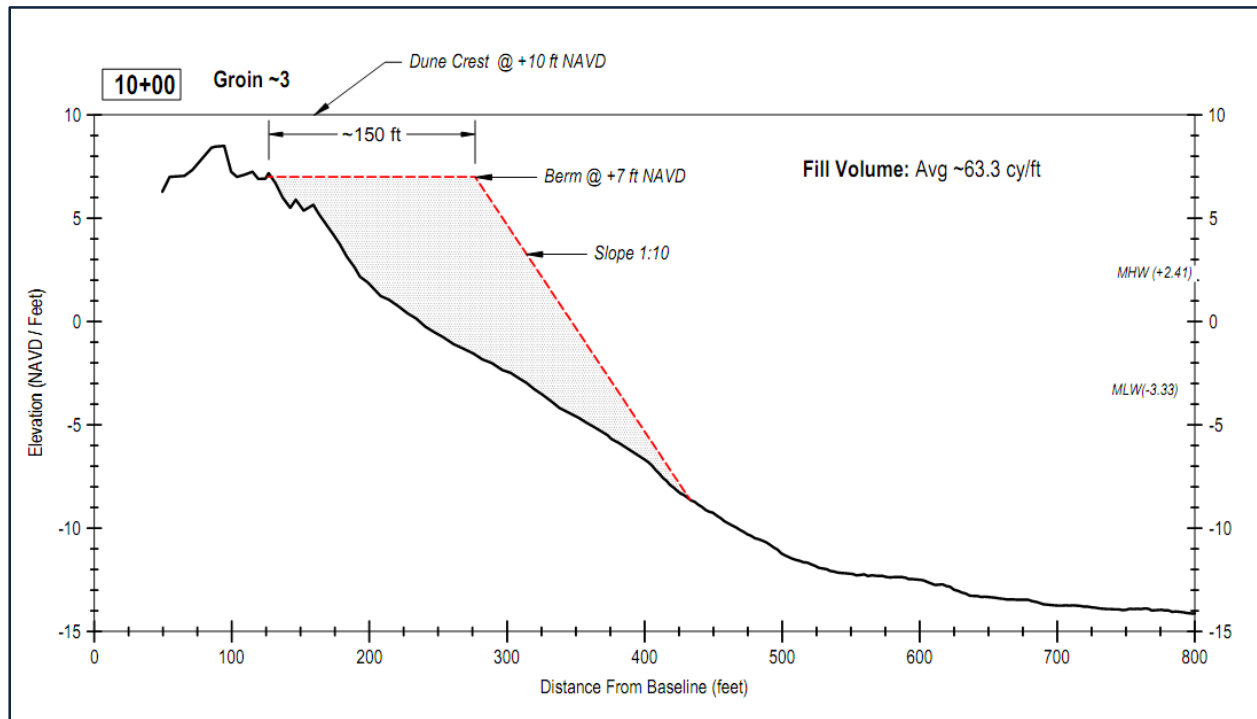
FIGURE 2.14. Typical nourishment design fill section in Reach 1. Note the dune placement is not indicated on the graphic. The contractor worked onsite with CSE to determine the best dune placement as the project progressed.

The design for the nourishment portion of the project followed similar parameters as the 2006 project. The design berm elevation was set at +7 ft NAVD, similar to the natural berm elevation during normal tides. Following the 2006 project, the berm elevation increased naturally due to sand washing over the berm. CSE elected to maintain the elevation to allow this process to continue as, over time, it provides a more natural looking berm. The design berm widths ranged from 55 ft to 165 ft, generally increasing from south to north. The seaward slope of the fill was set at 1 on 10 based on the pre-project beach slope and expected grain-size distribution of the borrow material; however, the contractor was allowed to adjust the slope during construction to account for variation in sediment characteristics in the borrow area. A typical design section from Reach 1 is shown in Figure 2.14.

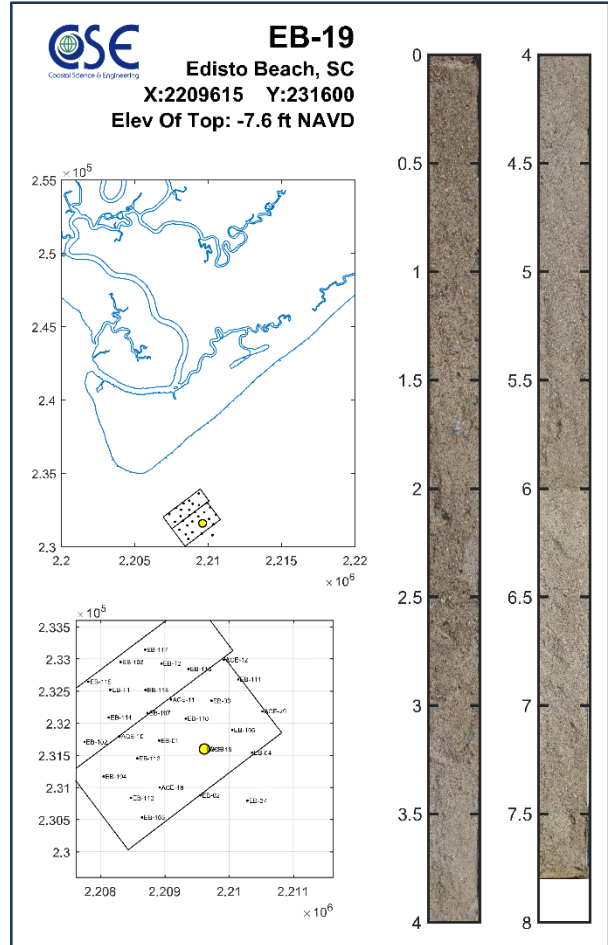
CORE LOG		Coastal Science & Engineering		Sheet 1 of 1	
PROJECT: 2416 - Edisto Nourishment		COORDINATES:		HOLE NUMBER	
LOCALITY: Edisto Beach, SC		Northing: 231600.130		EB-19	
DATE: 2014-Aug-21		Easting: 2209614.800		(As shown on the drawing and Memo)	
BORE ANGLE: 90.00°		Grid Datum: NAD '83			
TOP ELEVATION: -10.66 ft. NAVD '88		DEVICE DESIGNATION: Coastal Science & Engineering			
BURDEN THICKNESS: 7.8 ft.		BOTTOM ELEVATION: -18.46 ft. NAVD '88		BARREL SIZE/TYPE: 3 in. Aluminum	
CORE RECOVERY: 7.8 ft. (100.0%)		WATER DEPTH: -11.70 ft. (operational note only)		GEOLOGIST: TWK - SC #564	
				FIELD TEAM: DG, LF, ST	
Depth	Limnology	Classification Of Materials (Description)	Sample #	Remarks	
1		0.0 to 3.0 ft: Medium Sand - Shelly, clean, light tan mostly shell hash mixed. Highest shell fraction in upper 3 ft	S1	S1: 0.0 ft. to 3.0 ft. Shell: 28.3% Mud: 0.0% Mean Grain Size: 0.600mm	
2		-- 2.4 ft: Small Oyster - w/ surrounding minor shell concentration

3		3.0 to 6.0 ft: Medium Sand - Shelly, clean, light tan, uniform to bottom	S2	S2: 3.0 ft. to 6.0 ft. Shell: 23.9% Mud: 0.0% Mean Grain Size: 0.468mm	
4					
5					
6		6.0 to 7.8 ft: Medium Sand - Shelly, clean, light tan	S3	S3: 6.0 ft. to 7.8 ft. Shell: 24.8% Mud: 0.0% Mean Grain Size: 0.528mm	
7					
8					
9					
10

FIGURE 2.18. Example boring log showing the sediment characteristics of a portion of the borrow areas. Data like these were used to identify the borrow areas for the project.

CSE sampled each boring to determine the grain size distribution of the sediment and the amount of shell material present. The borrow areas were determined based on these sediment characteristics, as well as consideration of the sediment color. Figure 2.18 is an example core log showing the typical data utilized for confirming suitable borrow material. The final borrow areas were drawn around a group of 17 borings (Borrow Area A) and 12 borings (Borrow Area B) located landward (northwest) of the USACE-identified borrow area (see Fig 2.17). Table 2.3 provides the sediment characteristics for the borrow areas. Borrow Area A showed a mean grain size of 0.719 millimeters (mm) with 31 percent shell content. Borrow Area B contained finer sand with an average grain size of 0.656 mm and 26.7 percent shell content. These averages were skewed by a few borings, which showed a higher average grain size due to higher shell concentrations.

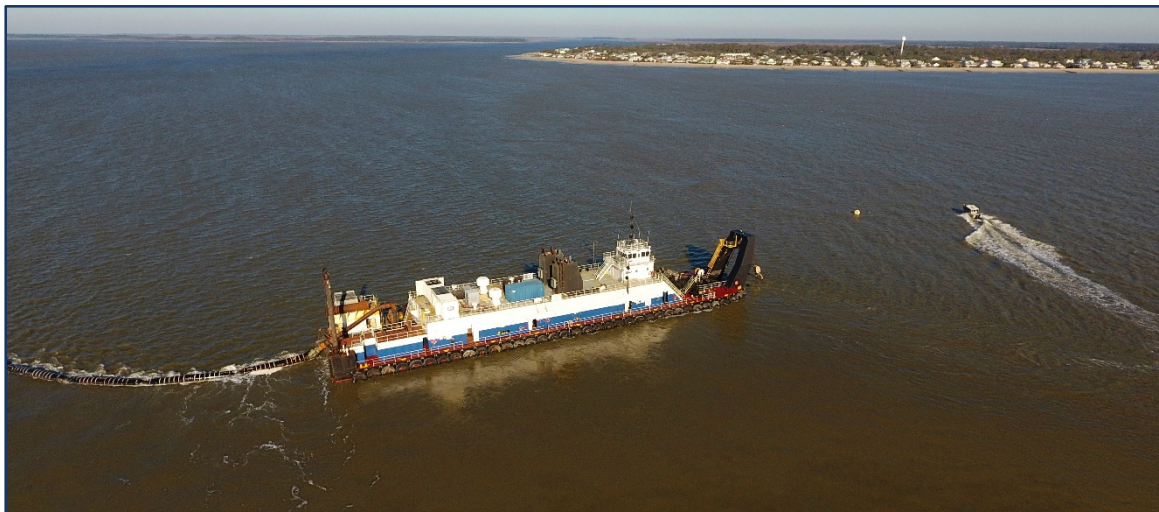
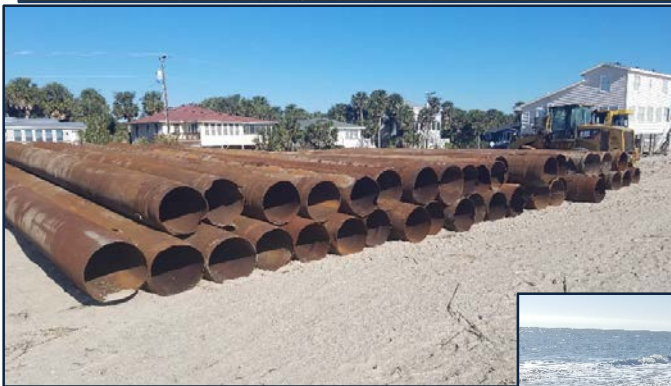
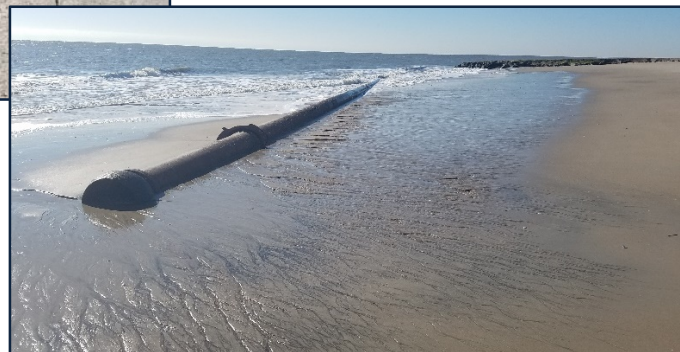
FIGURE 3.2.

[UPPER] The dredge, *Savannah*, offshore of Edisto Beach. [MIDDLE] Shore pipe staged prior to first pumping. [LOWER] The subline that connects the dredge to the beach comes ashore between Groin 9 and Groin 10.

Mobilization for the nourishment project began on 4 January 2017 with delivery of a bulldozer to the beach. Additional equipment continued to arrive over the next several days, along with the first shore pipe on 7 January. Marinex focused delivery of equipment and pipe near the 500 block, and effort was made to ensure that material was staged off vegetated areas (Fig 3.2). A total of ~10,000 lf of shore pipe was mobilized to the beach. The dredge *Savannah* arrived at Edisto Beach on 16 January and staged along the South Edisto River. Pumping started the night of 25–26 January in the 500 block between Groins 9 and 10. The initial work sought to build a “pad,” which is a broad platform used as a landing site for the subline and begins the berm at the design elevation. Once the pad was complete, pipe was placed on the new berm directed to the north to begin the normal fill plan (Fig 3.3).

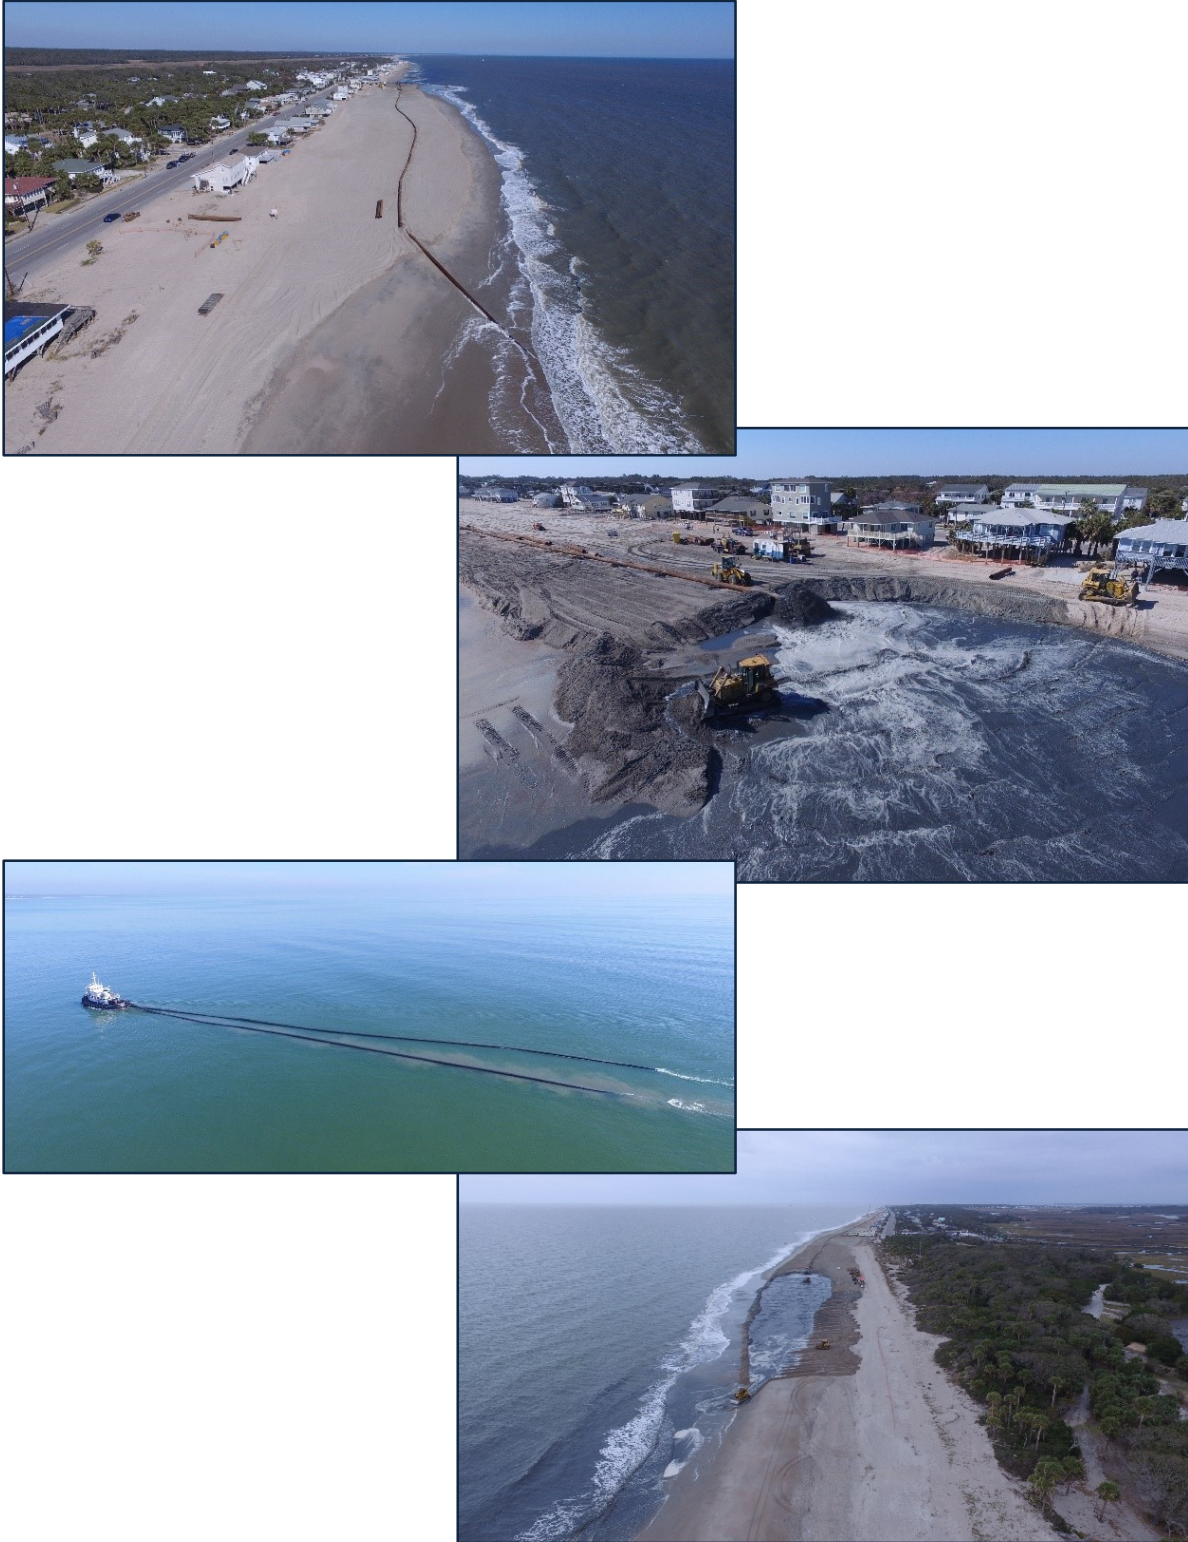
FIGURE 3.3. [UPPER LEFT] Early in the nourishment project, showing the subline coming onshore and the nourishment fill moving north. [CENTER RIGHT] The active fill area showing slurry coming from the discharge pipe. [CENTER LEFT] A tug towing new 500-ft sections of plastic shore pipe to the beach. [LOWER RIGHT] Fill in the state park area.

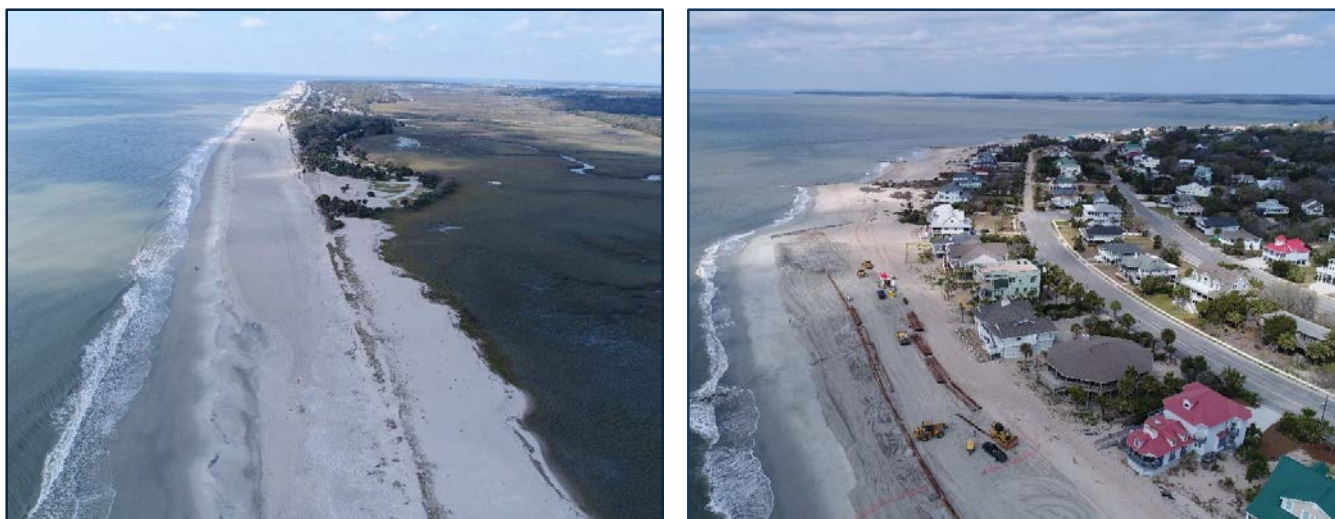
FIGURE 3.4. [LEFT] The completed beach at the state park. [RIGHT] Fill progress around Groin 27 at “The Point.”

Following completion of the state park, Marinex repositioned the subline to the beach between Groins 19 and 20 (near Baynard Street). Pumping resumed on 9 March, building a new pad. Marinex initially pumped sand to the north, reaching Groin 18 before switching back and pumping south. Work continued south to the southern end of the project at Groin 30 (Edisto Street), reaching it on 28 March (Fig 3.4).

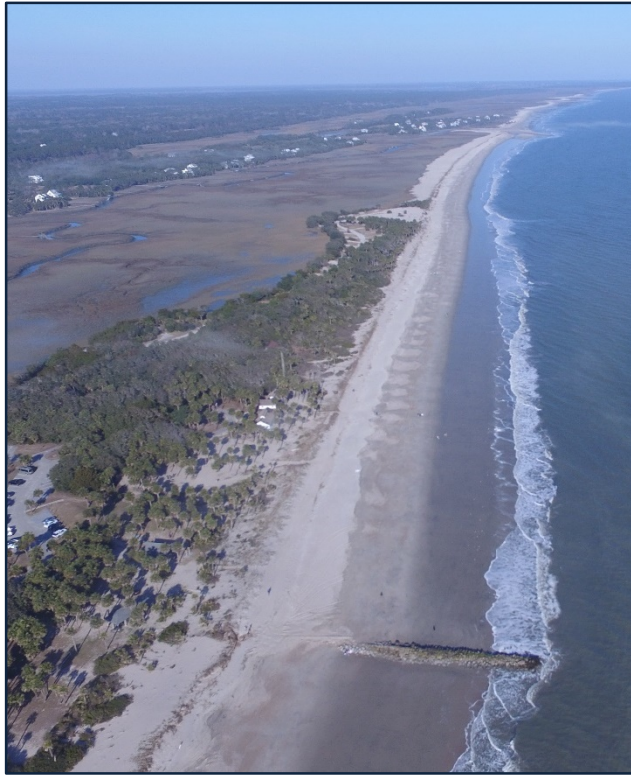
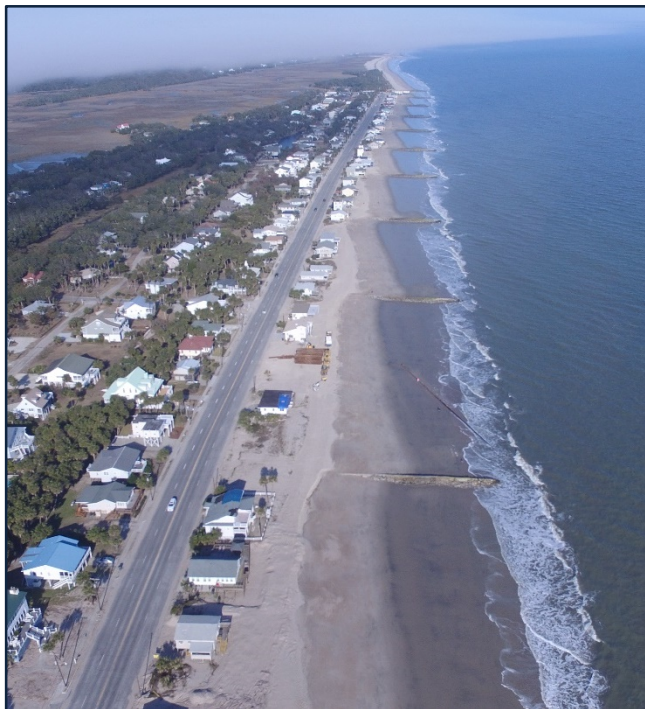
FIGURE 3.5 (page 1 of 2). Before (left) and after (right) images of the beach nourishment project at Edisto Beach (SC). [UPPER] Edisto State Park area. [LOWER] Reach 1.

The last area of beach to be filled was the area between Groins 9 and 18. Marinex continued working to the north from where they previously left off at Groin 18. The final pumping occurred on 14 April 2017 where the original subline was placed between Groins 9 and 10. A total of 79 working days were required for placement of the 1,006,072 cy fill volume. Production averaged ~12,700 cy per day including all weather and mechanical delays. Marinex submitted daily construction logs that included information on estimated production and delays, quantities and locations of discharge pipe, and weather information (Appendix B). Before and after photos are shown in Figure 3.5.

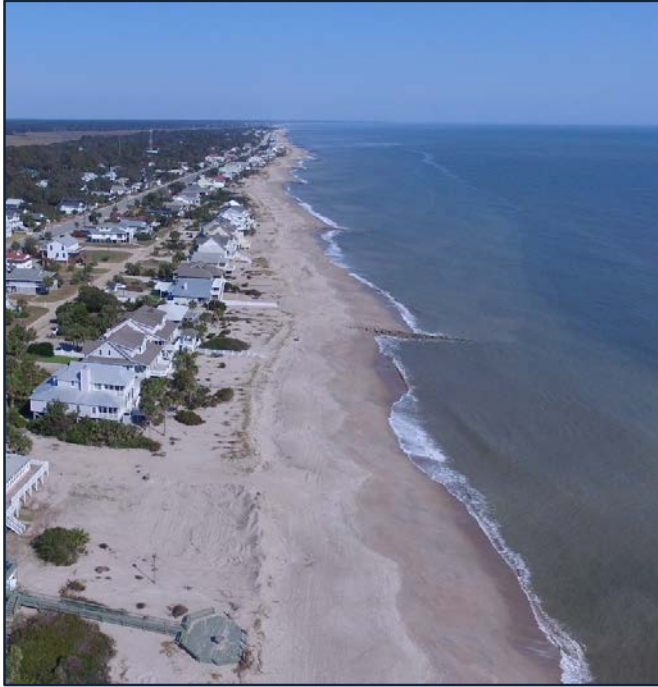
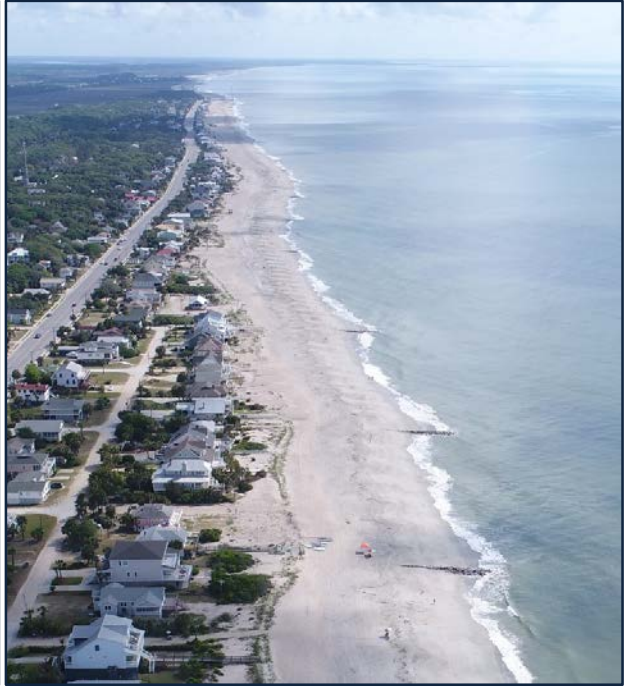
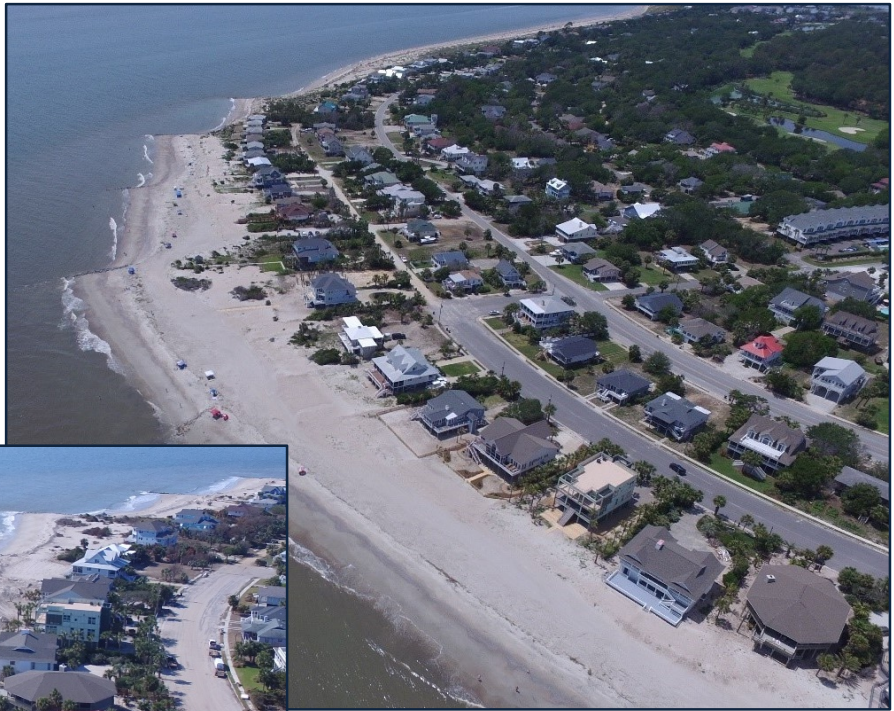
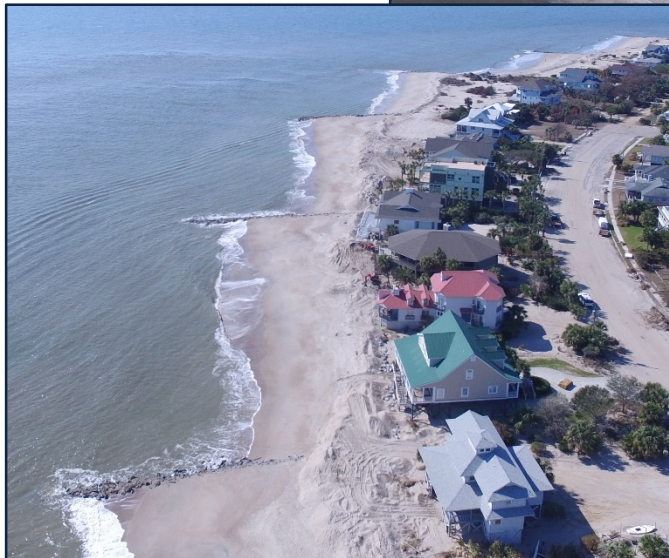
FIGURE 3.5 (page 2 of 2). Before (left) and after (right) images of the beach nourishment project at Edisto Beach (SC). [UPPER] Reach 2 and Reach 3. [LOWER] Reach 4.

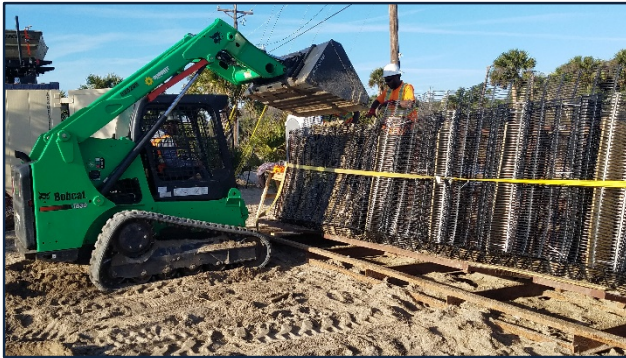
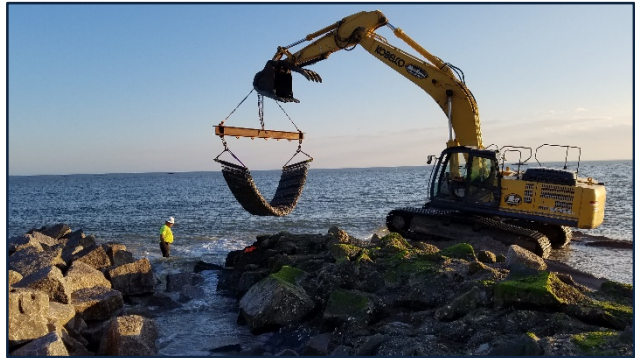
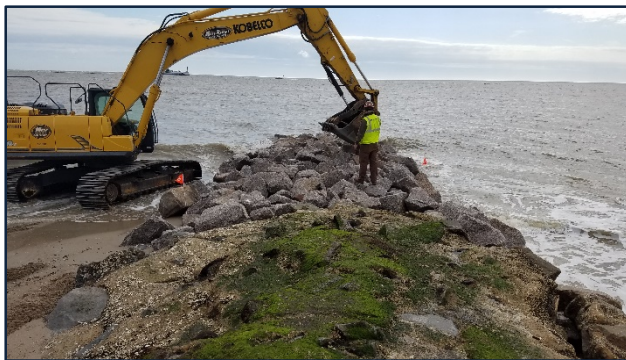
FIGURE 3.7 Images of the groin construction.

[UPPER LEFT] Filling marine mattresses with small stone.
[UPPER RIGHT] Placing marine mattresses via excavator.
[LOWER LEFT] Placing armor stone.

Material for the mattresses arrived on site beginning 16 January 2017. Crowder subcontracted with JLS (Kennesaw GA) to fill and tie the mattresses. The mattresses (manufactured by Tensar®) consisted of a plastic grid held together by UV-resistant polyrope. Mattresses were filled with stone typically 4–6 inches in size. To fill the mattresses, JLS would tie three sides of each ~20-ft-long unit and position the mattress on a rotating table. The mattress would be rotated vertically, and rocks would be placed in the opened end of each cell (Fig 3.7). Once filled, the top side would be tied closed, and the mattress would be rotated horizontally and

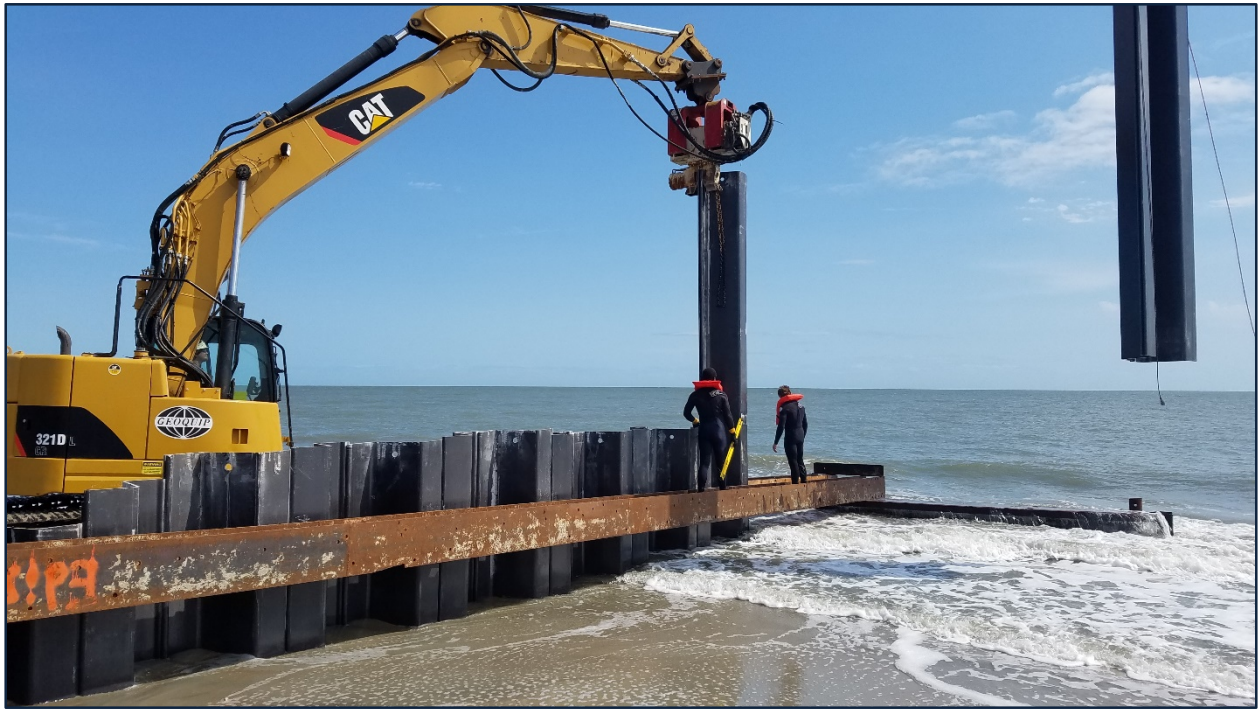
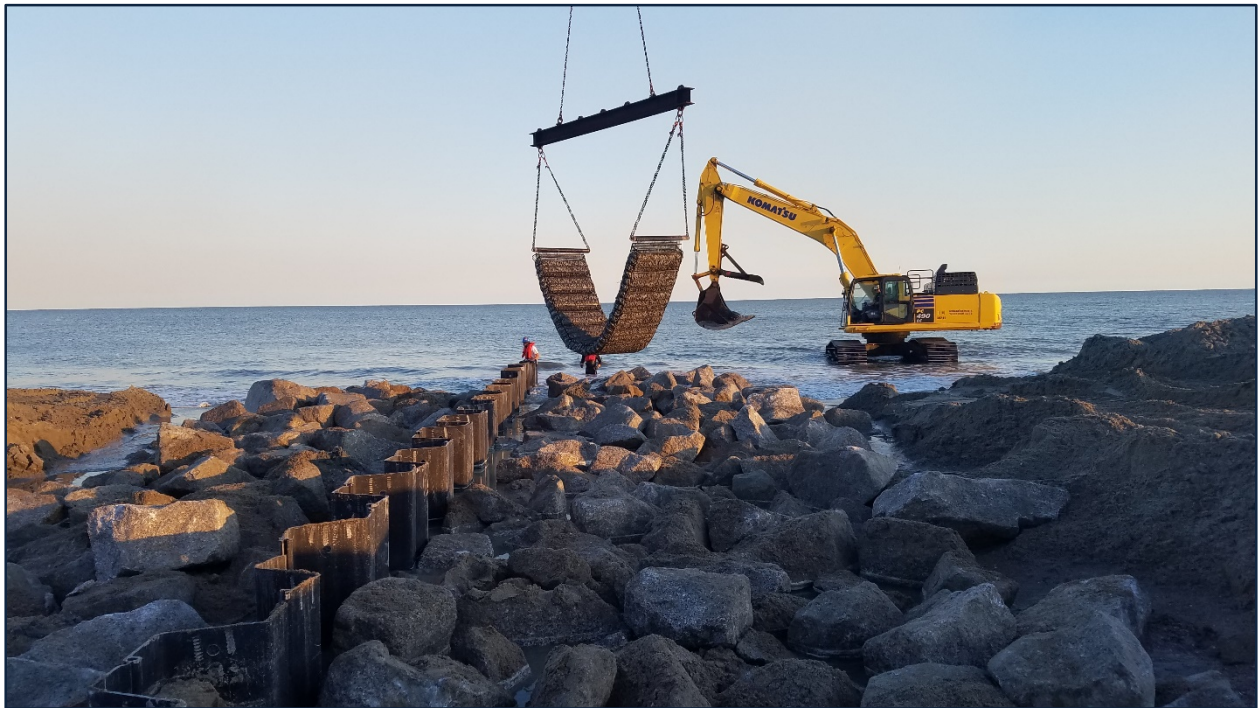
FIGURE 3.8. [UPPER] Installation of UC-95 composite sheets. [LOWER] Installation of marine mattress at the end of a sheet-pile groin.

The installation of sheet-pile groins began on 13 February at Groin 9. Crowder elected to begin at the landward end of the extension and initially used a moveable platform as a guide to drive the sheets; however, they quickly determined that a more robust template would be required to accurately drive the sheets. Crowder constructed a new form out of I-beams that would surround the sheet piles on two sides as they were being driven. The first sheets were driven using the excavator, which proved to be difficult with the composite sheets, as any variation from vertical would result in cracking of the top of the sheet. Crowder switched the vibratory hammer to the crane, and sheet driving improved. Crowder would drive a series of sheets until they reached the end of the template, and then would shift the template seaward (Fig 3.8). Once all of the sheets were driven to an elevation near mean sea level, the operators would drive the sheets to the final grade, checking elevations with a rod and level.
