FINAL REPORT

2017 BEACH RESTORATION AND GROIN LENGTHENING PROJECT Edisto Beach Colleton County SC

[CSE-2416FR]

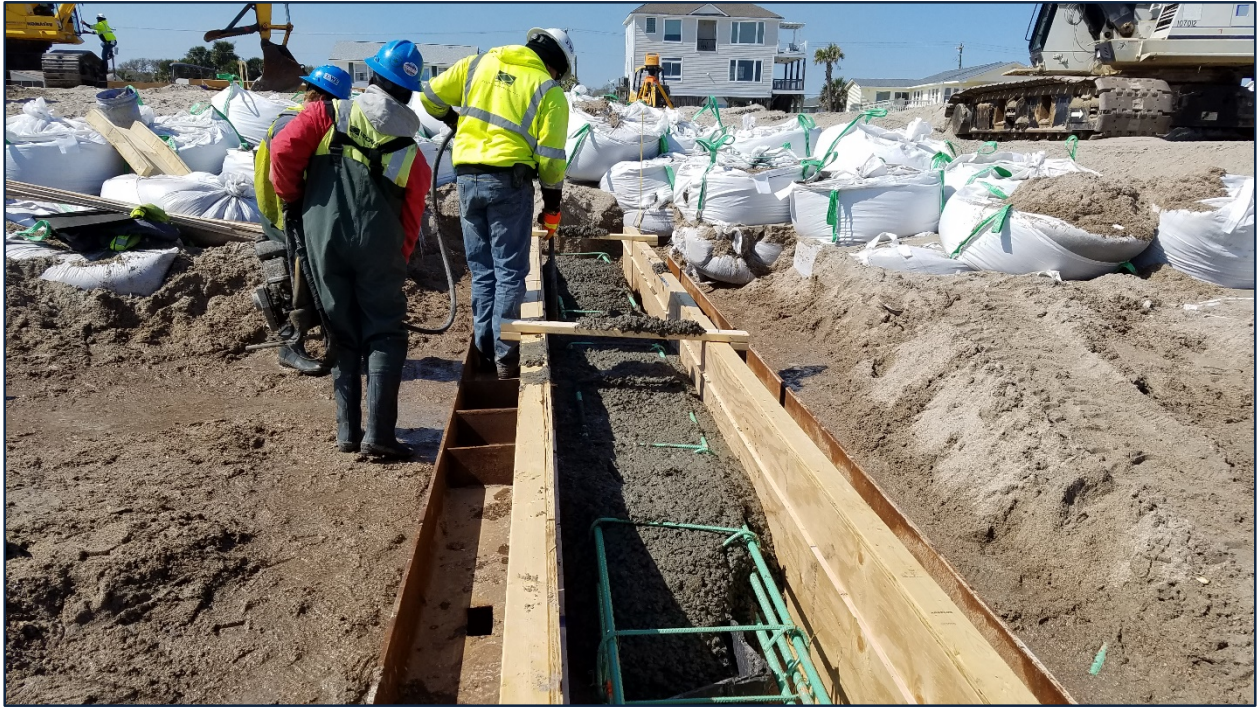
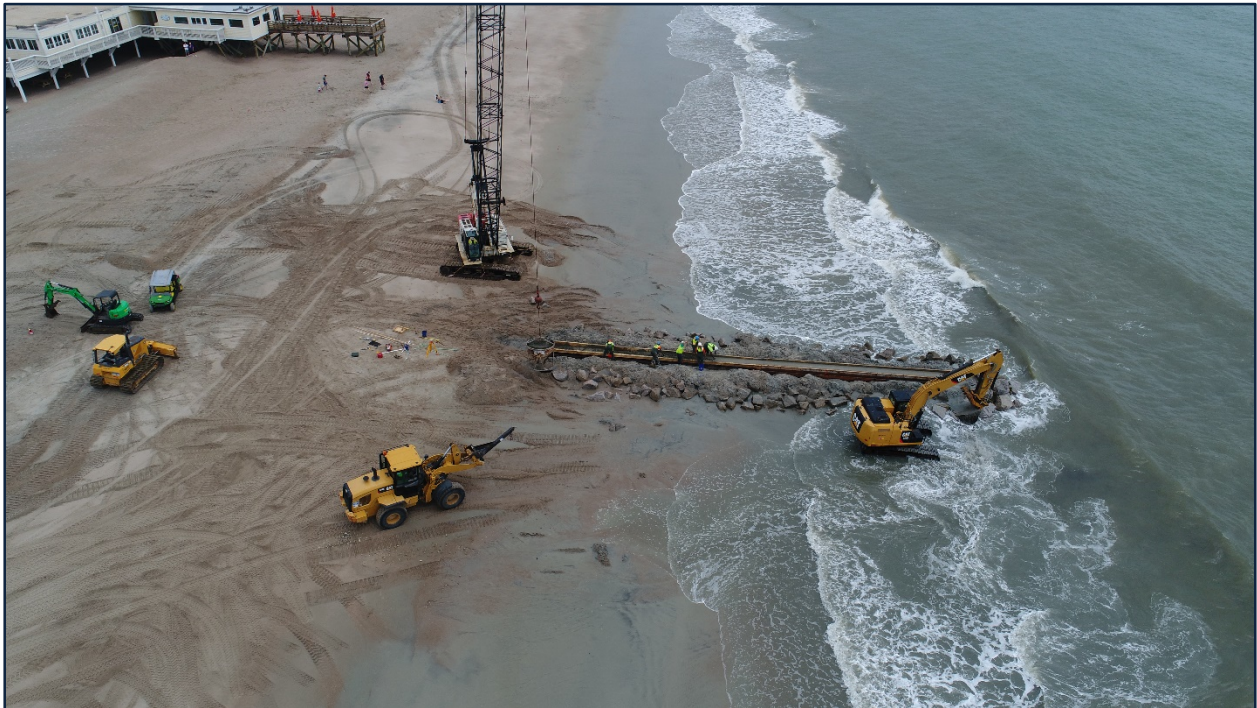
FIGURE 3.9. [UPPER] Pouring concrete into the forms. Note the epoxy-coated rebar (green). [LOWER] Aerial view of groin construction at Groin 2.

Following installation of the sheet pile, Crowder placed mattresses and a portion of the armor stone alongside the sheets. Once the armor stone was at an elevation near the bottom of the concrete cap design, Crowder placed forms around the tops of the sheets in preparation for pouring the concrete caps (Fig 3.9). Concrete pours needed to occur during periods of lower-than-average tides and very calm weather to prevent the concrete from washing away before it could cure. Once the concrete was poured, workers shaped a crown on the surface and the forms were left in place for at least 24 hours to allow the concrete to cure. Once the concrete was cured and the forms were removed, Crowder added additional armor stone to bring the section to the design grade. At that point, the groin extension was complete (Fig 3.10). Generally, multiple groin extensions were being constructed at any given time.

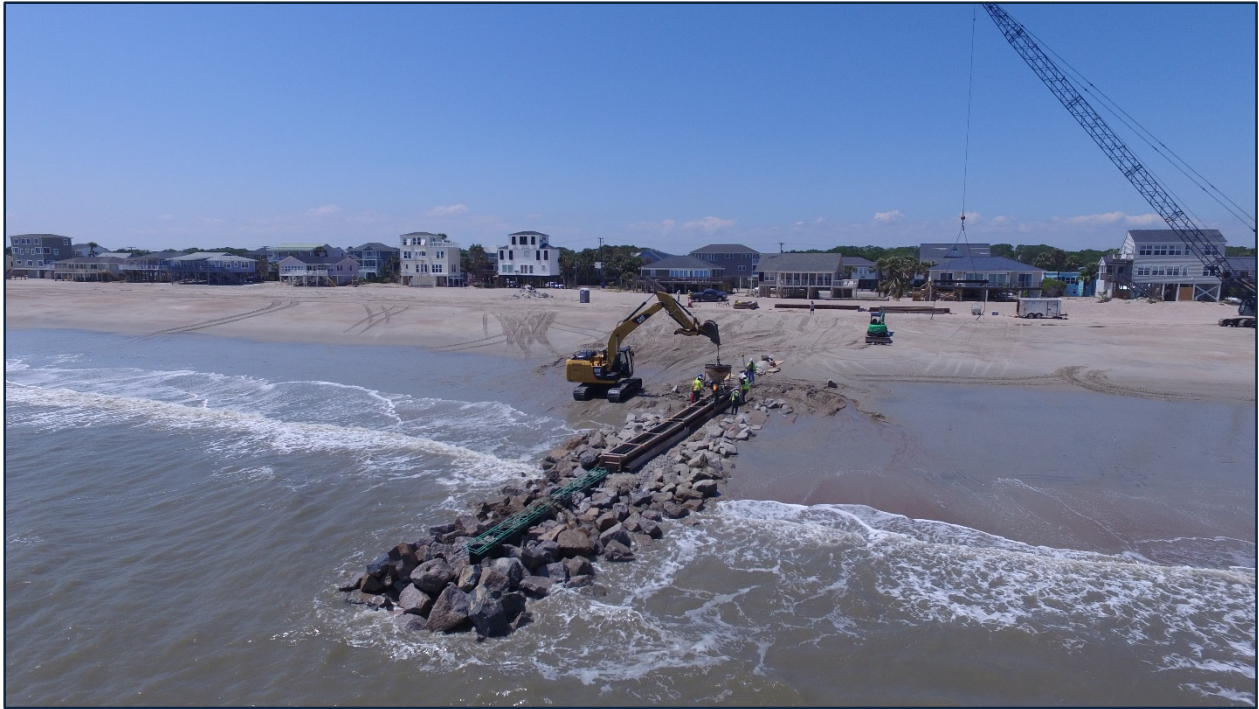
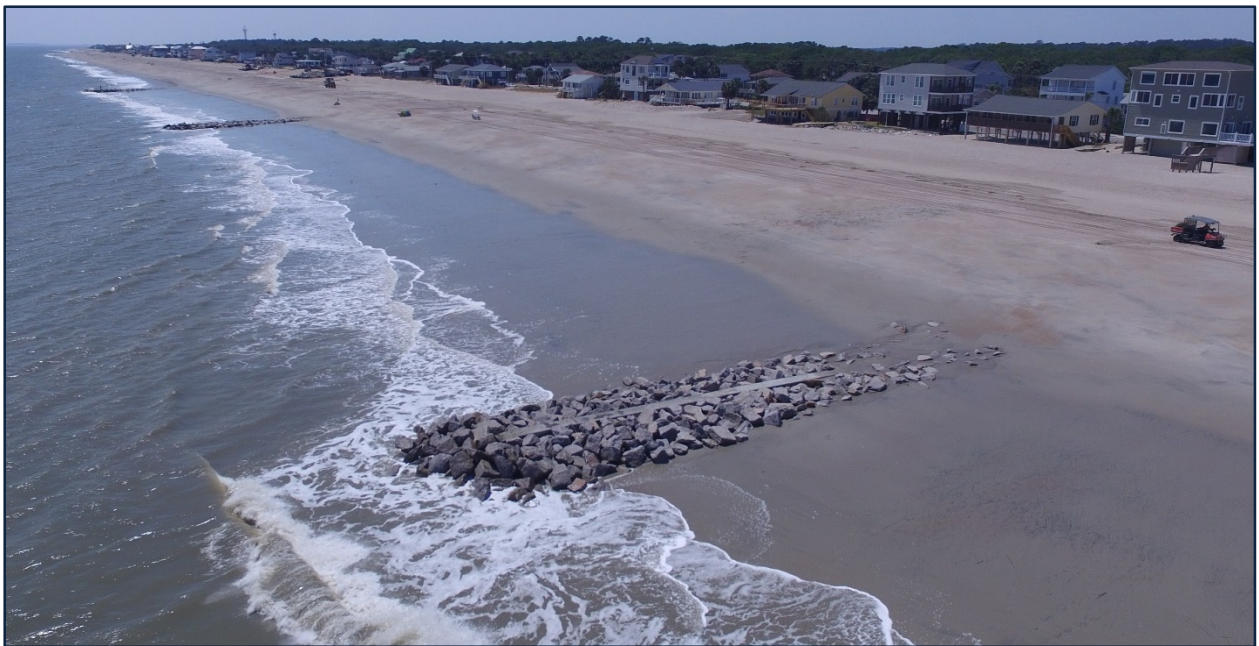
FIGURE 3.10. [UPPER] Pouring concrete cap on the landward end of groin extension. [LOWER] Completed extensions for Groin 7 (foreground), Groin 8 (middle), and Groin 9 (background).

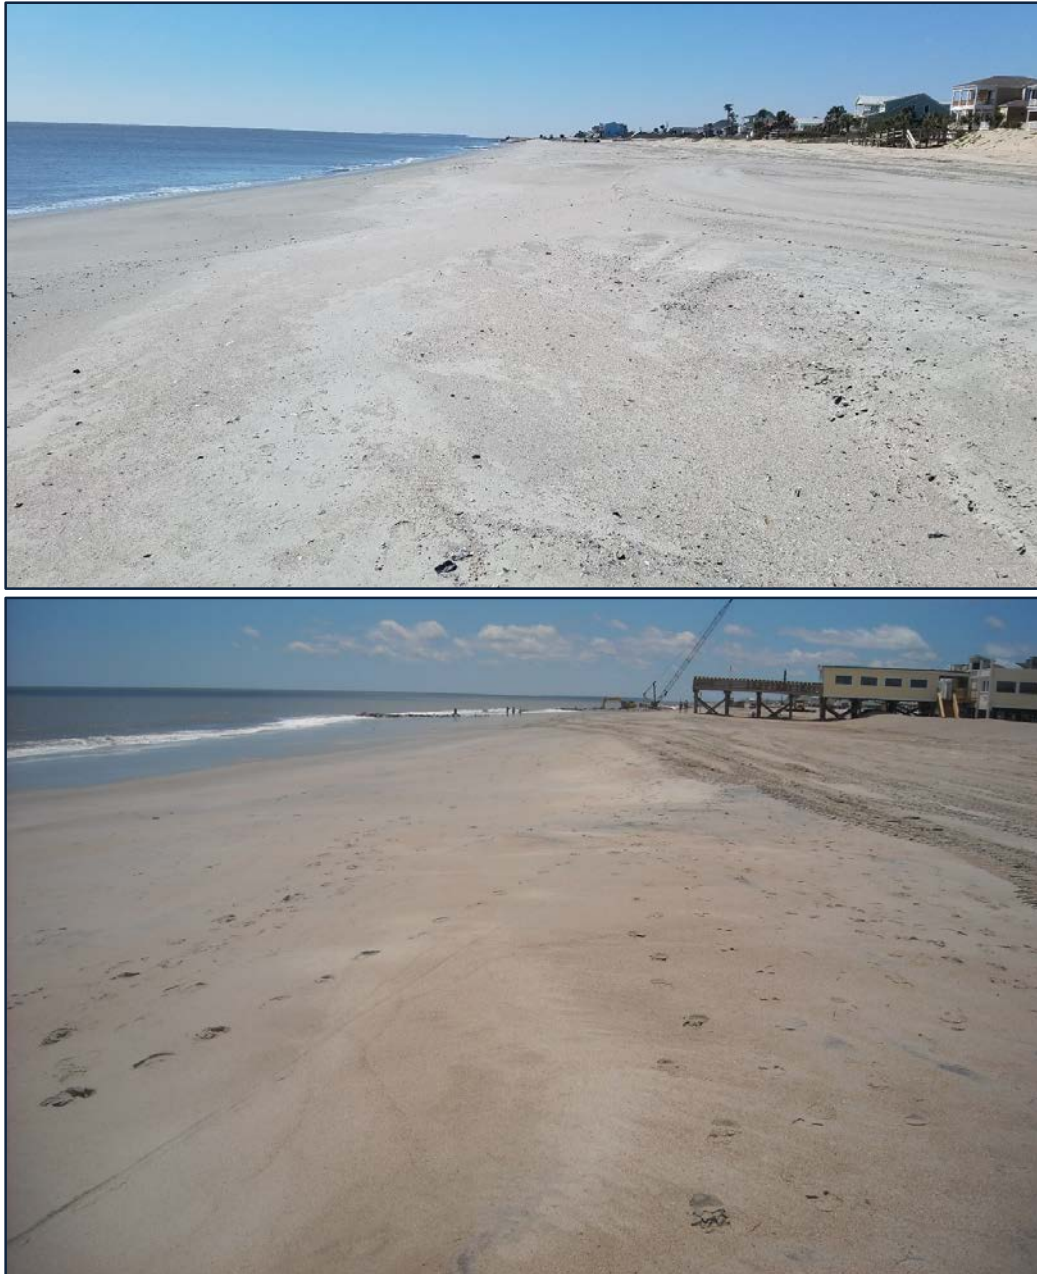
FIGURE 5.1. Example of sediment character of the fill sand. As the dredge moved within the borrow area, sediment characteristics changed slightly. Over time, exposed sediment will become more uniform over the length of the beach.

Nourishment sand placed on the beach was found to be consistent with the borings obtained by CSE. The mean grain size of all samples collected during project construction by CSE was calculated to be 0.508 mm. The nourishment sand is slightly coarser than the native beach sand; however, the sand contained less large shell fragments. Post-project observations show the beach generally has a shallower slope than the pre-project condition, which is partially a result of sediment grain size.

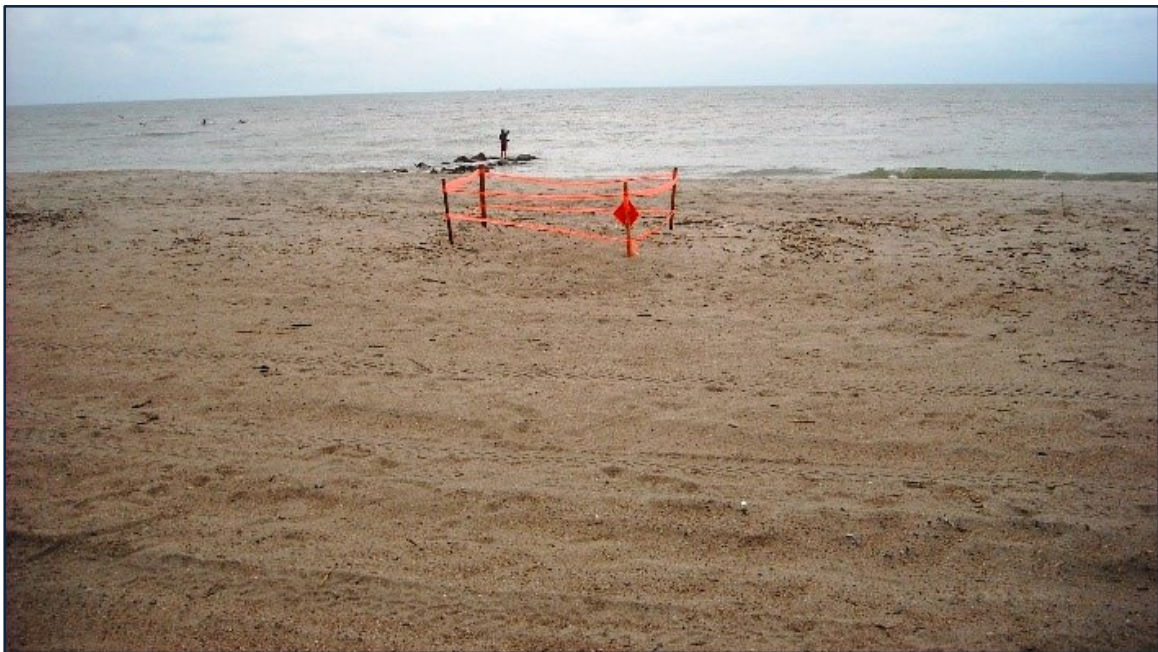
FIGURE 6.1. Example of turtle nest located and marked on the already constructed berm. A completed groin extension is visible in the background.
