EDISTO BEACH
COASTAL STORM DAMAGE REDUCTION
GENERAL INVESTIGATION STUDY

APPENDIX J
HARDBOTTOM AND CULTURAL
RESOURCE SURVEYS

HARDBOTTOM AND CULTURAL RESOURCE SURVEYS EDISTO BEACH OFFSHORE BORROW SITE EDISTO BEACH, SOUTH CAROLINA

April 2013

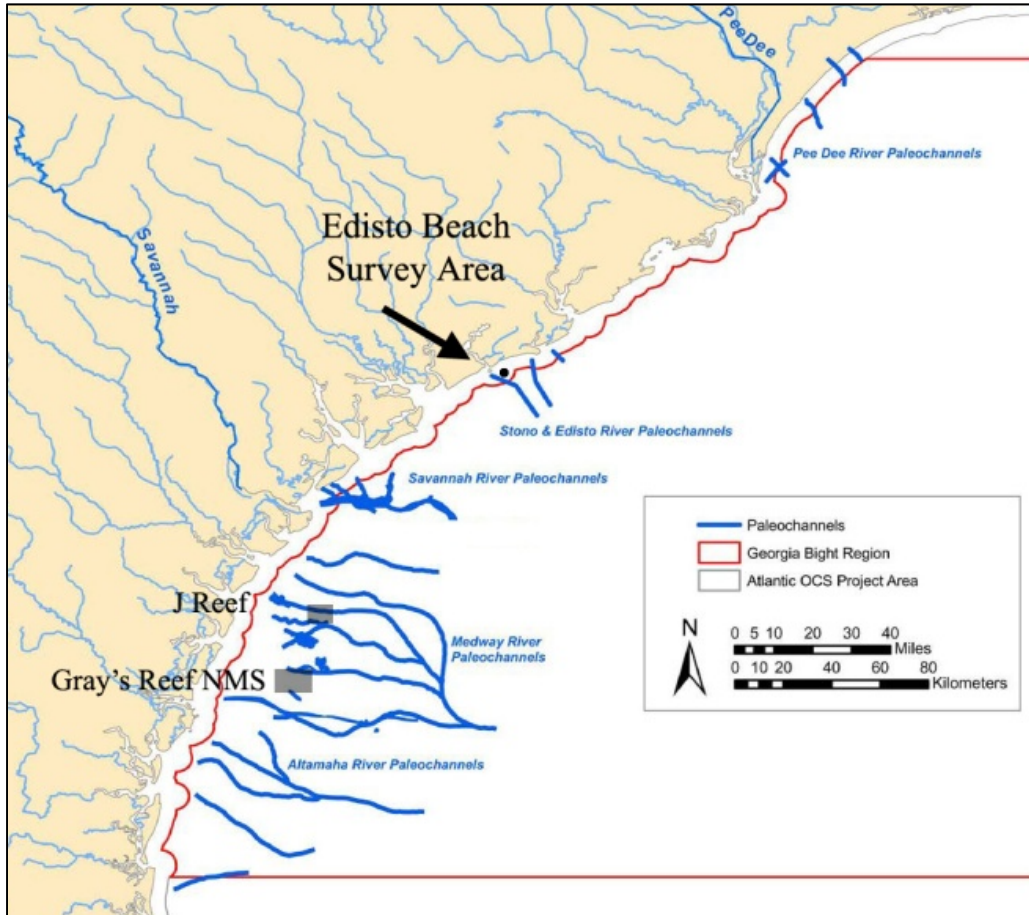
Figure 2. Adapted from Garrison et al. (2012), this figure shows a portion of the Georgia Bight's known paleochannels, J Reef and Gray's Reef, and the location of the Edisto Beach survey area.

These large areas of sand offshore are interspersed with rocky outcrops of “harbottom” (Garrison et al. 2012:111) that are Miocene- and Pliocene-aged limestones scattered as erosional remnants, ledges, and “ramps.” Some of these features indicate weathering in subaerial (exposed) conditions, including evidence for stream erosion and karst formation (Garrison et al. 2012:111). Notches in the Pliocene-aged Raysor Formation at the 20-meter isobath, indicate a still stand, but its age of formation is unknown. These limestone outcrops are the main geomorphic features that occur in the Georgia Bight, some having live bottoms like Gray’s Reef and J Reef shown in Figure 2, indicating sustained exposure of the outcrop.

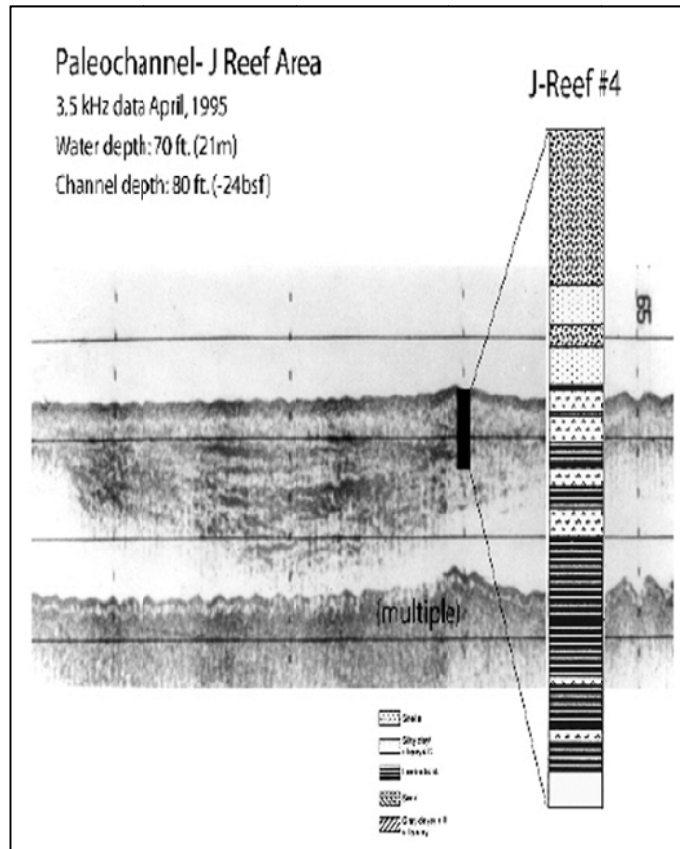
Figure 3. An example of a paleochannel underneath the sand sheet cover from Garrison et al. (2008) that is analogous to the paleochannel feature recorded in this survey project.

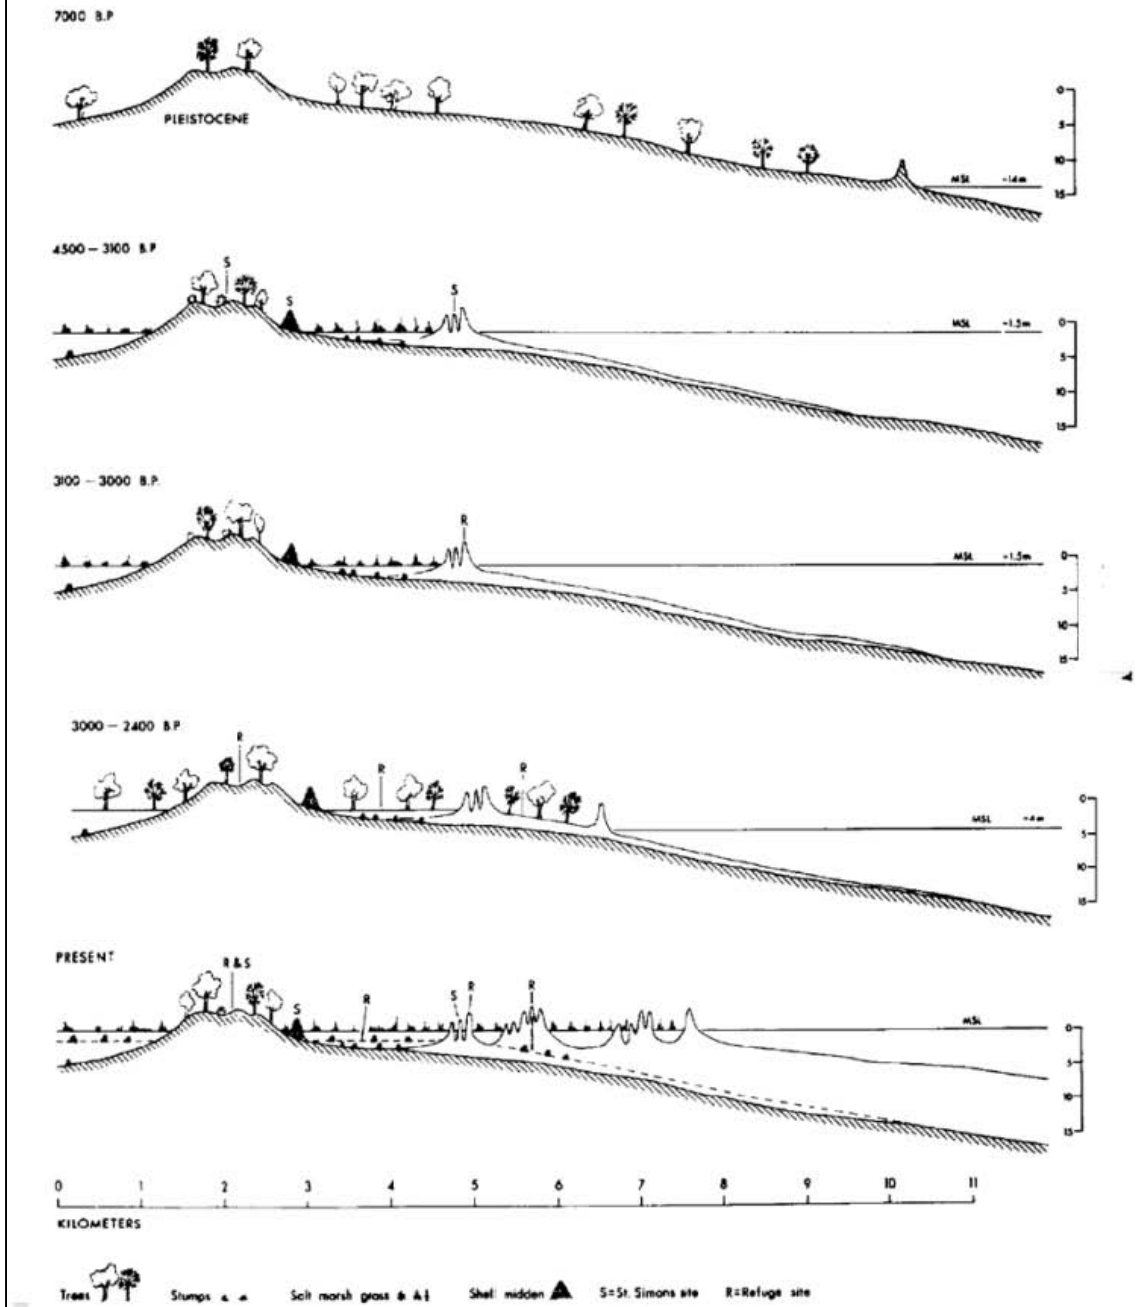
FIG. 2.—Schematic cross-section showing changes in coastal morphology and sites of Indian occupation on the Georgia coast from 7000 B.P. to present. This reconstruction is a composite of data gathered along the whole Georgia coast. The profile, however, is based on the area immediately south of the Savannah River where maximum shoreline progradation has occurred.

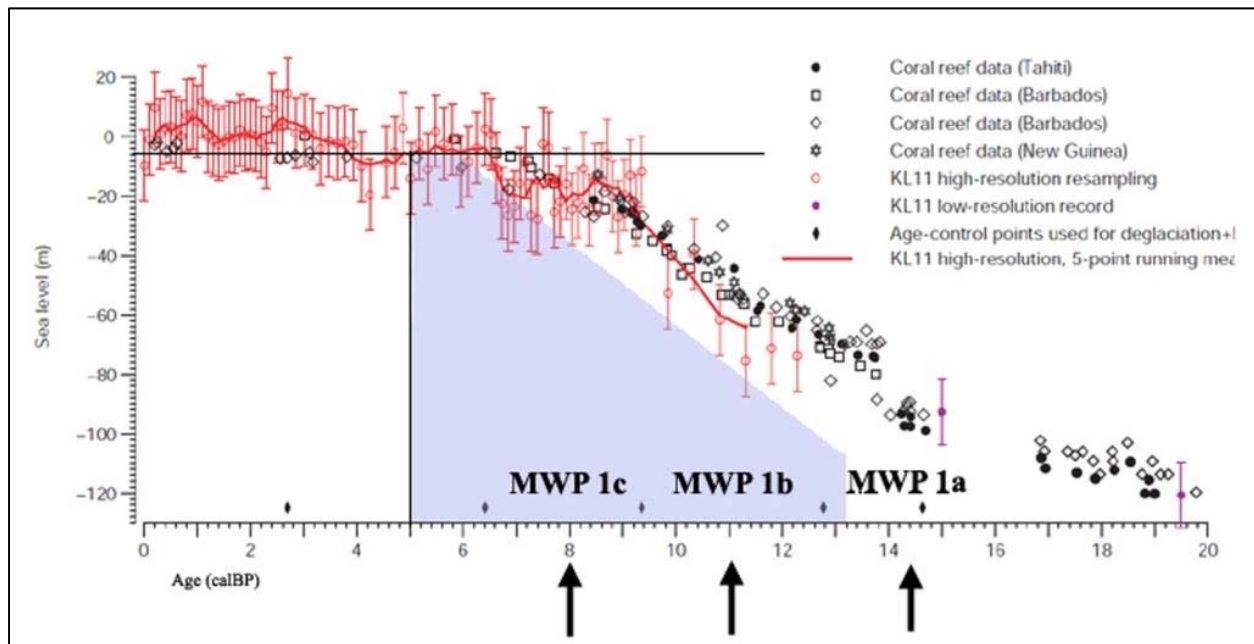
Figure 5. Global eustatic sea level curve from Siddall et al. (2003) with Blanchon (2011) chronology of MWPs 1a, 1b, and 1c shown. The horizontal line represents the survey area depths, indicating submergence after 5,000 calYBP.

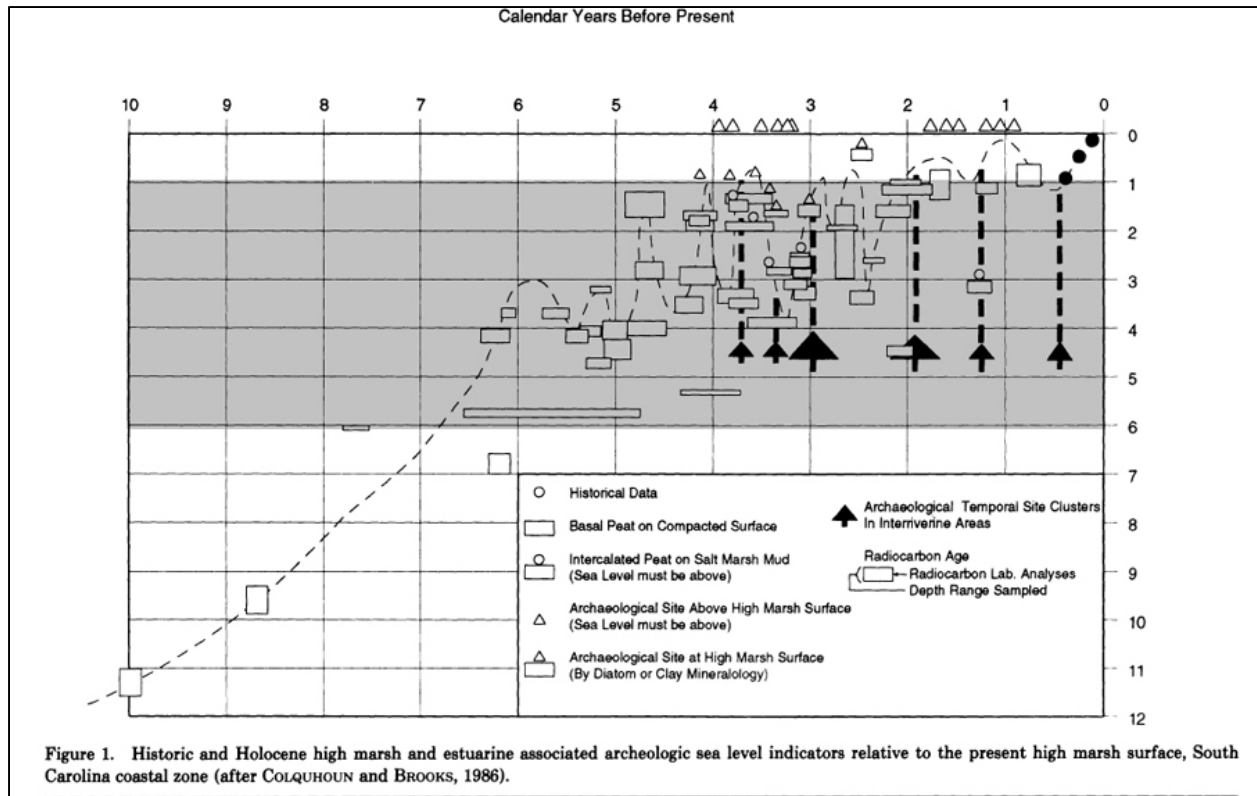
Figure 6. Fluctuating sea level curve for South Carolina from Colquhoun et al. (1995) relevant to the Project Area showing depths recorded in the Edisto Beach study area. The implication is that the study area was terrestrial before 8,000 calYBP and probably near coastal after that, until submergence between 5,000 and 4,000.

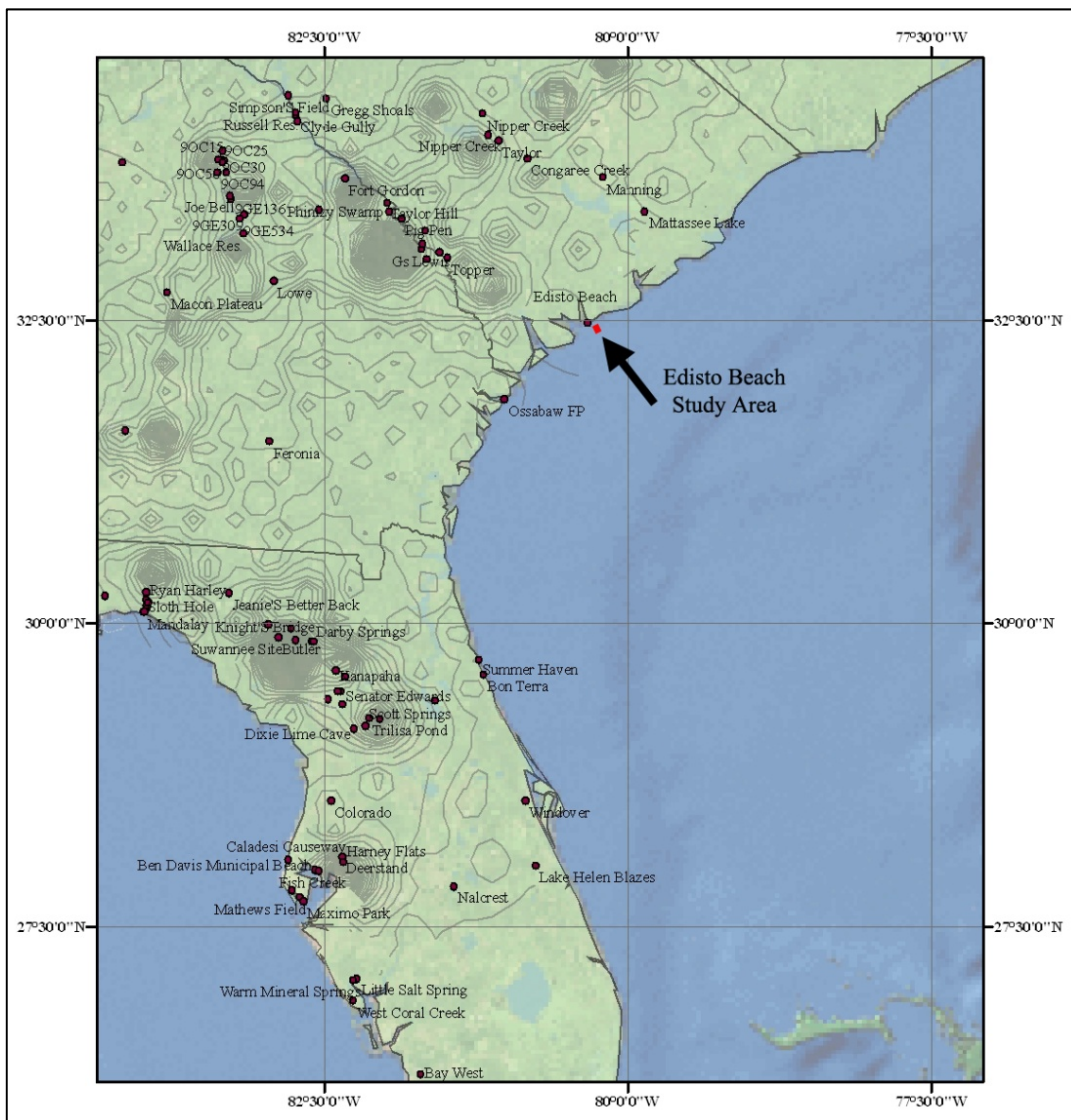
Figure 7. A composite of ARCOOP (Archaeological Research Cooperative) data of archaeological sites earlier than 9,000 calYBP (black dots) and distribution of Paleindian lanceolates contoured from PIDBA data. Note the cluster of late Paleindian and Early Archaic sites up the Savannah and Pee Dee rivers.

Figure 7 shows contours of the frequency of fluted and unfluted lanceolates contoured in Surfer (at 2 points per interval), using data with county level positioning data from the Paleoindian Database of the Americas (PIDBA) that can be found online. The filled circles in Figure 7 represent the locations of sites with diagnostics, stratigraphic exposures, age estimates of 9,000 calYBP (8,000 YBP) or older, or some combination of all of the above, especially those described by O'Steen (1996) and Ledbetter et al. (1996).

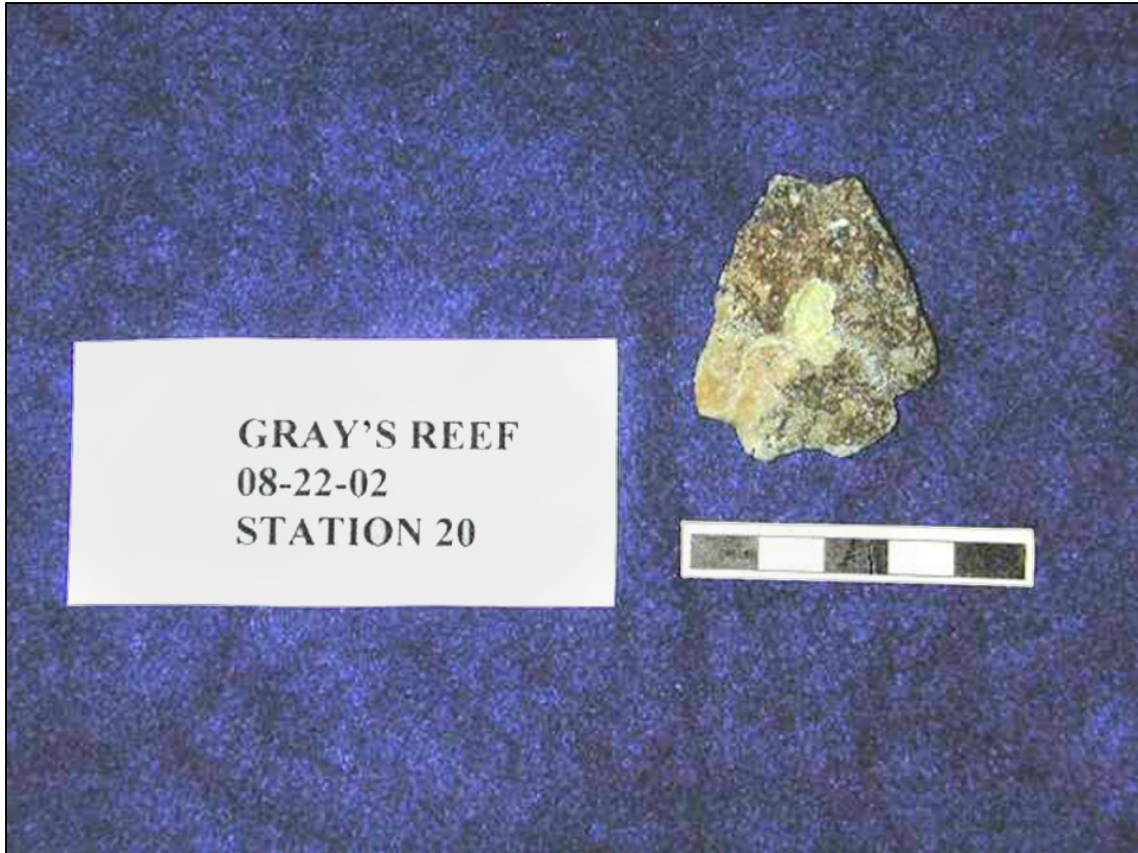
Figure 8. Bifurcate base projectile point found at Gray's Reef, note the corrosion and patination of the surface of the material from exposure to the saltwater environment (photo courtesy of E. Garrison; scale in centimeters).

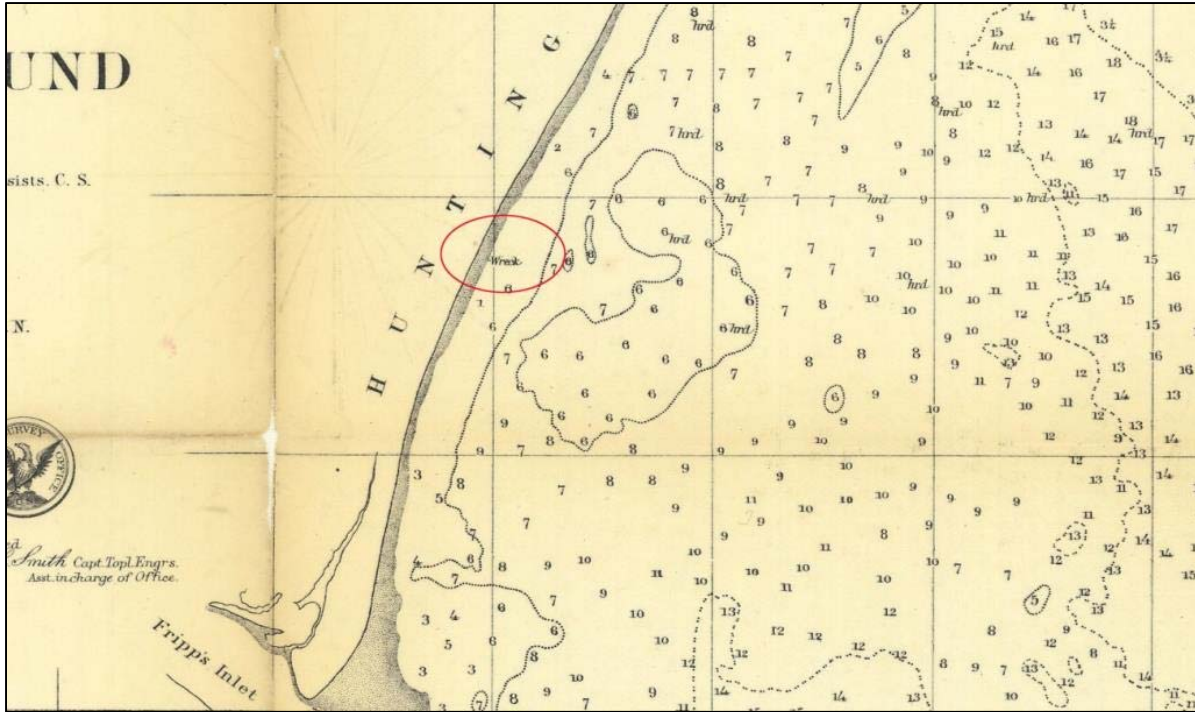
Figure 10. Excerpt from the 1857 Coastal Survey Chart "St. Helena Sound" showing single wreck notation on shore at the southern end of Hunting Island across the sound from the Project Area (Courtesy of National Oceanic and Atmospheric Administration's Office of Coast Survey's Historical Map and Chart Collection).

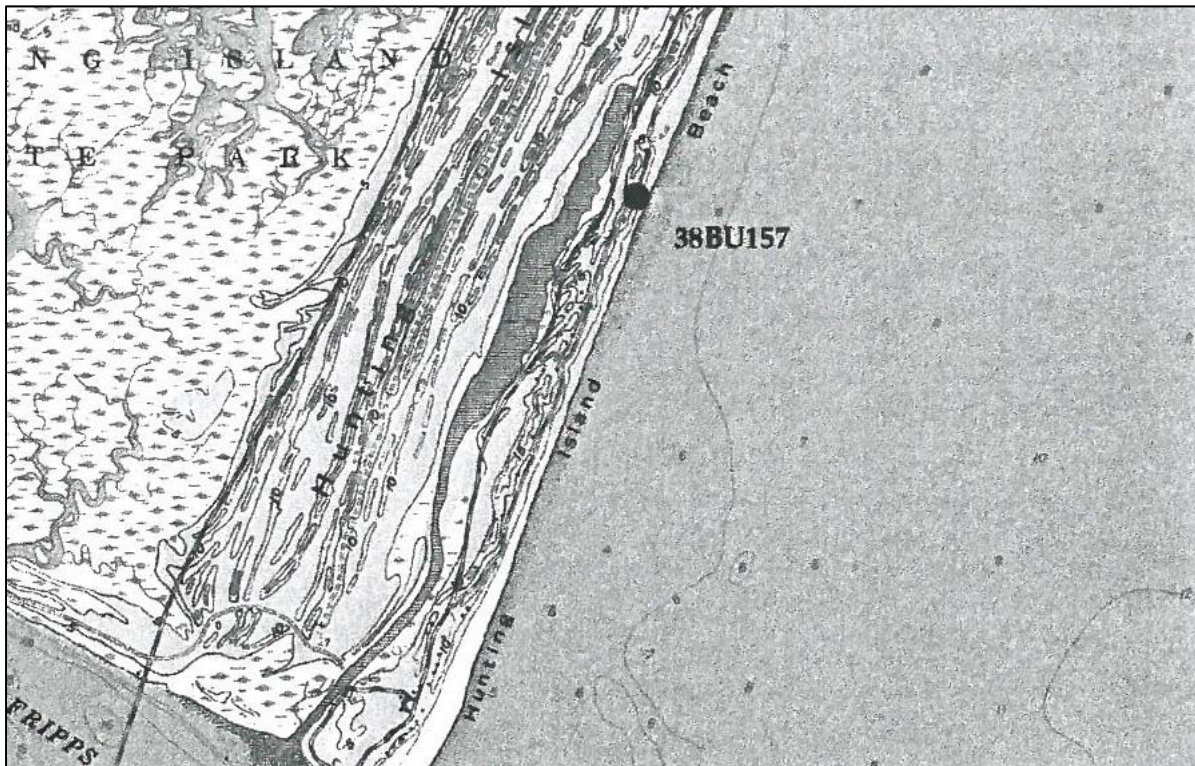
Figure 11. Location of Site 38BU157, vessel remains suggestive of a well smack, a type of fishing vessel introduced in the 1830s-1840s (as presented in Watts 2005:17). Compare the site's location with the wreck noted in Figure 10 above.

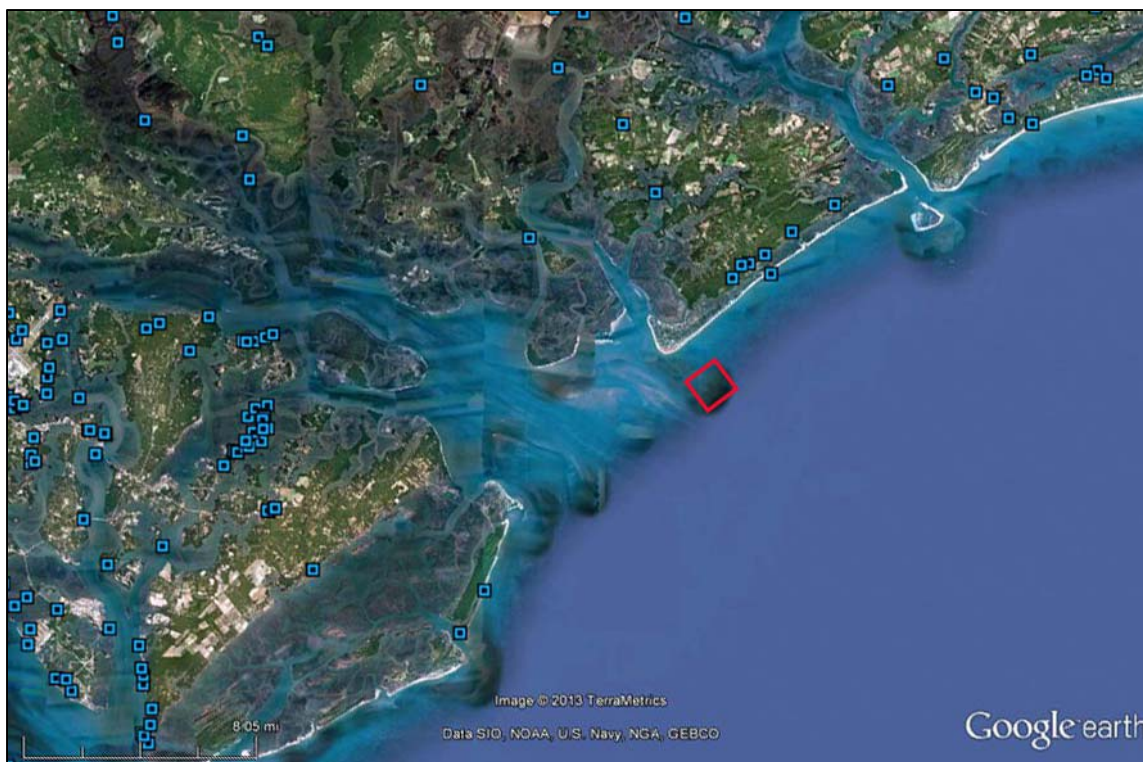
Figure 12. Recorded cultural resources sites with trinomials in relationship to the Project Area (base map courtesy of Google Earth). Note the two sites along the shore of Hunting Island to the south are shipwreck sites mentioned above.

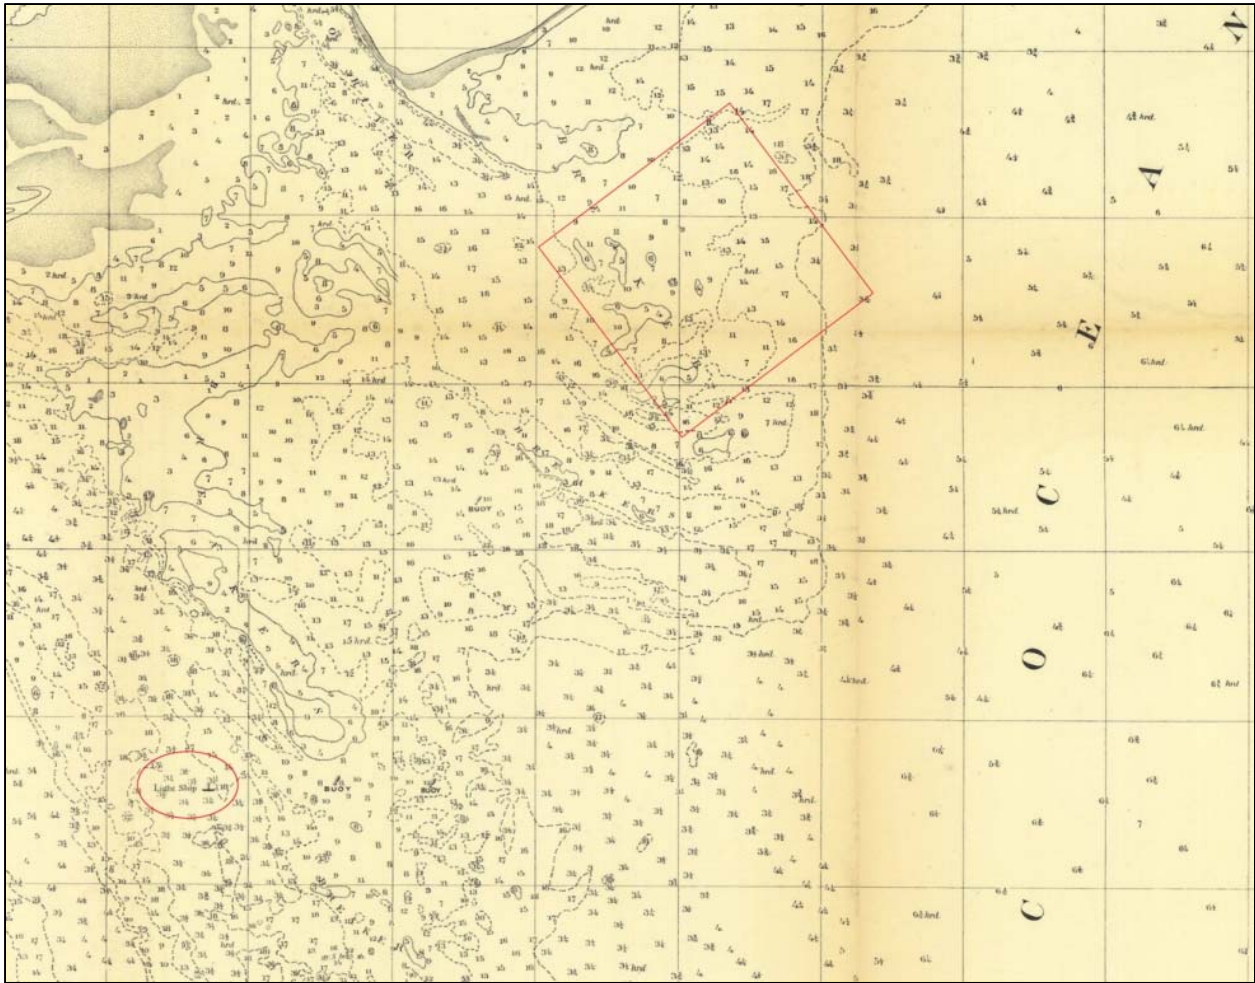
Figure 13. 1857 Coastal Survey Chart “St. Helena Sound.” Note the Project Area upper right and Light Ship marking the channel into the sound circled in red at lower left. No buoys or directions are noted for entering South Edisto River, while buoys mark the entrance into the sound channel (courtesy of NOAA’s Office of Coast Survey’s Historical Map and Chart Collection; Project Area is approximate and not georeferenced).

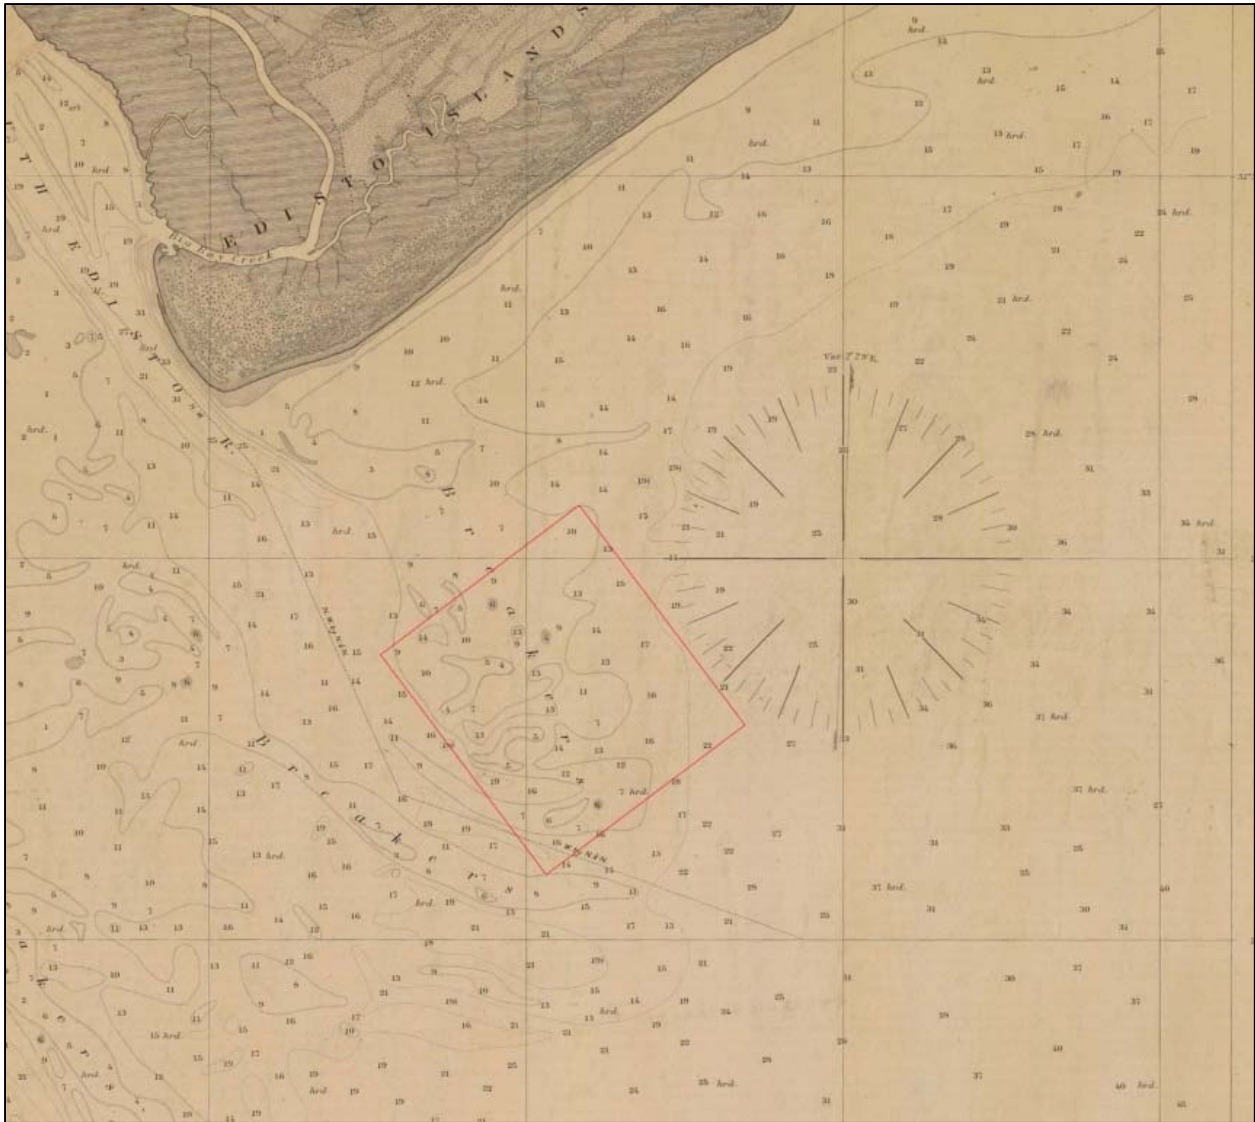
Figure 14. 1864 Coastal Survey Chart “St. Helena Sound.” Note that navigation directions are present for entering South Edisto River and goes between two sets of breakers, one on each side of a very narrow channel (courtesy of NOAA’s Office of Coast Survey’s Historical Map and Chart Collection).

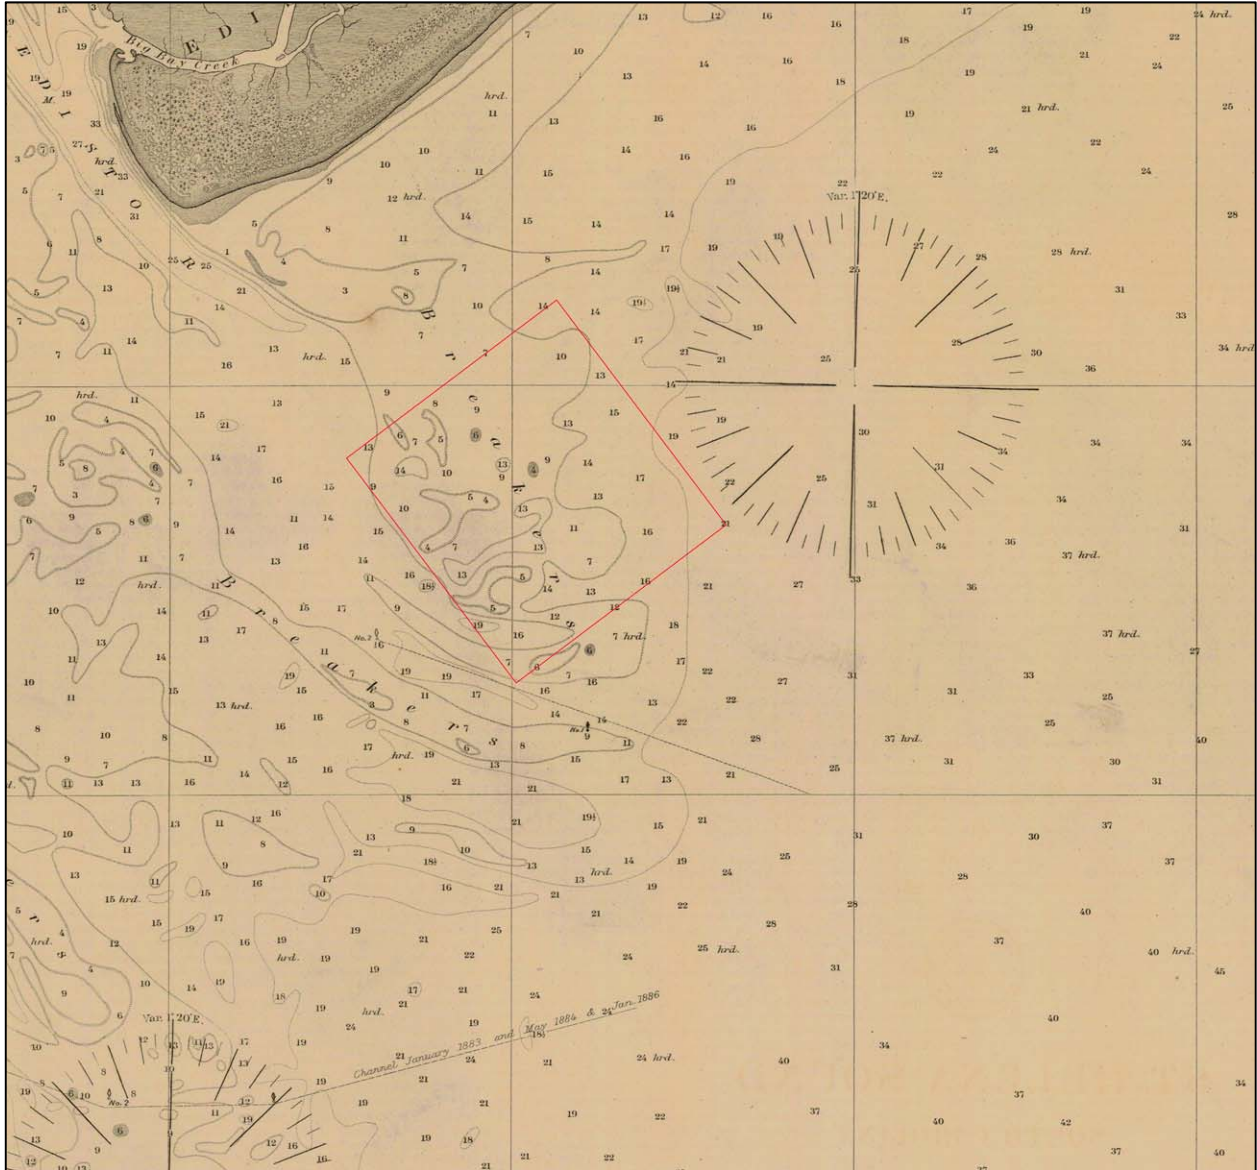
Figure 16. 1878 Coastal Survey Chart “St. Helena Sound.” Note the South Edisto River entrance channel now has two buoys marking the channel through the breakers (courtesy of NOAA’s Office of Coast Survey’s Historical Map and Chart Collection).

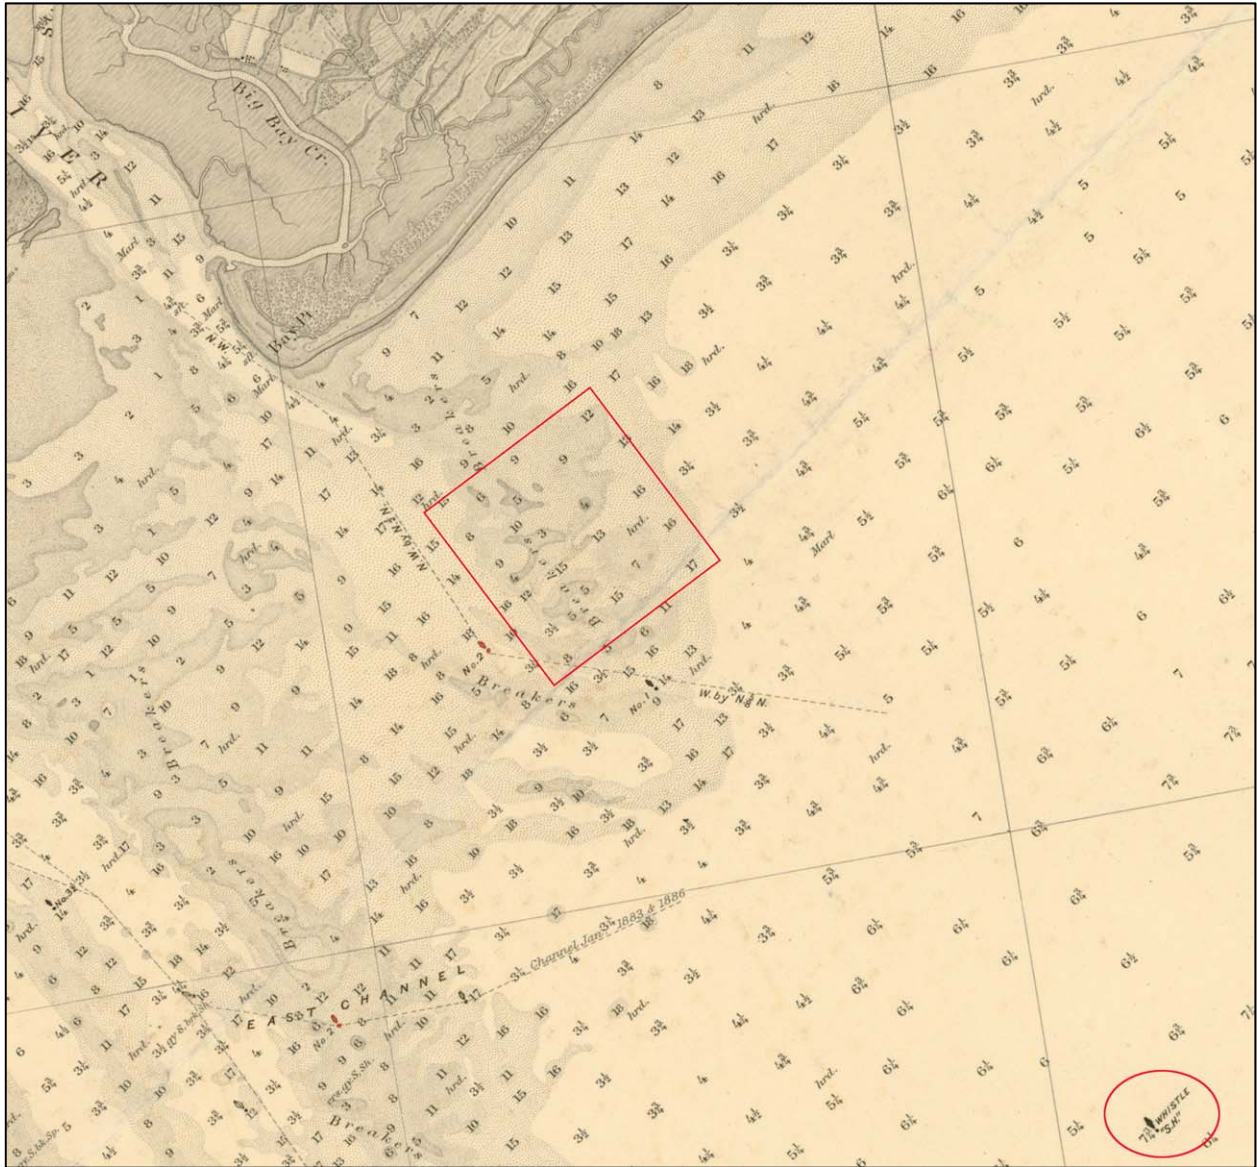
Figure 17. 1897 Coastal Survey Chart “St. Helena Sound.” Note the South Edisto River entrance channel is well marked by two buoys. A “Sea Whistle” buoy is now in place offshore the entrance channels for the Sound and South Edisto River (courtesy of NOAA’s Office of Coast Survey’s Historical Map and Chart Collection).

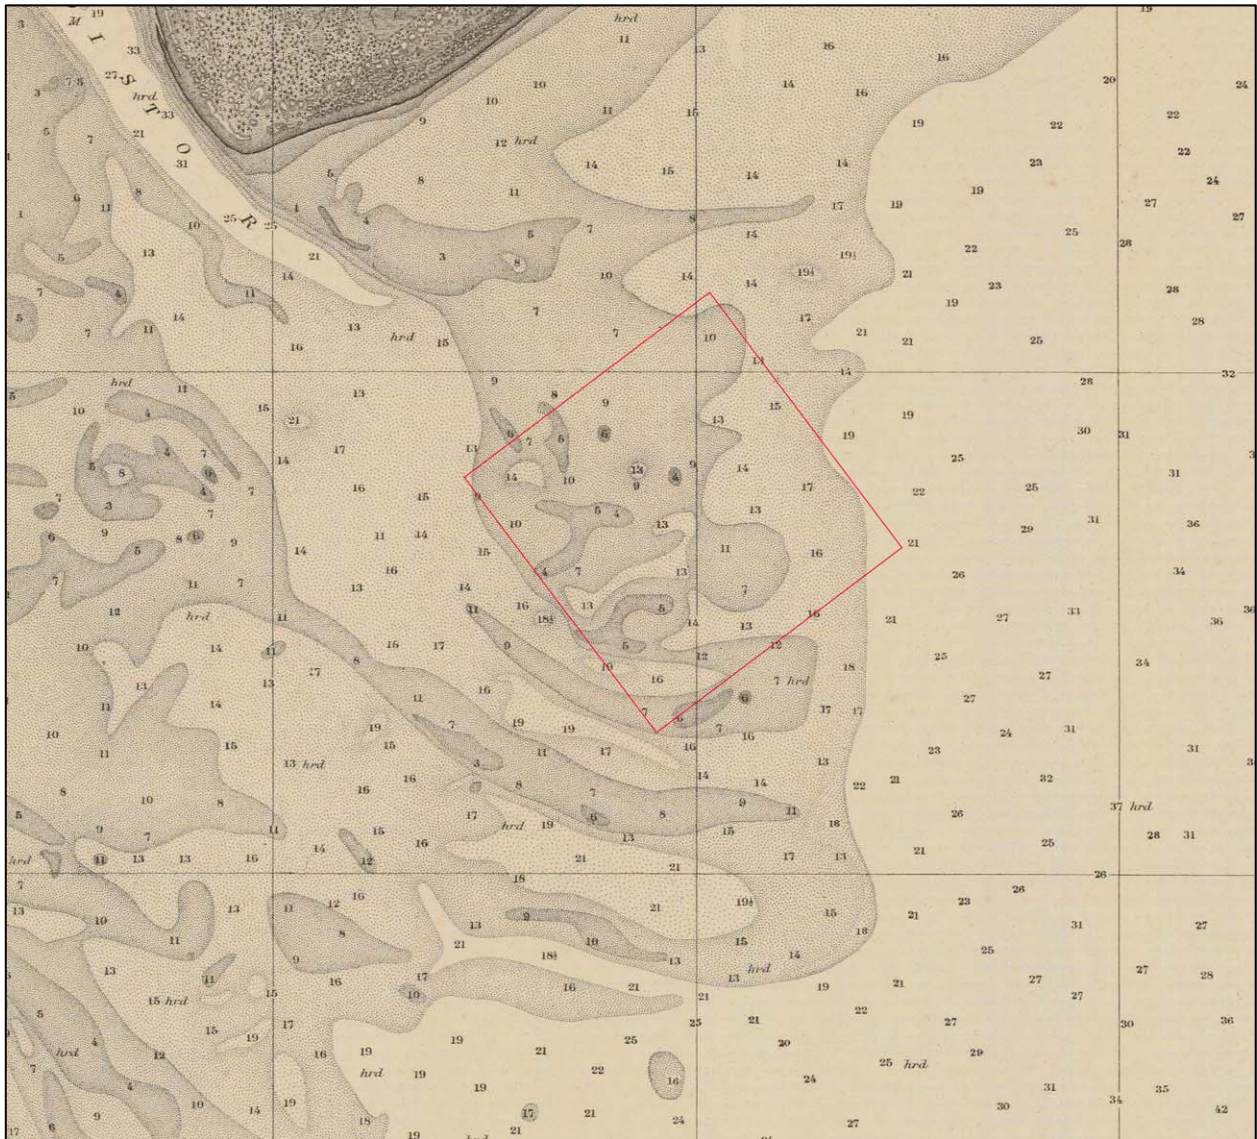
Figure 19. 1918 Coastal Survey Chart “St. Helena Sound.” Note the buoys once marking the South Edisto River entrance channel are not present, indicating a possible closure of the channel by shifting sands or storm. (courtesy of NOAA’s Office of Coast Survey’s Historical Map and Chart Collection).

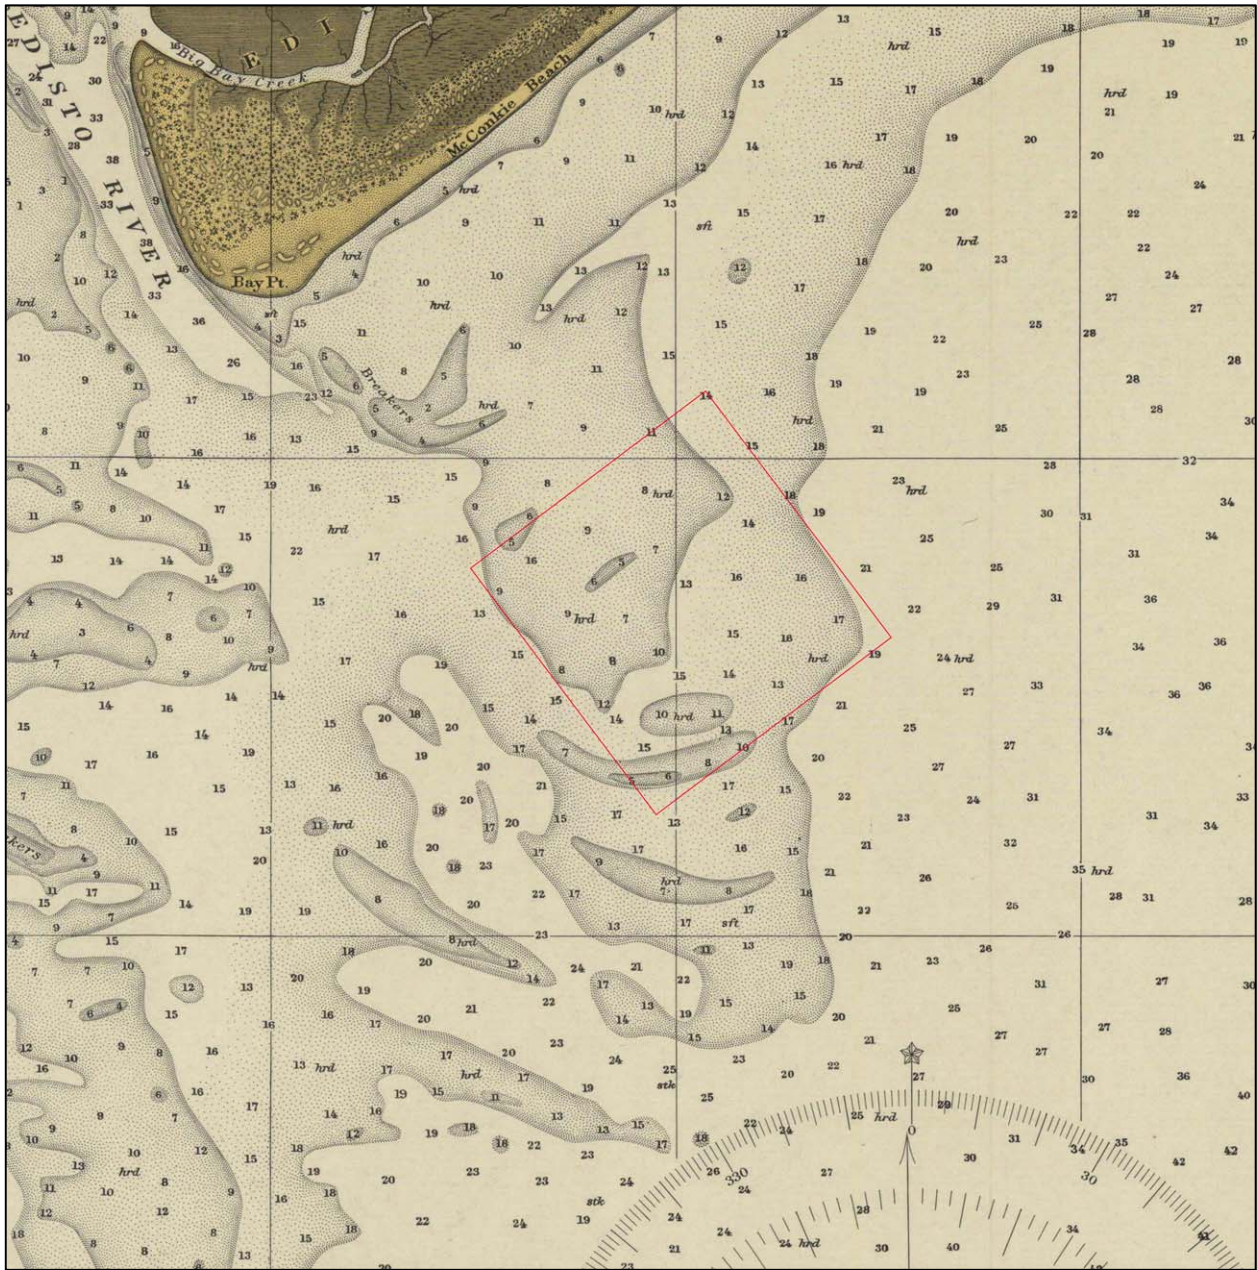
Figure 20. 1931 Coastal Survey Chart “St. Helena Sound” shows no buoys marking the channel through the breakers. Note that the beach on Edisto Island is labeled McConkie Beach. Bay Point is also labeled (courtesy of NOAA’s Office of Coast Survey’s Historical Map and Chart Collection).

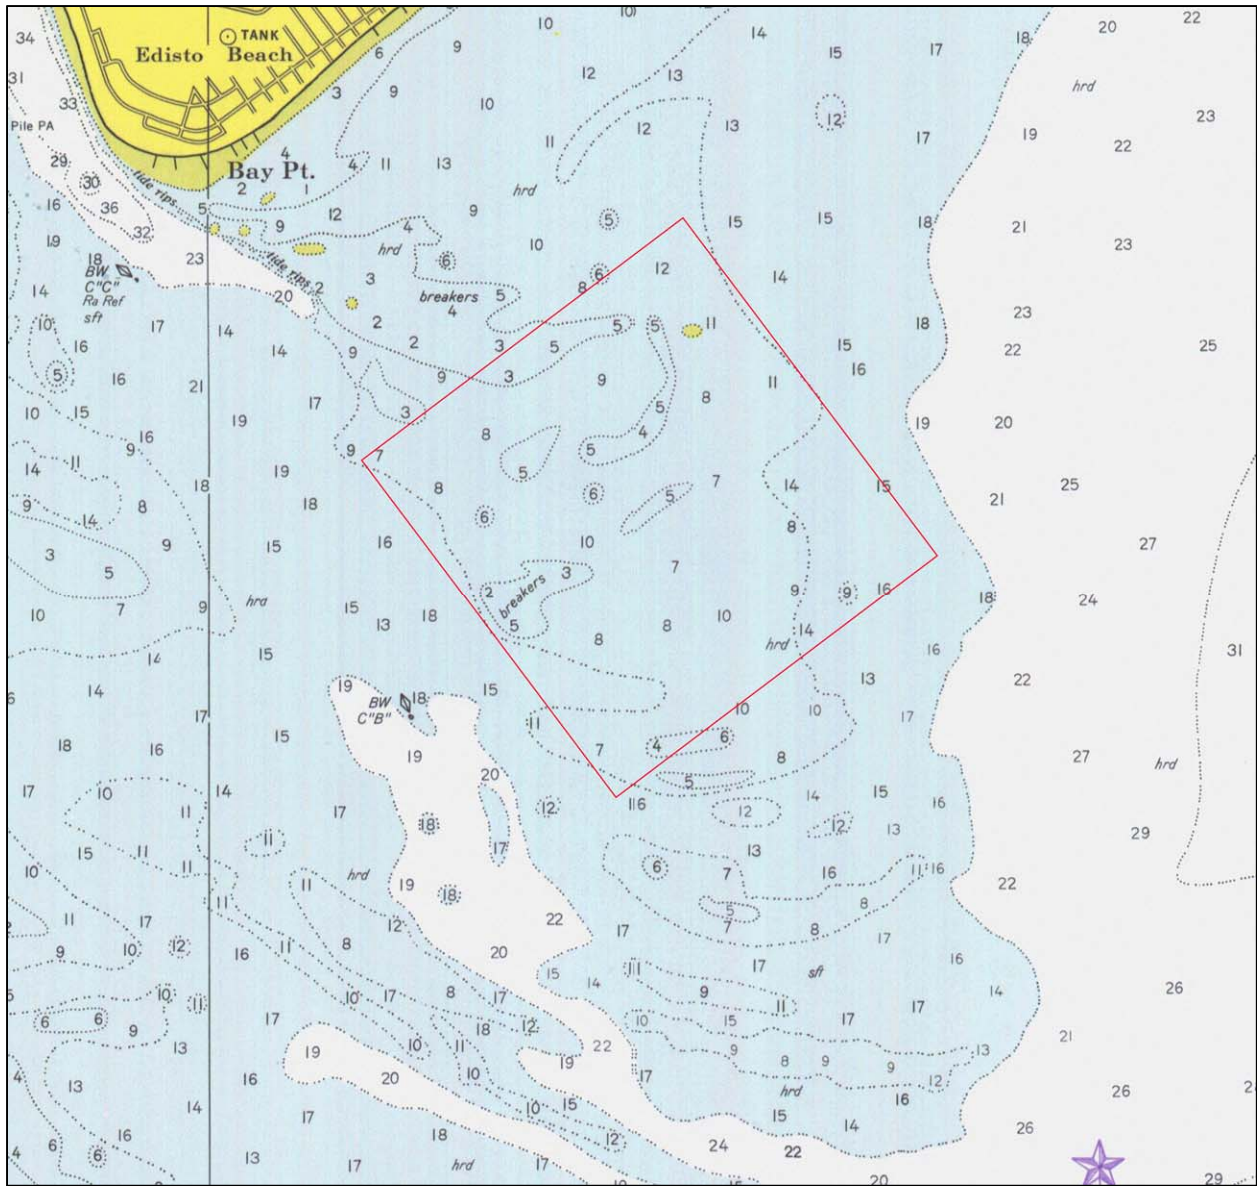
Figure 21. 1974 Coastal Survey Chart “St. Helena Sound” showing the channel is marked with two channel markers. Some exposed/above high tide shoals are now noted for the area. No wreck symbols are present (courtesy of NOAA’s Office of Coast Survey’s Historical Map and Chart Collection).

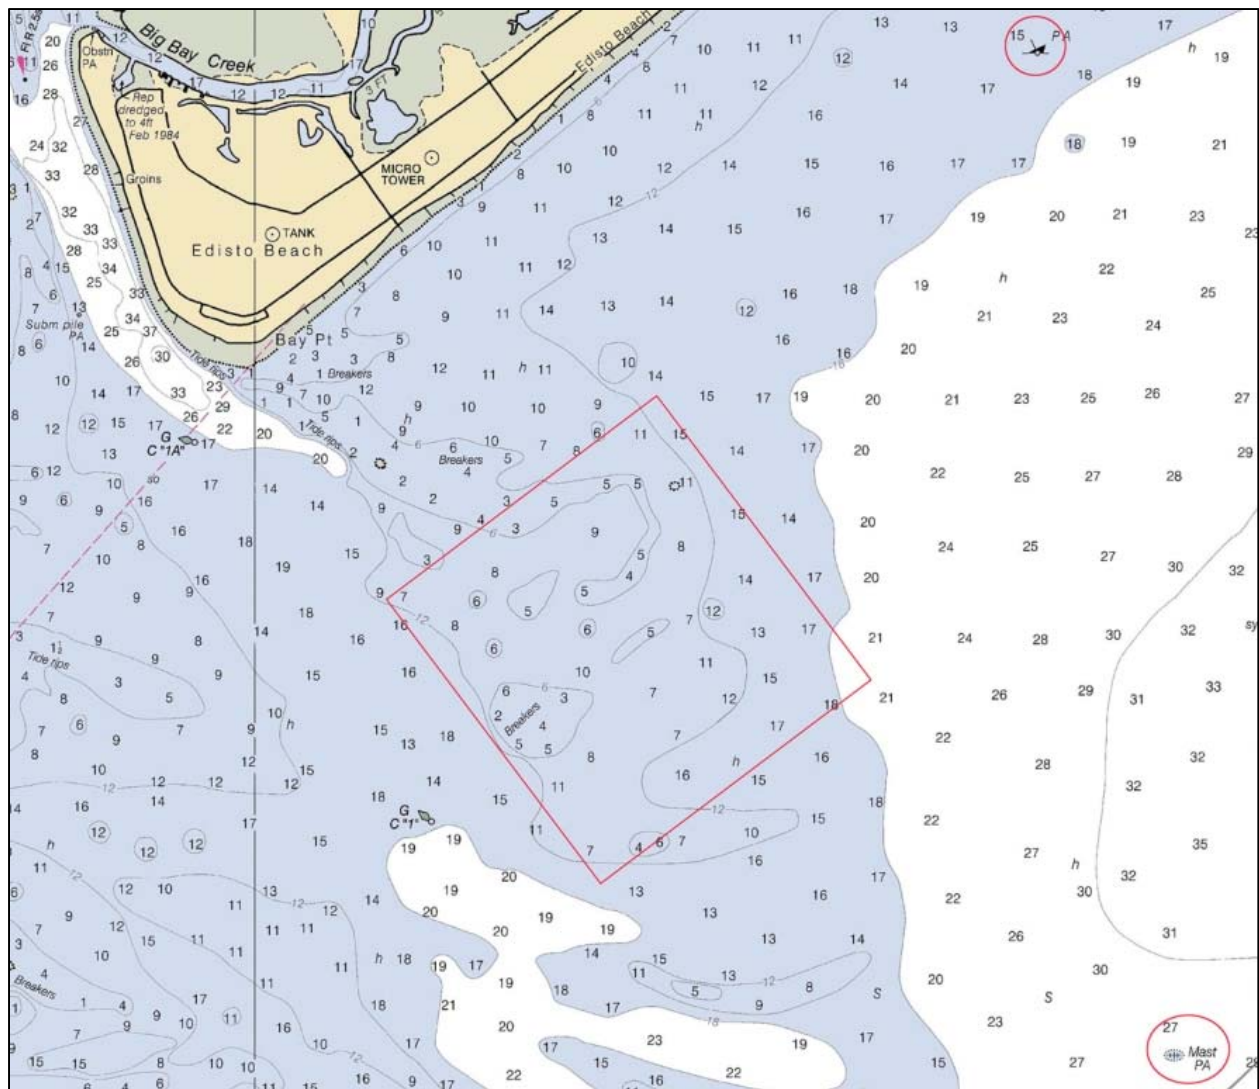
Figure 22. 2007 Coastal Survey Chart “St. Helena Sound.” Note the channel is well marked with very little shoaling. Breakers are still labeled on the northern side of the channel. A wreck symbol is present to the southeast of the Project Area and another is located well to the northeast closer to shore. These are not noted in AWOIS (courtesy of NOAA’s Office of Coast Survey’s Historical Map and Chart Collection).
