EDISTO BEACH
COASTAL STORM DAMAGE REDUCTION
GENERAL INVESTIGATION STUDY

APPENDIX J
HARDBOTTOM AND CULTURAL
RESOURCE SURVEYS

HARDBOTTOM AND CULTURAL RESOURCE SURVEYS EDISTO BEACH OFFSHORE BORROW SITE EDISTO BEACH, SOUTH CAROLINA

April 2013

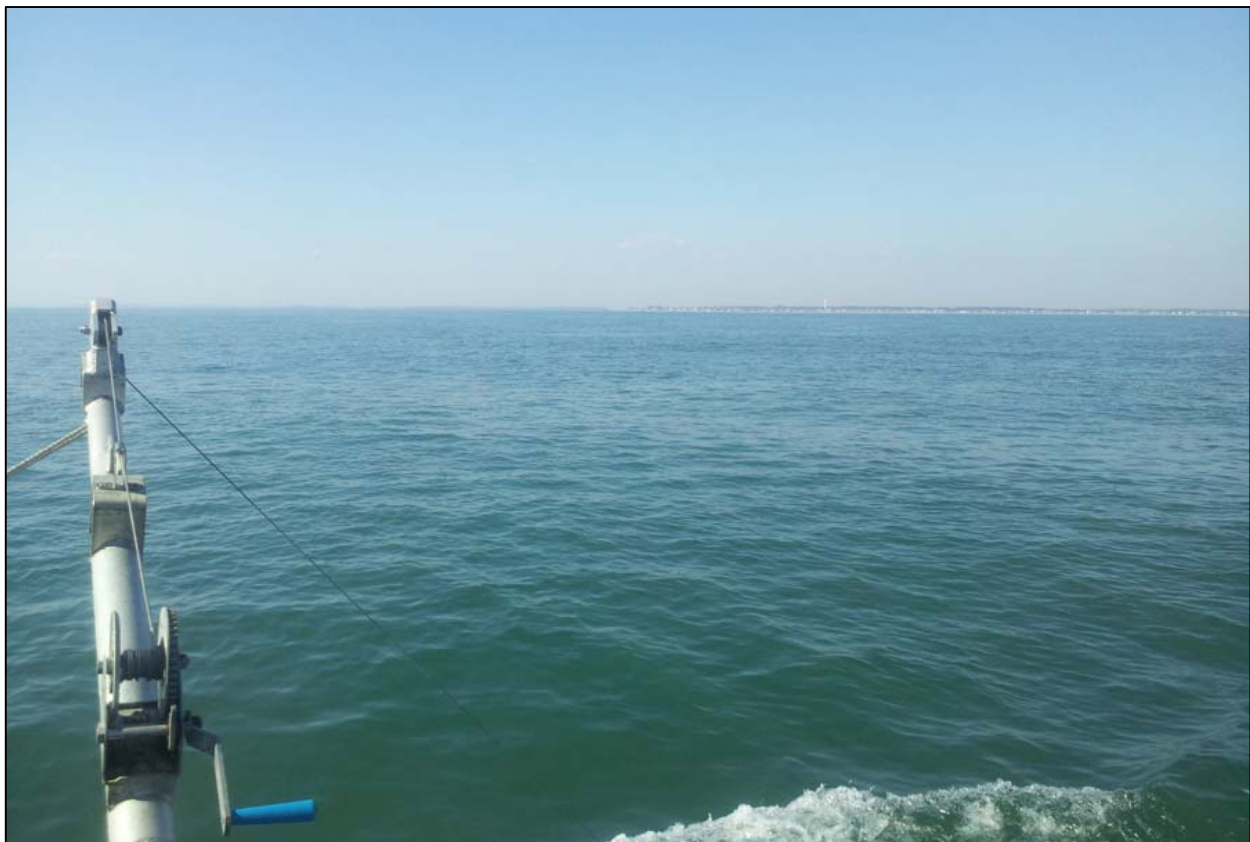
Figure 23. Looking north towards Edisto Beach from the southern end of Project Area. Boom at left holds the subbottom profiler. The smooth sea state shown here is the exception rather than the rough norm encountered during the survey.

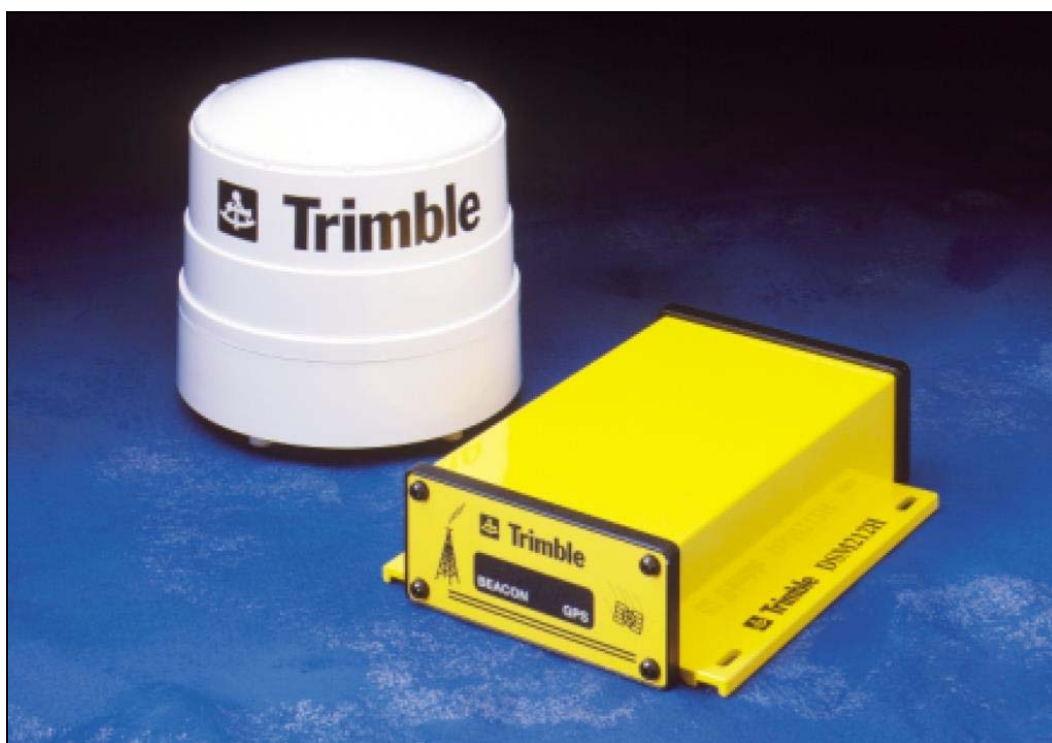
Figure 24. Trimble Navigation DSM 12/212 global-based positioning system used during the investigation.

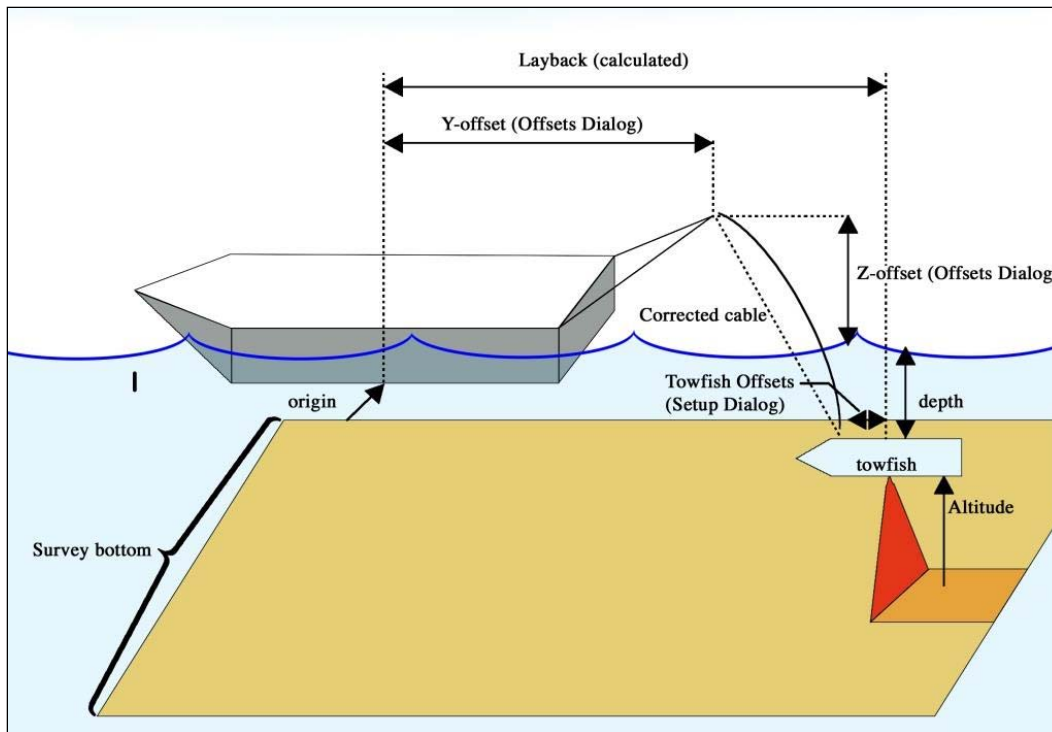
Figure 25. Equipment schematic illustrating layback (courtesy of Coastal Oceanographics, Inc.).

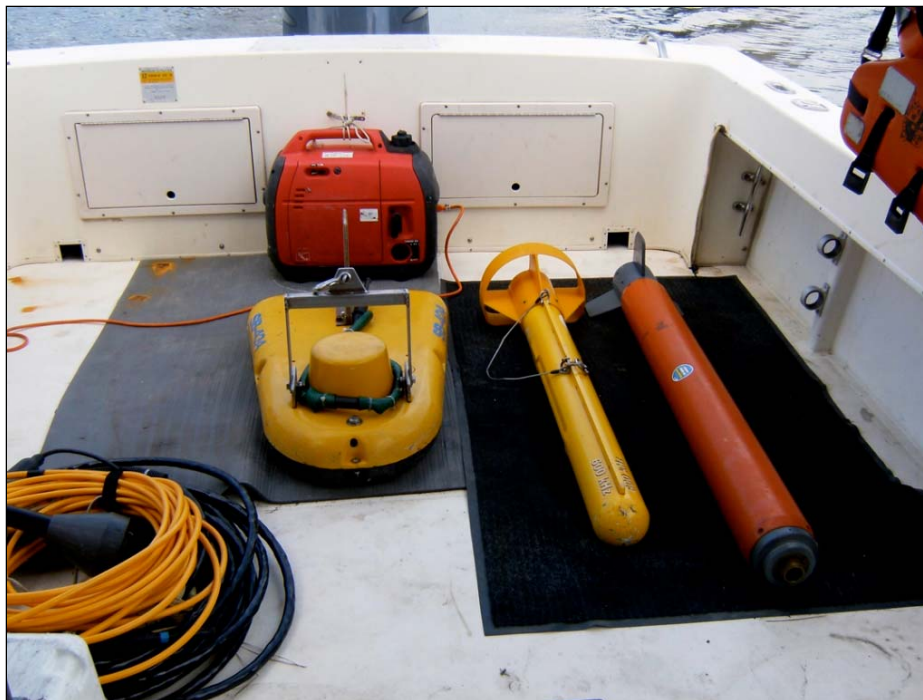
Figure 26. Survey instruments employed during the investigation included (from right to left) the magnetometer, the sidescan sonar, and the subbottom profiler. Honda generator employed to power the instruments is in the background adjacent to the transom.

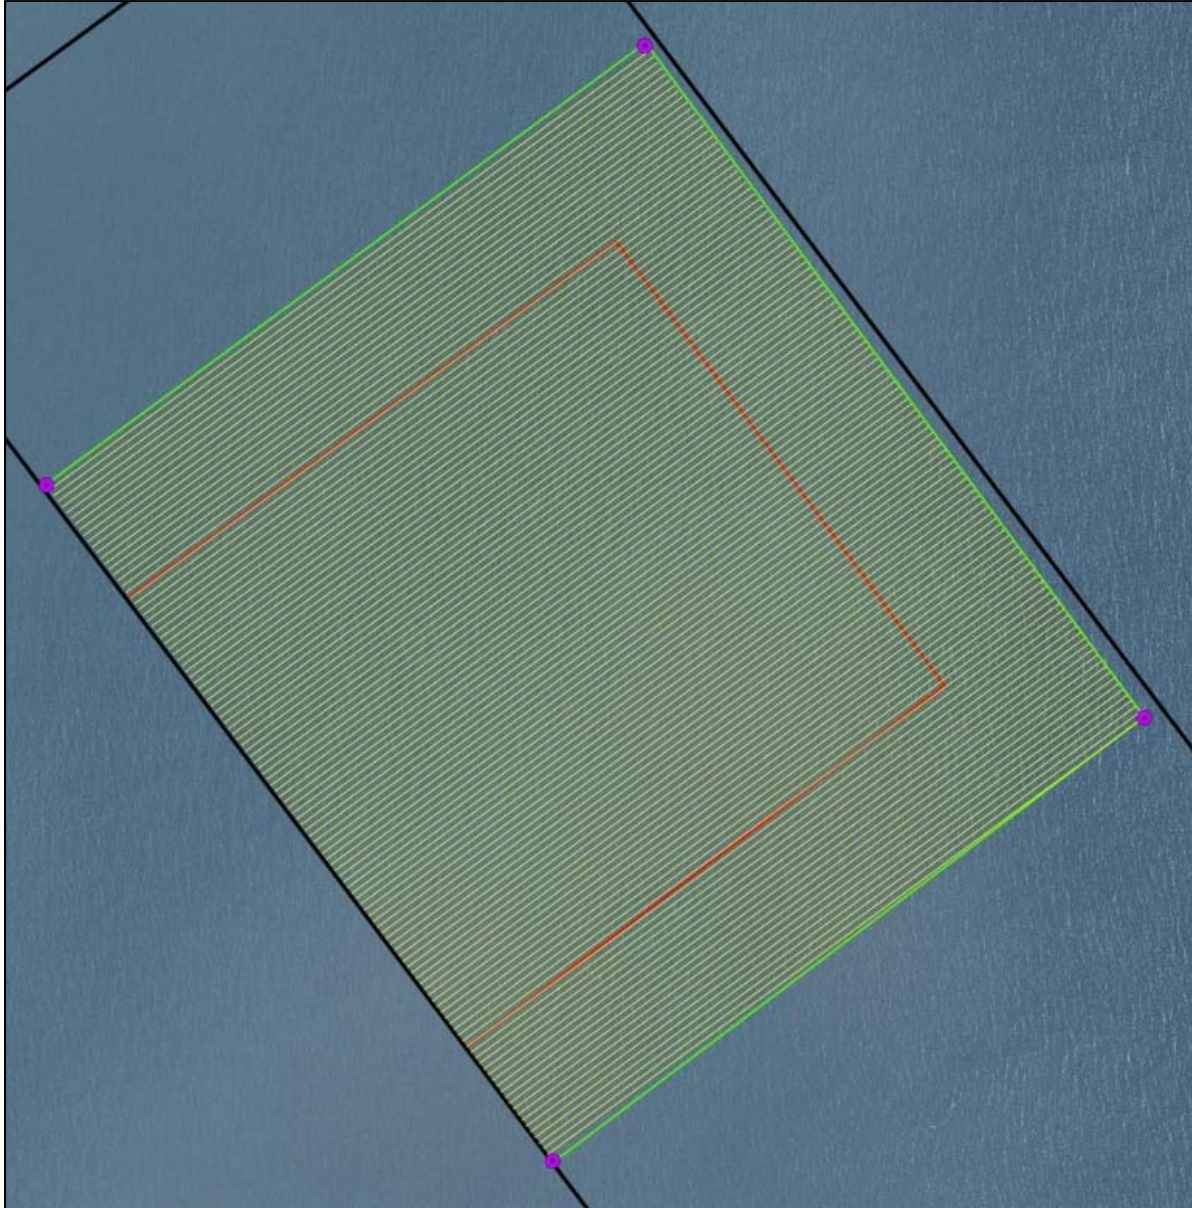
Figure 28. Planned survey lines within the Edisto Beach borrow area.

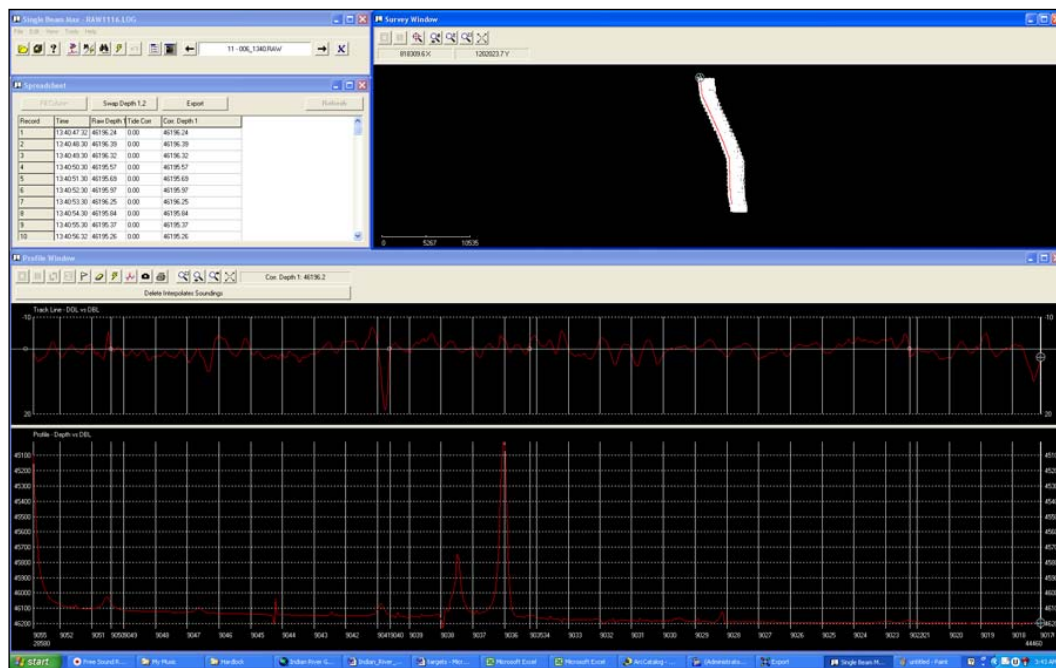
Figure 29. Hypack Single Beam Editor magnetic data display of a section of a survey line. Using these windows one can analyze anomaly position, strength, duration, and type. The peaks of these variations are the locations of target coordinates; their width is the duration.

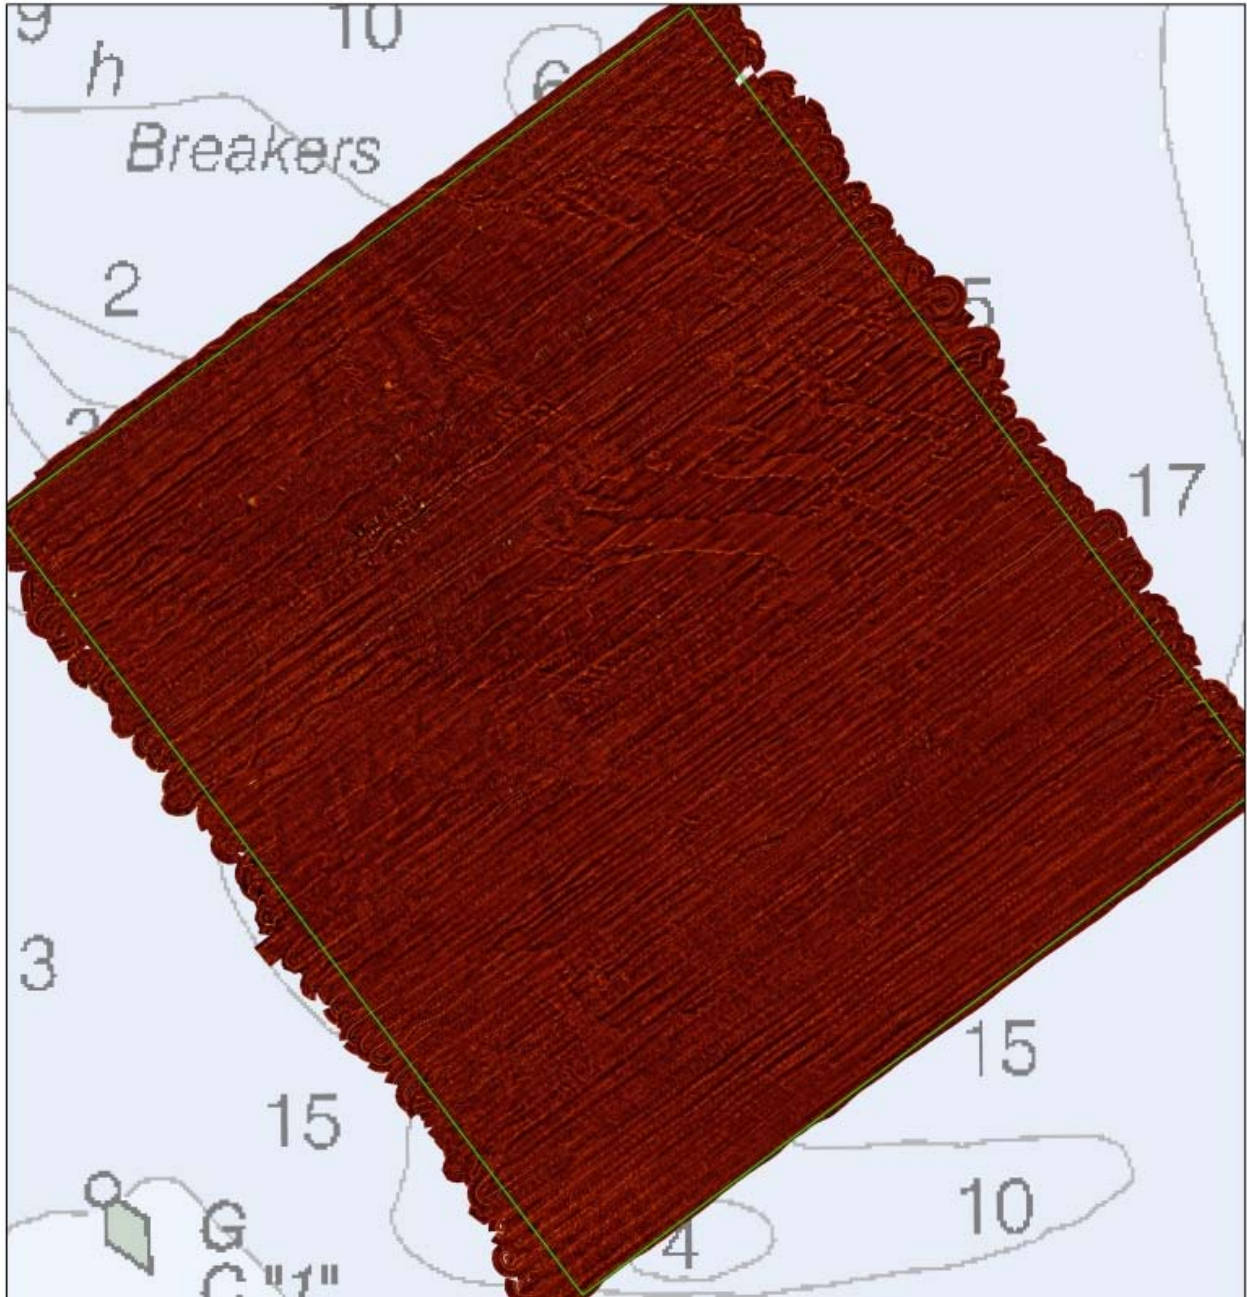
Figure 30. Sonar mosaic generated in SonarWiz.MAP showing 100% coverage of the Project Area.

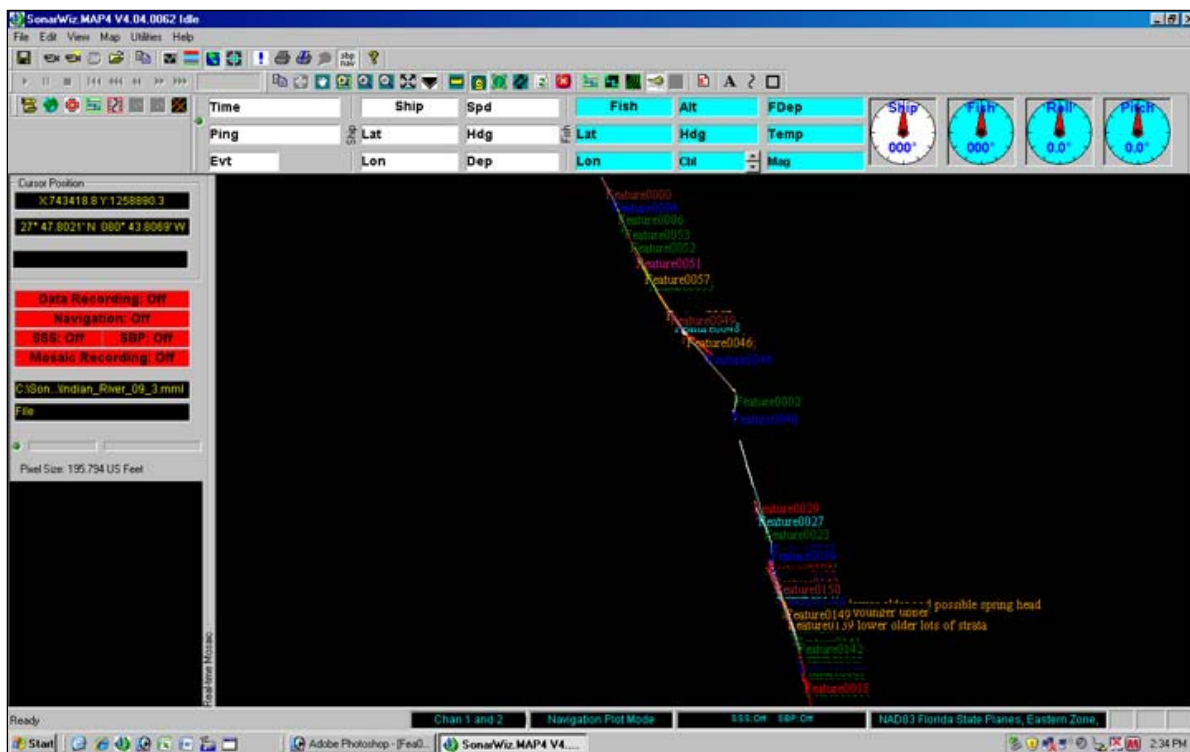
Figure 32. Trackline configuration example and various “reflector” features digitized.

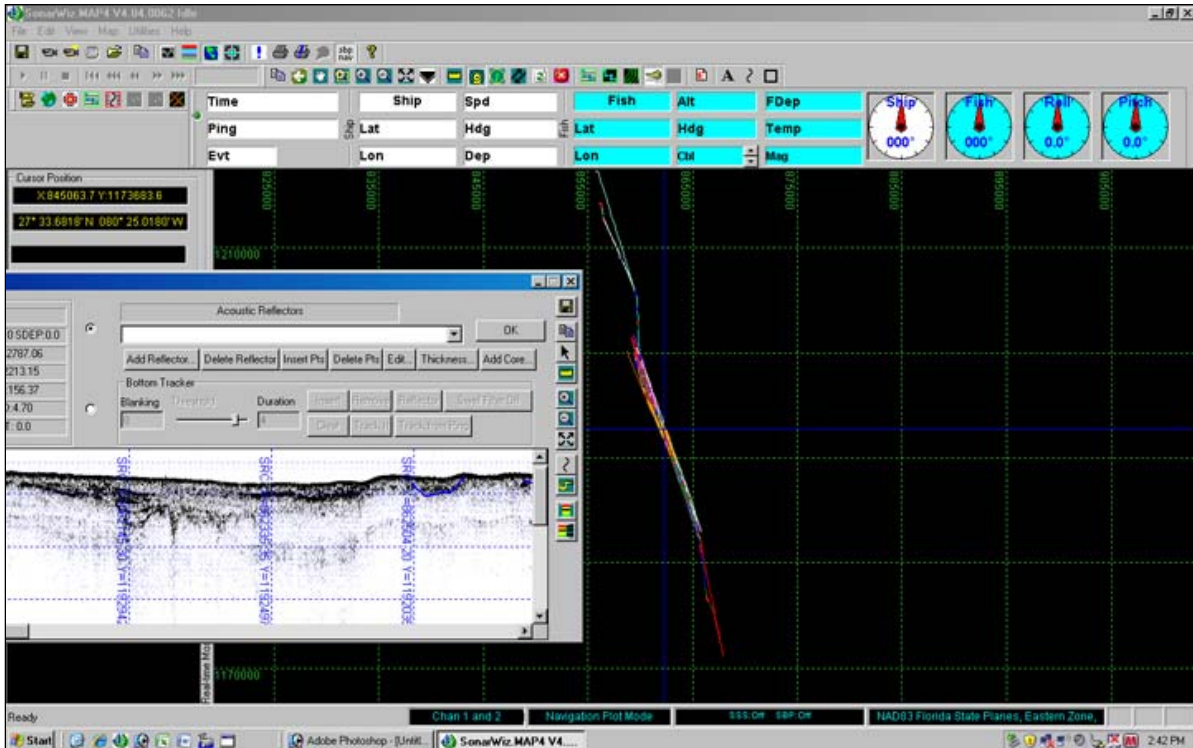
Figure 33. SonarWiz.MAP subbottom waterfall image example showing the seismic profile-digitizing window. The blue cross hairs in the background chart show the location of the cursor, which at the time of the image was directly over the peak of the positive relief feature shown.

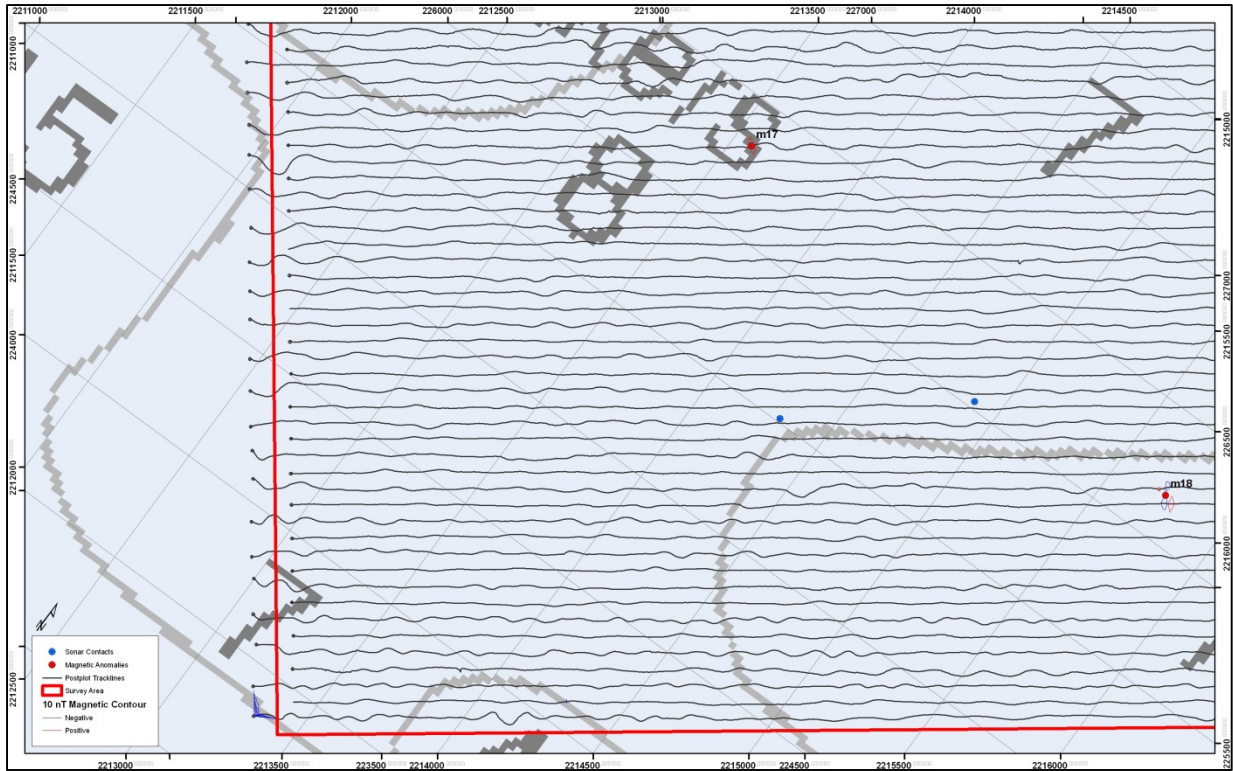
Figure 34. Magnetic contour map in GIS with the RNC chart as the background. Map presents layers of magnetic anomalies, sonar contacts, magnetic contours, and survey track lines.

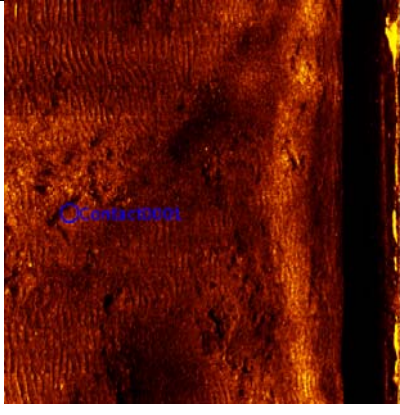
<p>SS-01</p> <ul style="list-style-type: none"> • Sonar Time at Target: 02/05/2013 13:30:57 • Click Position (Projected Coordinates) (X) 2213206.31 (Y) 232855.93 • Map Proj: SC83F • Acoustic Source File: C:\SonarWiz-Projects\Edisto\05FEB047-to-05FEB066.csf • Ping Number: 14151 • Range to Target: 25.08 US Feet • Fish Height: 0.29 US Feet • Heading: 52.200 degrees • Event Number: 0 • Line Name: 05FEB047-to-05FEB066 	<p>Dimensions Target Height: = 0 US Feet Target Length: 30 US Feet Target Shadow: 0 US Feet Target Width: 20 US Feet Mag Anomaly: Avoidance Area: Classification 1: Classification 2: Area: Block: Description: sediment clumps</p>

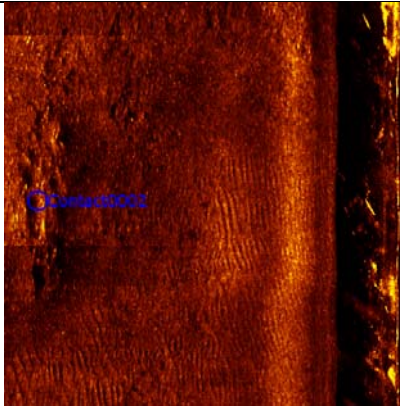
<p>SS-02</p> <ul style="list-style-type: none"> • Sonar Time at Target: 02/05/2013 14:35:52 • Click Position (Projected Coordinates) (X) 2213748.29 (Y) 232938.74 • Map Proj: SC83F • Acoustic Source File: C:\SonarWiz-Projects\Edisto\05FEB125-to-05FEB144.csf • Ping Number: 15809 • Range to Target: 27.42 US Feet • Fish Height: 0.12 US Feet • Heading: 45.400 degrees • Event Number: 0 • Line Name: 05FEB125-to-05FEB144 	<p>Dimensions Target Height: = 0 US Feet Target Length: 33 US Feet Target Shadow: 0 US Feet Target Width: 4 US Feet Mag Anomaly: Avoidance Area: Classification 1: Classification 2: Area: Block: Description: Object in bottom .. tree stump or log?</p>

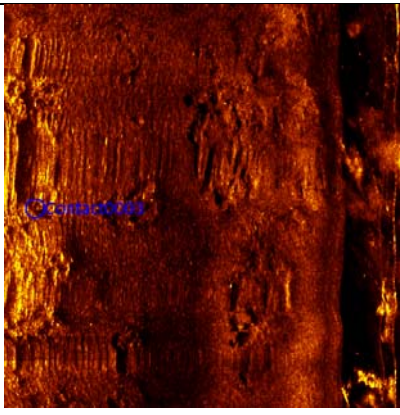
<p>SS-03</p> <ul style="list-style-type: none"> • Sonar Time at Target: 02/05/2013 15:06:12 • Click Position (Projected Coordinates) (X) 2213128.86 (Y) 232330.31 • Map Proj: SC83F • Acoustic Source File: C:\SonarWiz-Projects\Edisto\05FEB165-to-05FEB183.csf • Ping Number: 12768 • Range to Target: 27.66 US Feet • Fish Height: 0.29 US Feet • Heading: 47.200 degrees • Event Number: 0 • Line Name: 05FEB165-to-05FEB183 	<p>Dimensions Target Height: = 0 US Feet Target Length: 19 US Feet Target Shadow: 0 US Feet Target Width: 14 US Feet Mag Anomaly: Avoidance Area: Classification 1: Classification 2: Area: Block: Description: sediment clumps measure top one</p>

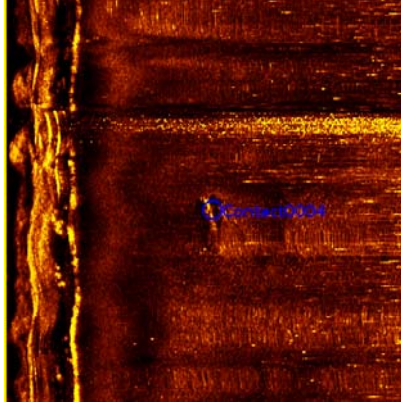
<p>SS-04</p> <ul style="list-style-type: none"> • Sonar Time at Target: 02/05/2013 15:17:42 • Click Position (Projected Coordinates) (X) 2212874.48 (Y) 231978.79 • Map Proj: SC83F • Acoustic Source File: C:\SonarWiz-Projects\Edisto\05FEB186-to-05FEB204.csf • Ping Number: 5777 • Range to Target: 15.47 US Feet • Fish Height: 0.29 US Feet • Heading: 260.800 degrees • Event Number: 0 • Line Name: 05FEB186-to-05FEB204 	<p>Dimensions</p> <p>Target Height: = 0 US Feet Target Length: 10 US Feet Target Shadow: 0 US Feet Target Width: 2 US Feet Mag Anomaly: Avoidance Area: Classification 1: Classification 2: Area: Block: Description: object</p>

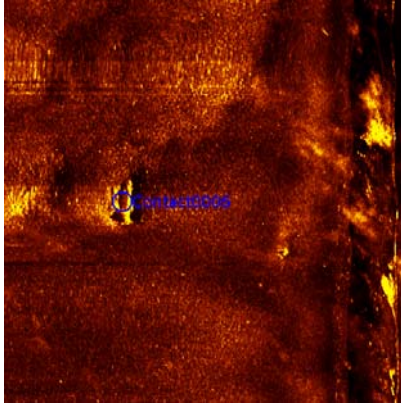
<p>SS-06</p> <ul style="list-style-type: none"> • Sonar Time at Target: 02/05/2013 15:44:10 • Click Position (Projected Coordinates) (X) 2212924.53 (Y) 231989.83 • Map Proj: SC83F • Acoustic Source File: C:\SonarWiz-Projects\Edisto\05FEB213-to-05FEB231.csf • Ping Number: 11907 • Range to Target: 21.15 US Feet • Fish Height: 0.12 US Feet • Heading: 61.600 degrees • Event Number: 0 • Line Name: 05FEB213-to-05FEB231 	<p>Dimensions</p> <p>Target Height: = 0 US Feet Target Length: 13 US Feet Target Shadow: 0 US Feet Target Width: 7 US Feet Mag Anomaly: Avoidance Area: Classification 1: Classification 2: Area: Block: Description: object in bottom</p>

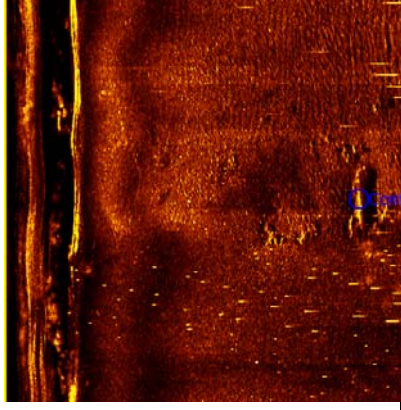
<p>SS-07</p> <ul style="list-style-type: none"> • Sonar Time at Target: 02/05/2013 15:44:58 • Click Position (Projected Coordinates) (X) 2213318.79 (Y) 232094.90 • Map Proj: SC83F • Acoustic Source File: C:\SonarWiz-Projects\Edisto\05FEB213-to-05FEB231.csf • Ping Number: 12837 • Range to Target: 26.31 US Feet • Fish Height: 0.12 US Feet • Heading: 35.000 degrees • Event Number: 0 • Line Name: 05FEB213-to-05FEB231 	<p>Dimensions</p> <p>Target Height: = 0 US Feet Target Length: 15 US Feet Target Shadow: 0 US Feet Target Width: 4 US Feet Mag Anomaly: Avoidance Area: Classification 1: Classification 2: Area: Block: Description: stump or roots or both possible shell scatter</p>

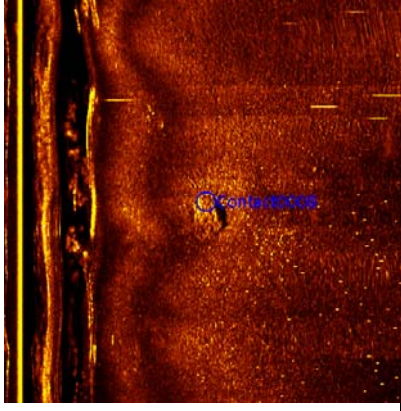
<p>SS-08</p> <ul style="list-style-type: none"> • Sonar Time at Target: 02/05/2013 16:47:16 • Click Position (Projected Coordinates) (X) 2213610.34 (Y) 232196.29 • Map Proj: SC83F • Acoustic Source File: C:\SonarWiz-Projects\Edisto\05FEB233-to-05FEB269.csf • Ping Number: 14523 • Range to Target: 13.77 US Feet • Fish Height: 0.76 US Feet • Heading: 43.200 degrees • Event Number: 0 • Line Name: 05FEB233-to-05FEB269 	<p>Dimensions</p> <p>Target Height: = 0 US Feet Target Length: 9 US Feet Target Shadow: 0 US Feet Target Width: 6 US Feet Mag Anomaly: Avoidance Area: Classification 1: Classification 2: Area: Block: Description: object</p>

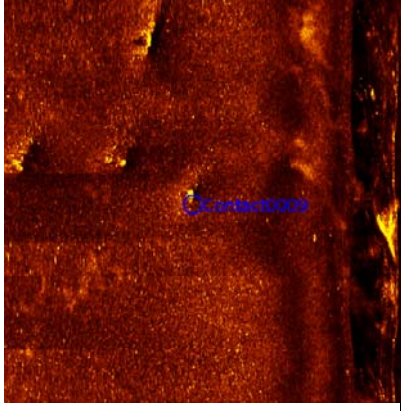
<p>SS-09</p> <ul style="list-style-type: none"> • Sonar Time at Target: 02/05/2013 16:15:38 • Click Position (Projected Coordinates) (X) 2212906.93 (Y) 231877.37 • Map Proj: SC83F • Acoustic Source File: C:\SonarWiz-Projects\Edisto\05FEB234-to-05FEB250.csf • Ping Number: 10984 • Range to Target: 15.94 US Feet • Fish Height: 0.35 US Feet • Heading: 50.700 degrees • Event Number: 0 • Line Name: 05FEB234-to-05FEB250 	<p>Dimensions</p> <p>Target Height: = 0 US Feet Target Length: 0 US Feet Target Shadow: 0 US Feet Target Width: 0 US Feet Mag Anomaly: Avoidance Area: Classification 1: Classification 2: Area: Block: Description: posts or stumps?? buried structure</p>

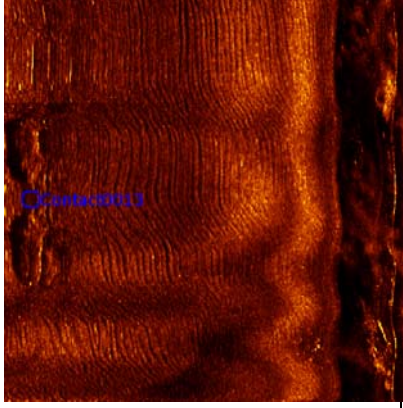
<p>SS-13</p> <ul style="list-style-type: none"> • Sonar Time at Target: 02/05/2013 16:18:11 • Click Position (Projected Coordinates) (X) 2213947.91 (Y) 232666.89 • Map Proj: SC83F • Acoustic Source File: C:\SonarWiz-Projects\Edisto\05FEB234-to-05FEB250.csf • Ping Number: 14103 • Range to Target: 27.95 US Feet • Fish Height: 0.35 US Feet • Heading: 61.300 degrees • Event Number: 0 • Line Name: 05FEB234-to-05FEB250 	<p>Dimensions</p> <p>Target Height: = 0 US Feet Target Length: 41 US Feet Target Shadow: 0 US Feet Target Width: 8 US Feet Mag Anomaly: Avoidance Area: Classification 1: Classification 2: Area: Block: Description: objects on bottom</p>

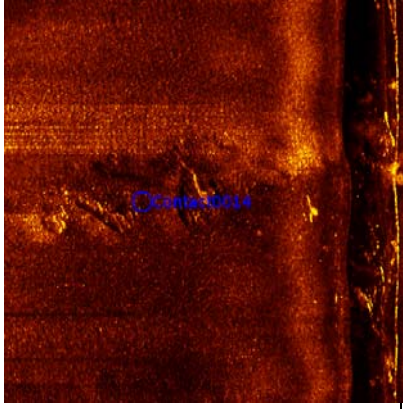
<p>SS-14</p> <ul style="list-style-type: none"> • Sonar Time at Target: 02/05/2013 17:19:02 • Click Position (Projected Coordinates) (X) 2213374.41 (Y) 232085.50 • Map Proj: SC83F • Acoustic Source File: C:\SonarWiz-Projects\Edisto\05FEB271-to-05FEB287.csf • Ping Number: 12585 • Range to Target: 19.69 US Feet • Fish Height: 0.47 US Feet • Heading: 51.800 degrees • Event Number: 0 • Line Name: 05FEB271-to-05FEB287 	<p>Dimensions</p> <p>Target Height: = 0 US Feet Target Length: 15 US Feet Target Shadow: 0 US Feet Target Width: 5 US Feet Mag Anomaly: Avoidance Area: Classification 1: Classification 2: Area: Block: Description: objects on bottom</p>

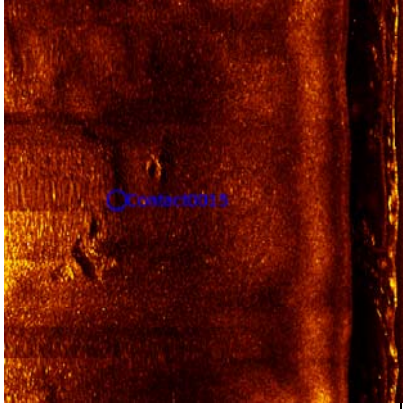
<p>SS-15</p> <ul style="list-style-type: none"> • Sonar Time at Target: 02/05/2013 17:19:17 • Click Position (Projected Coordinates) (X) 2213482.15 (Y) 232172.32 • Map Proj: SC83F • Acoustic Source File: C:\SonarWiz-Projects\Edisto\05FEB271-to-05FEB287.csf • Ping Number: 12901 • Range to Target: 21.56 US Feet • Fish Height: 0.47 US Feet • Heading: 57.100 degrees • Event Number: 0 • Line Name: 05FEB271-to-05FEB287 	<p>Dimensions</p> <p>Target Height: = 0 US Feet Target Length: 10 US Feet Target Shadow: 0 US Feet Target Width: 6 US Feet Mag Anomaly: Avoidance Area: Classification 1: Classification 2: Area: Block: Description: objects on bottom</p>

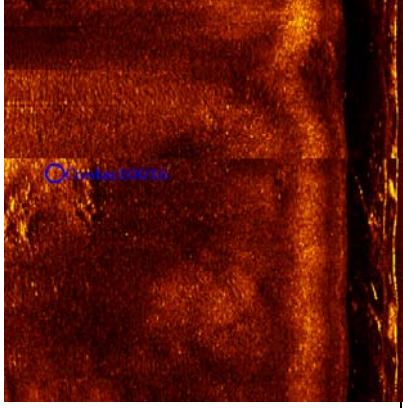
<p>SS-16</p> <ul style="list-style-type: none"> • Sonar Time at Target: 02/05/2013 17:19:27 • Click Position (Projected Coordinates) (X) 2213536.97 (Y) 232231.00 • Map Proj: SC83F • Acoustic Source File: C:\SonarWiz-Projects\Edisto\05FEB271-to-05FEB287.csf • Ping Number: 13114 • Range to Target: 26.19 US Feet • Fish Height: 0.47 US Feet • Heading: 56.100 degrees • Event Number: 0 • Line Name: 05FEB271-to-05FEB287 	<p>Dimensions</p> <p>Target Height: = 0 US Feet Target Length: 22 US Feet Target Shadow: 0 US Feet Target Width: 11 US Feet Mag Anomaly: Avoidance Area: Classification 1: Classification 2: Area: Block: Description: looks like wood maybe</p>

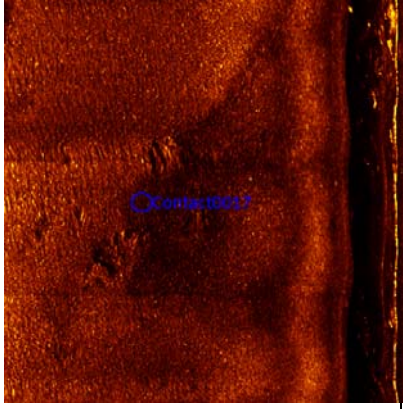
<p>SS-17</p> <ul style="list-style-type: none"> • Sonar Time at Target: 02/05/2013 17:50:30 • Click Position (Projected Coordinates) (X) 2213811.35 (Y) 232306.40 • Map Proj: SC83F • Acoustic Source File: C:\SonarWiz-Projects\Edisto\05FEB289-to-05FEB307.csf • Ping Number: 14656 • Range to Target: 19.75 US Feet • Fish Height: 0.35 US Feet • Heading: 58.800 degrees • Event Number: 0 • Line Name: 05FEB289-to-05FEB307 	<p>Dimensions</p> <p>Target Height: = 0 US Feet Target Length: 12 US Feet Target Shadow: 0 US Feet Target Width: 12 US Feet Mag Anomaly: Avoidance Area: Classification 1: Classification 2: Area: Block: Description: stumps on river margin??</p>

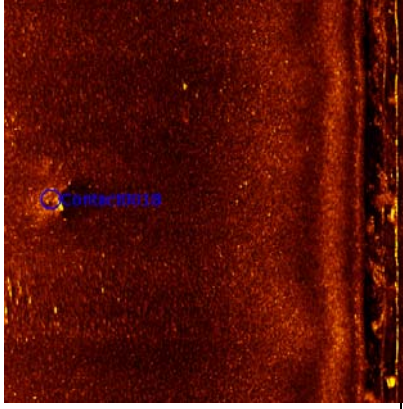
<p>SS-18</p> <ul style="list-style-type: none"> • Sonar Time at Target: 02/05/2013 20:16:28 • Click Position (Projected Coordinates) (X) 2214250.00 (Y) 232106.87 • Map Proj: SC83F • Acoustic Source File: C:\SonarWiz-Projects\Edisto\05FEB446-to-05FEB464.csf • Ping Number: 14547 • Range to Target: 26.43 US Feet • Fish Height: 0.35 US Feet • Heading: 50.600 degrees • Event Number: 0 • Line Name: 05FEB446-to-05FEB464 	<p>Dimensions</p> <p>Target Height: = 0 US Feet Target Length: 4 US Feet Target Shadow: 0 US Feet Target Width: 4 US Feet Mag Anomaly: Avoidance Area: Classification 1: Classification 2: Area: Block: Description: Crab Pot</p>

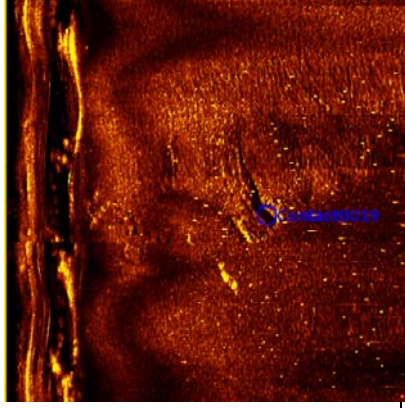
<p>SS-19</p> <ul style="list-style-type: none"> • Sonar Time at Target: 02/05/2013 16:16:34 • Click Position (Projected Coordinates) (X) 2213379.06 (Y) 232074.21 • Map Proj: SC83F • Acoustic Source File: C:\SonarWiz-Projects\Edisto\05FEB234-to-05FEB250.csf • Ping Number: 12138 • Range to Target: 19.51 US Feet • Fish Height: 0.35 US Feet • Heading: 51.900 degrees • Event Number: 0 • Line Name: 05FEB234-to-05FEB250 	<p>Dimensions</p> <p>Target Height: = 0 US Feet Target Length: 22 US Feet Target Shadow: 0 US Feet Target Width: 9 US Feet Mag Anomaly: Avoidance Area: Classification 1: Classification 2: Area: Block: Description: Object on bottom</p>

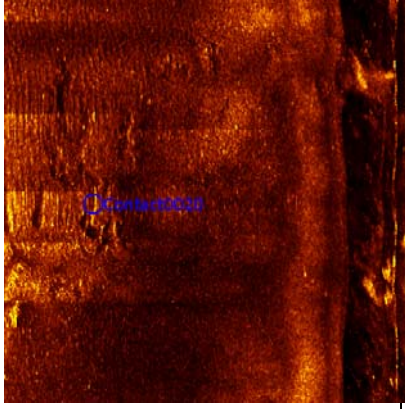
<p>SS-20</p> <ul style="list-style-type: none"> • Sonar Time at Target: 02/05/2013 16:16:27 • Click Position (Projected Coordinates) (X) 2213250.53 (Y) 232149.44 • Map Proj: SC83F • Acoustic Source File: C:\SonarWiz-Projects\Edisto\05FEB234-to-05FEB250.csf • Ping Number: 11992 • Range to Target: 23.32 US Feet • Fish Height: 0.35 US Feet • Heading: 65.700 degrees • Event Number: 0 • Line Name: 05FEB234-to-05FEB250 	<p>Dimensions</p> <p>Target Height: = 0 US Feet Target Length: 28 US Feet Target Shadow: 0 US Feet Target Width: 31 US Feet Mag Anomaly: Avoidance Area: Classification 1: Classification 2: Area: Block: Description: texture difference in parallel - matting??</p>

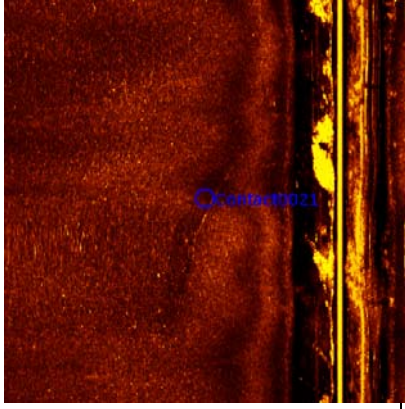
<p>SS-21</p> <ul style="list-style-type: none"> • Sonar Time at Target: 02/06/2013 17:24:01 • Click Position (Projected Coordinates) (X) 2213194.12 (Y) 229815.08 • Map Proj: SC83F • Acoustic Source File: C:\SonarWiz-Projects\Edisto2\06FEB417-to-06FEB434.csf • Ping Number: 9006 • Range to Target: 9.90 US Feet • Fish Height: 0.41 US Feet • Heading: 52.600 degrees • Event Number: 0 • Line Name: 06FEB417-to-06FEB434 	<p>Dimensions</p> <p>Target Height: = 0 US Feet Target Length: 24 US Feet Target Shadow: 0 US Feet Target Width: 0 US Feet Mag Anomaly: Avoidance Area: Classification 1: Classification 2: Area: Block: Description: teeny piece of cable??</p>

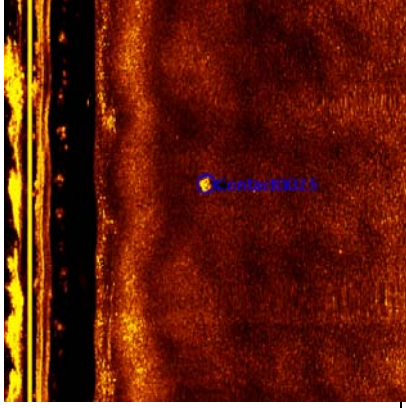
<p>SS-25</p> <ul style="list-style-type: none"> • Sonar Time at Target: 02/07/2013 04:38:32 • Click Position (Projected Coordinates) (X) 2215945.56 (Y) 228491.46 • Map Proj: SC83F • Acoustic Source File: C:\SonarWiz-Projects\Edisto3\06FE1216-to-06FE1234.csf • Ping Number: 4256 • Range to Target: 13.07 US Feet • Fish Height: 0.00 US Feet • Heading: 230.900 degrees • Event Number: 0 • Line Name: 06FE1216-to-06FE1234 	<p>Dimensions</p> <p>Target Height: = 0 US Feet Target Length: 3 US Feet Target Shadow: 0 US Feet Target Width: 3 US Feet Mag Anomaly: Avoidance Area: Classification 1: Classification 2: Area: Block: Description: crab pot</p>

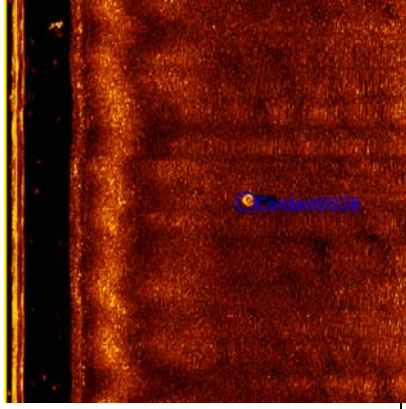
<p>SS-26</p> <ul style="list-style-type: none"> • Sonar Time at Target: 02/07/2013 04:30:13 • Click Position (Projected Coordinates) (X) 2215948.11 (Y) 228486.05 • Map Proj: SC83F • Acoustic Source File: C:\SonarWiz-Projects\Edisto3\06FE1196-to-06FE1215.csf • Ping Number: 13676 • Range to Target: 17.99 US Feet • Fish Height: 0.00 US Feet • Heading: 57.900 degrees • Event Number: 0 • Line Name: 06FE1196-to-06FE1215 	<p>Dimensions</p> <p>Target Height: = 0 US Feet Target Length: 3 US Feet Target Shadow: 0 US Feet Target Width: 3 US Feet Mag Anomaly: Avoidance Area: Classification 1: Classification 2: Area: Block: Description: Crab pot</p>

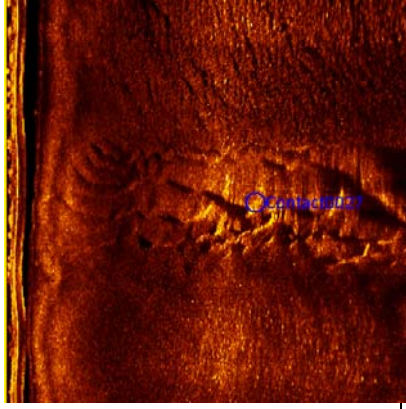
<p>SS-27</p> <ul style="list-style-type: none"> • Sonar Time at Target: 02/06/2013 22:44:20 • Click Position (Projected Coordinates) (X) 2213157.92 (Y) 228191.12 • Map Proj: SC83F • Acoustic Source File: C:\SonarWiz-Projects\Edisto3\06FEB776-to-06FEB794.csf • Ping Number: 7036 • Range to Target: 18.63 US Feet • Fish Height: 0.00 US Feet • Heading: 55.000 degrees • Event Number: 0 • Line Name: 06FEB776-to-06FEB794 	<p>Dimensions</p> <p>Target Height: = 0 US Feet Target Length: 82 US Feet Target Shadow: 0 US Feet Target Width: 22 US Feet Mag Anomaly: Avoidance Area: Classification 1: Classification 2: Area: Block: Description: Exposed sand wave? Bedrock?</p>

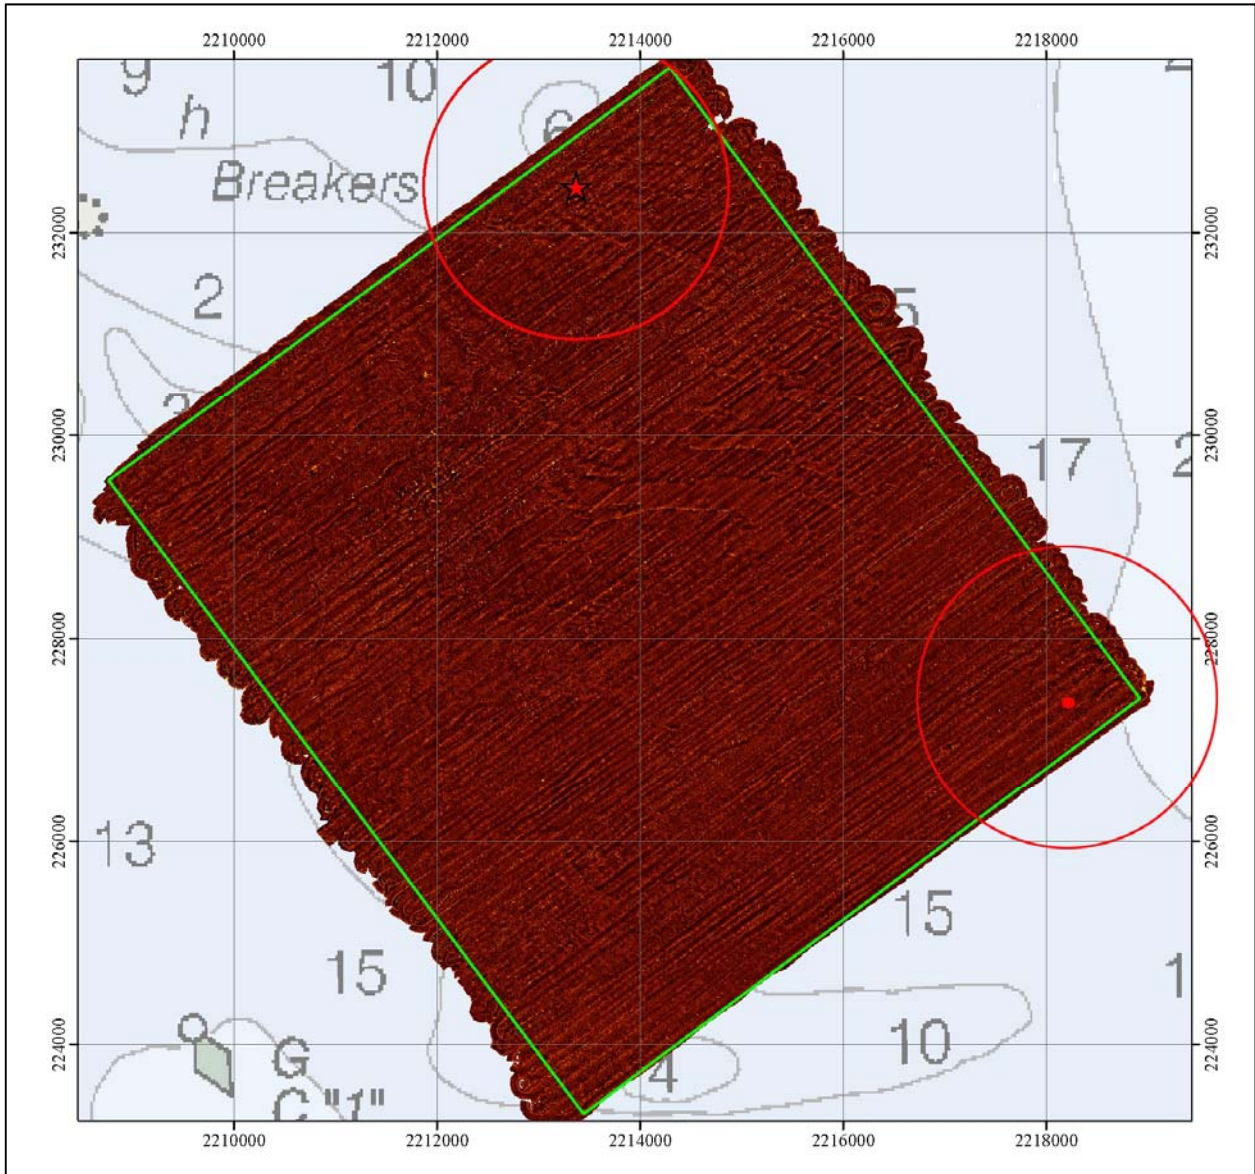
Figure 42. Recommended avoidance zones.

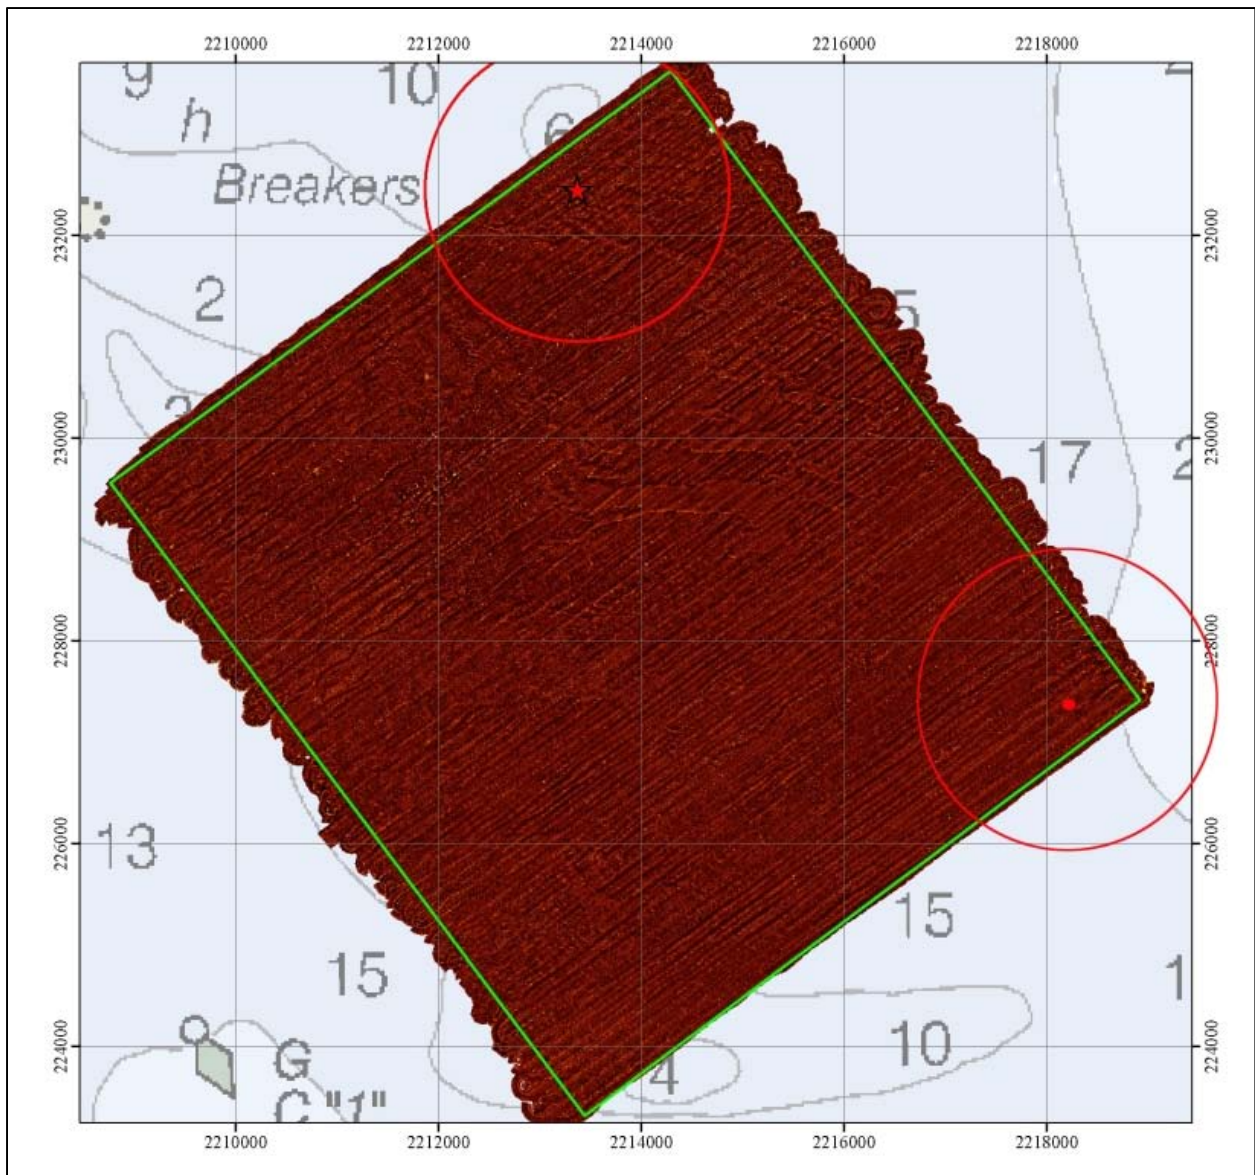
Figure 43. Two recommended avoidance zones.
